**PUBLIC AGENDA
EXECUTIVE COMMITTEE**

**Wednesday, February 11, 2015, 1:00 p.m.
Council Chamber, City Hall**

Nutana Slope Failure Overview

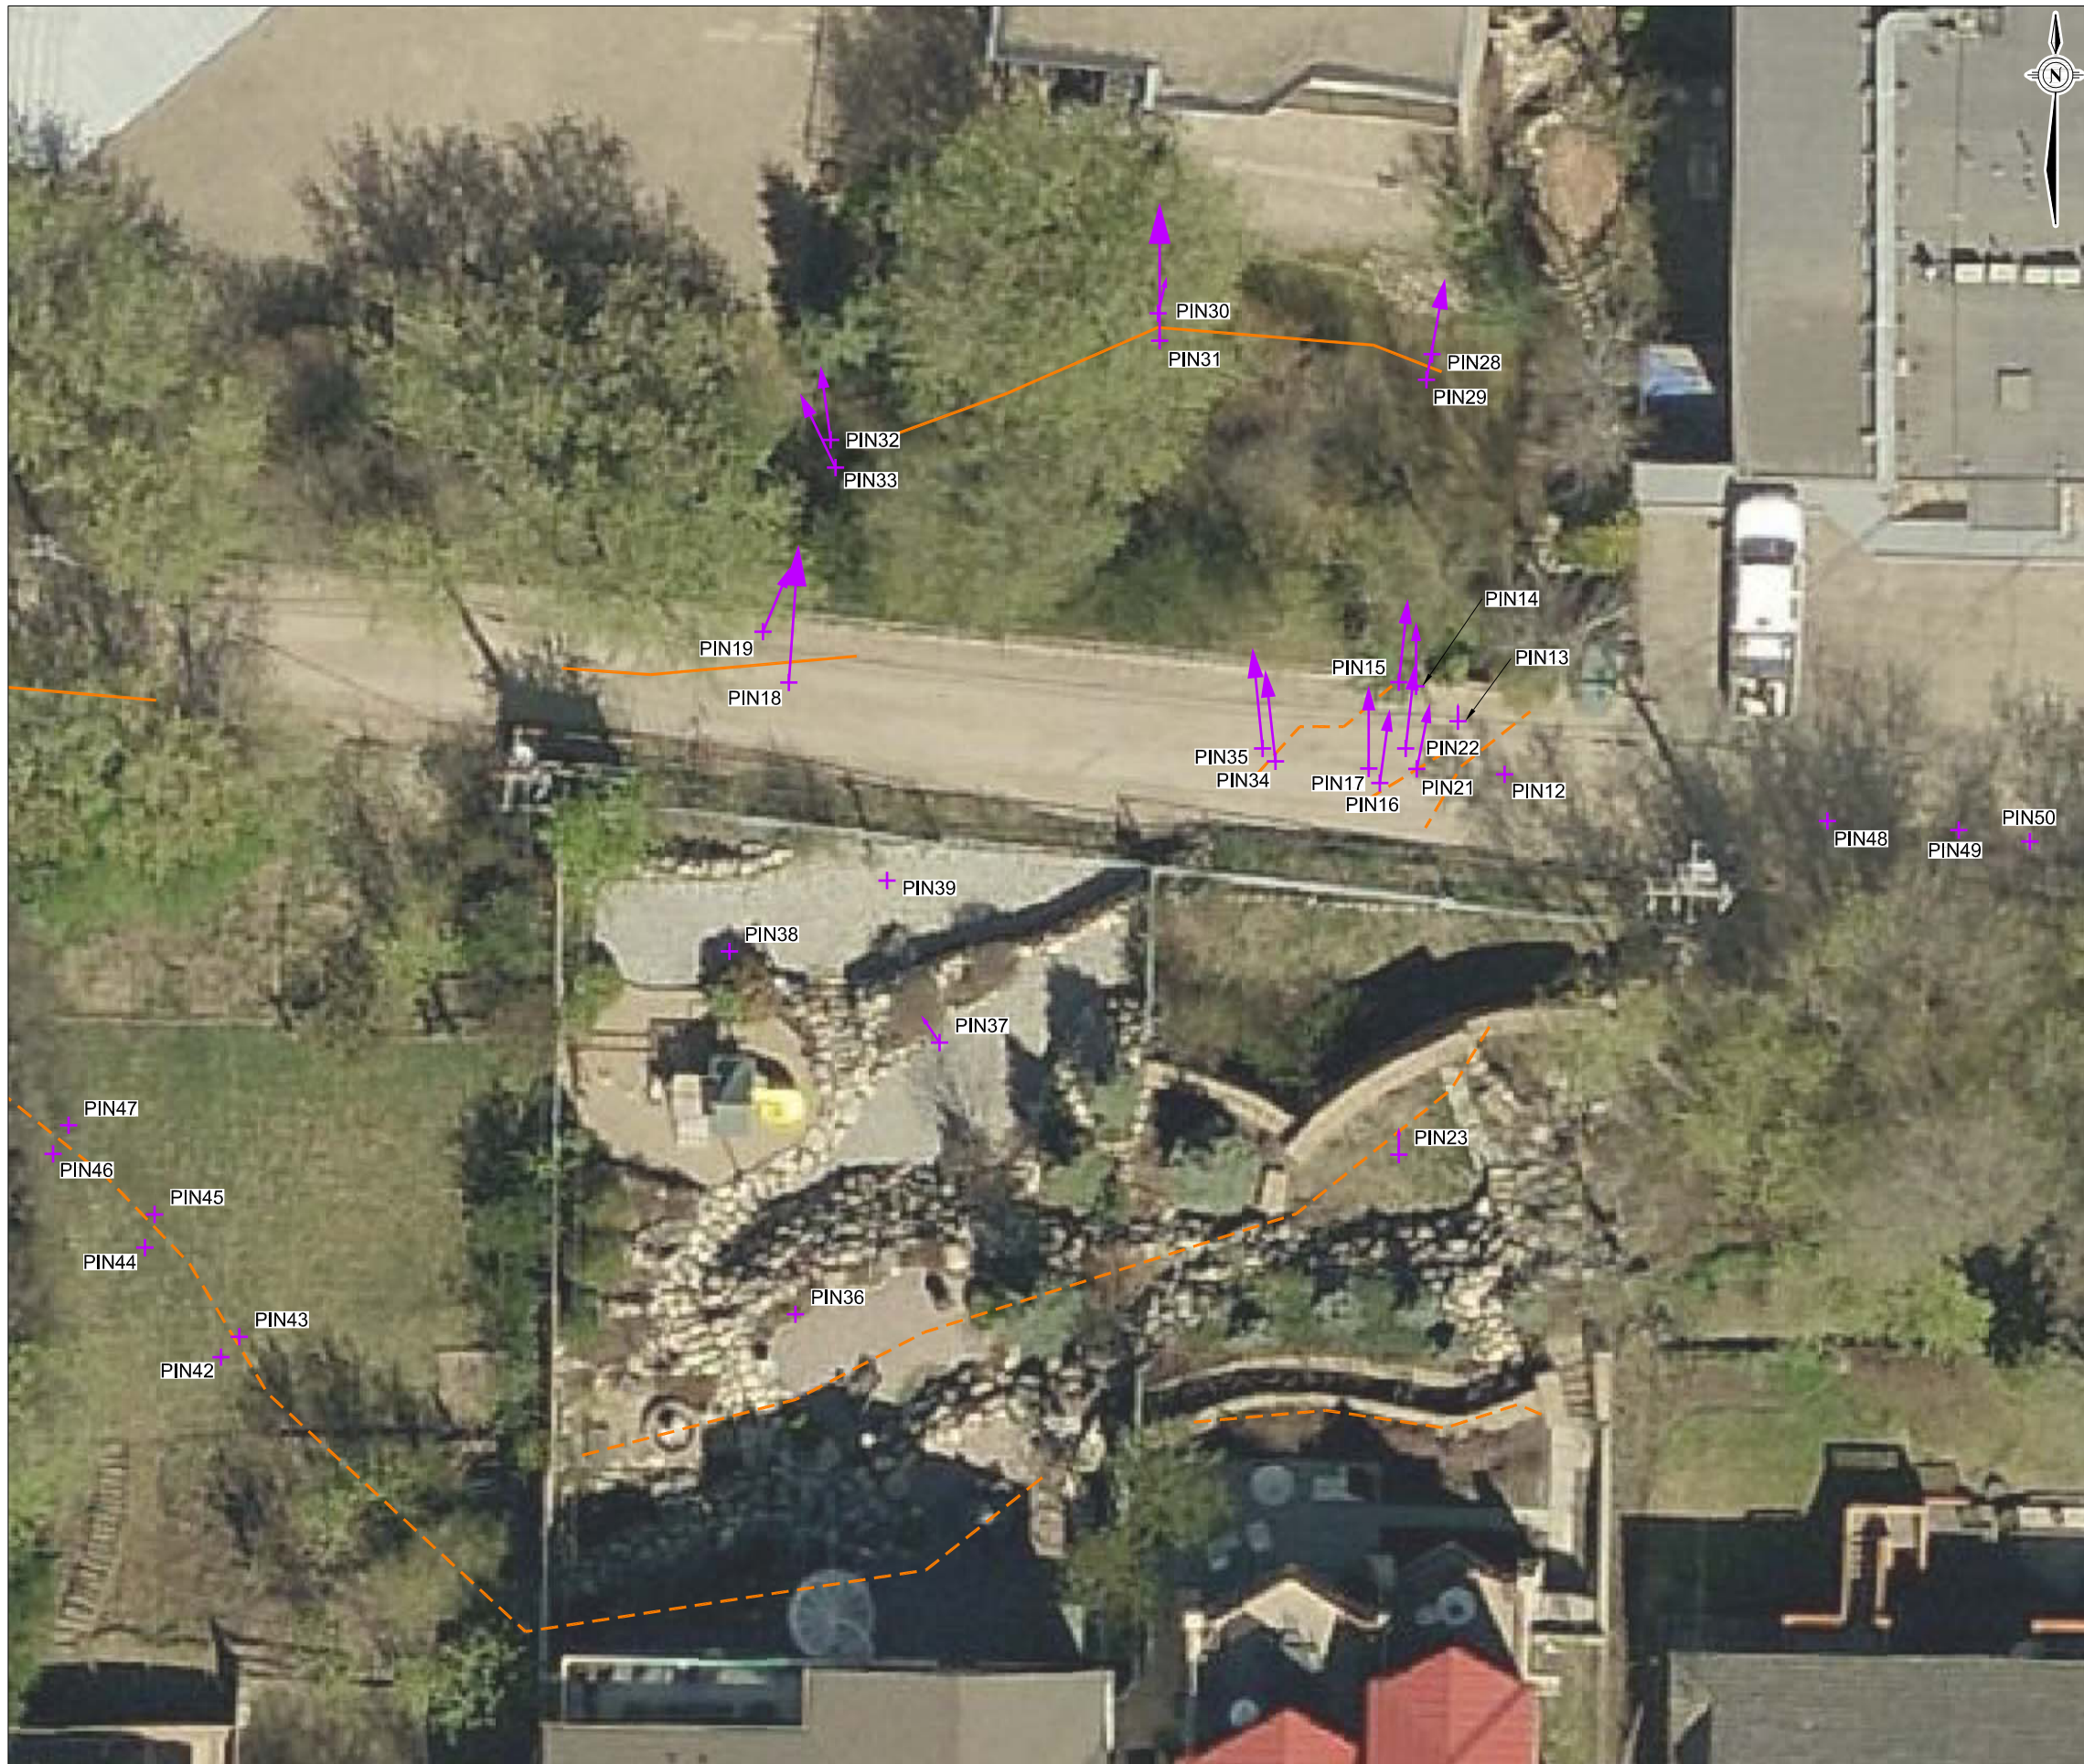
PIN MOVEMENT (BETWEEN JUNE 22-24, 2012)	
PIN NUMBER	RECORDED MOVEMENT (mm)
PIN13	20
PIN14	70
PIN15	91
PIN16	81
PIN17	90
PIN18	150
PIN19	76
PIN21	73
PIN22	91
PIN23	30
PIN29	112
PIN30	41
PIN31	150
PIN32	81
PIN33	89
PIN34	100
PIN35	110
PIN37	36

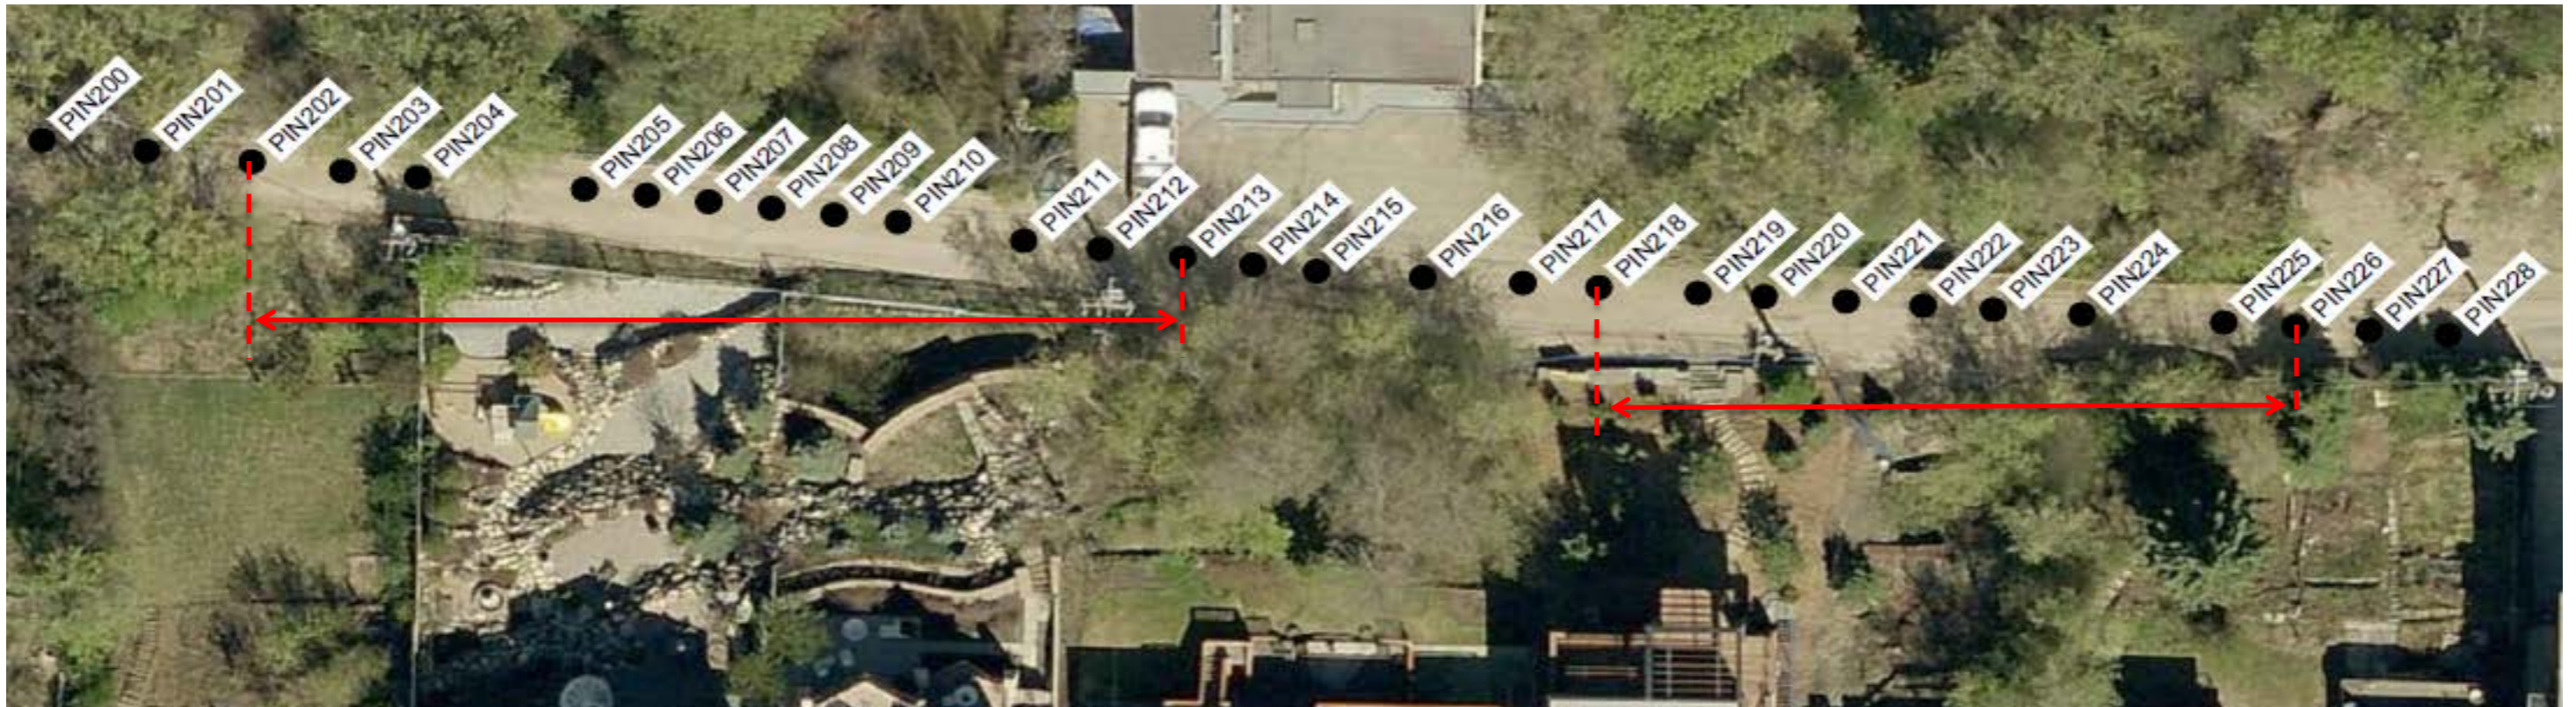
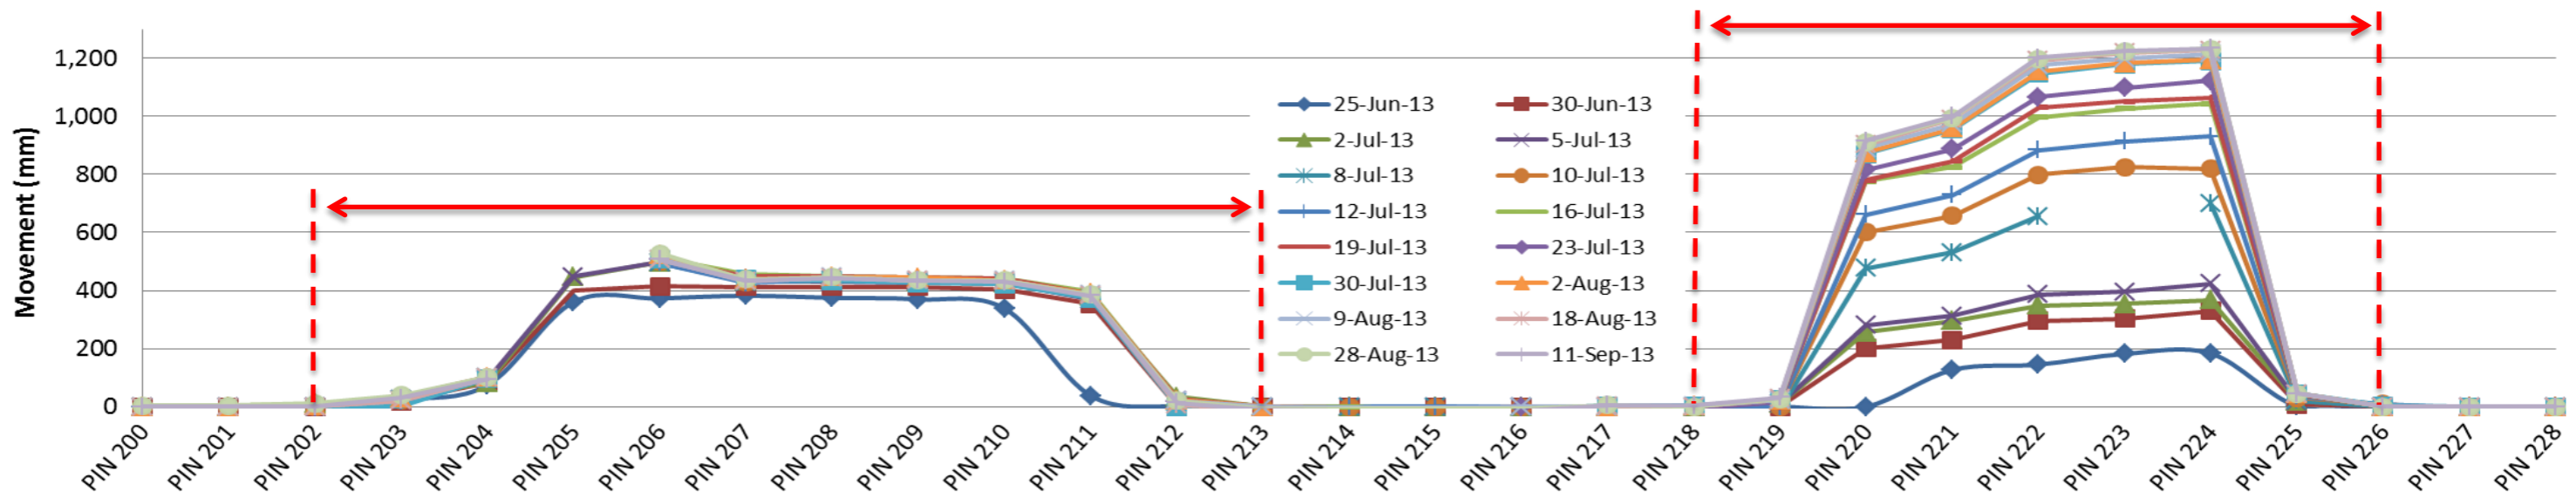
The rate of movement for the 200 series of pins has been less than 5 mm since July 2013 at the West Failure and since August 2013 at the East Failure.

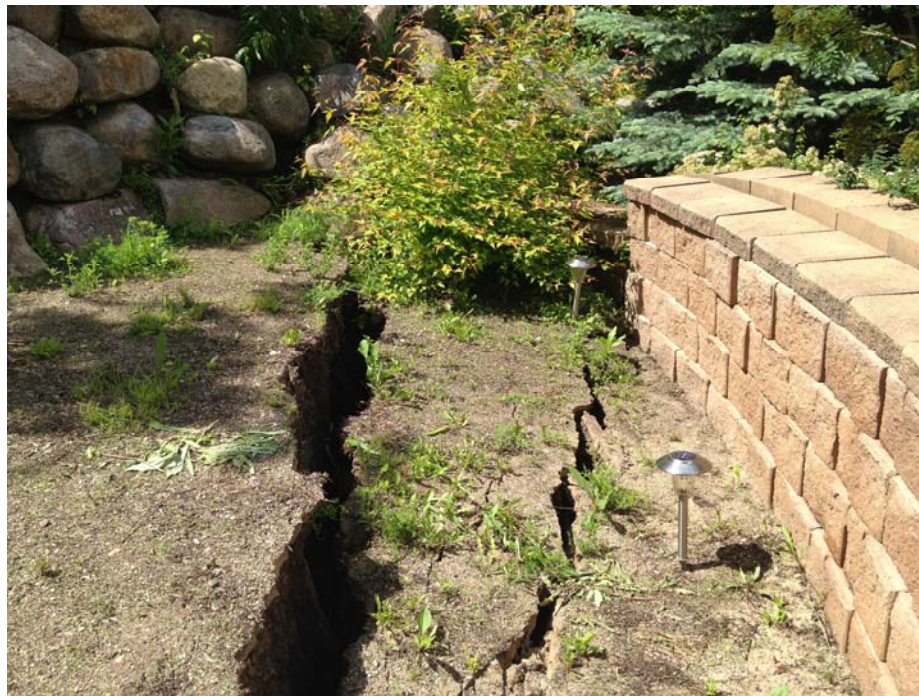
Photo C.8. Cracking Behind Retaining Wall in Backyard of 237-239 11th St. E. (June 21, 2012)

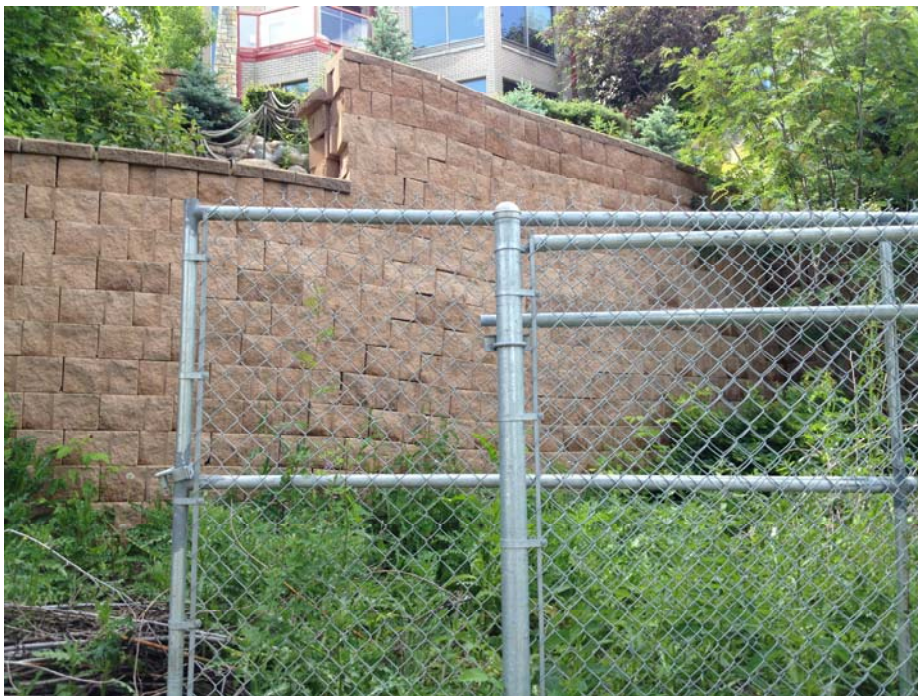
Photo C.9. Retaining Wall in Backyard of 237-239 11th St. E. (June 21, 2012)

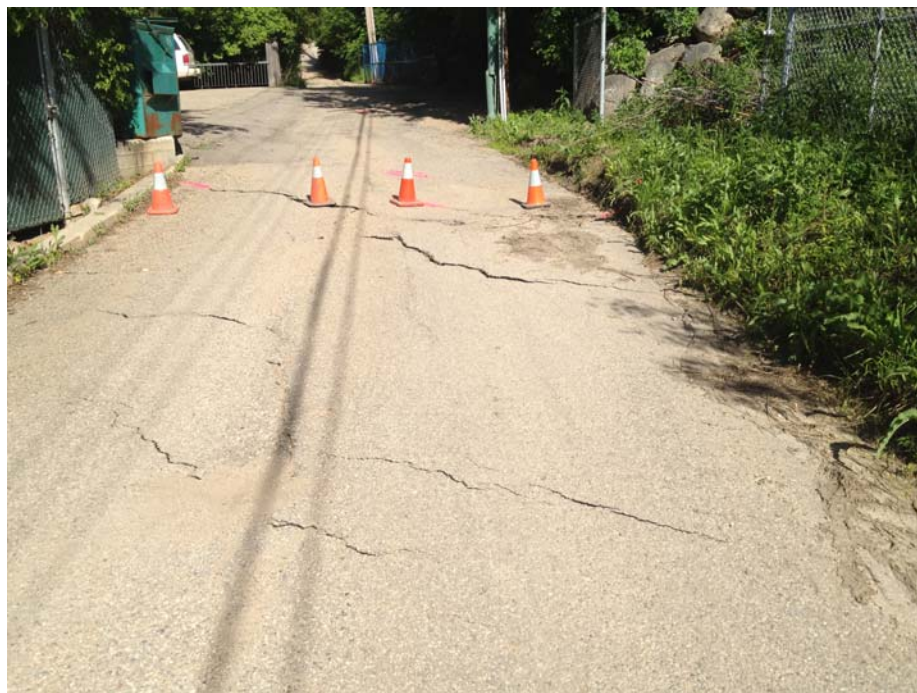
Photo C.10. Looking East at Tension Cracking along Cherry Lane (June 21, 2013)

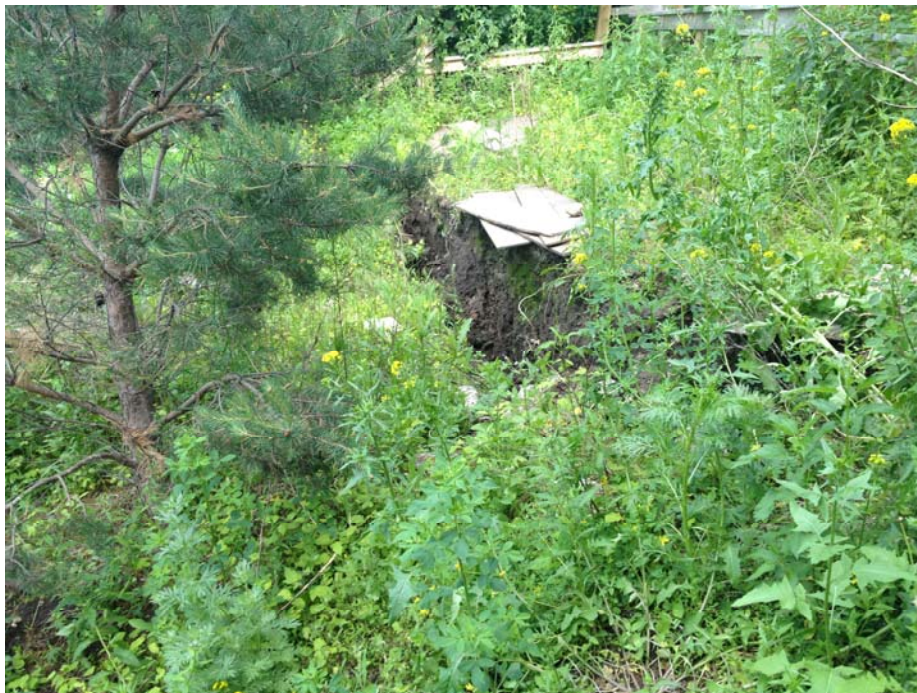
Photo C.12. Looking East at Headscarp of East Failure in Backyard of 305 11th St. E.; Approx. 90 cm Drop (June 24, 2013)

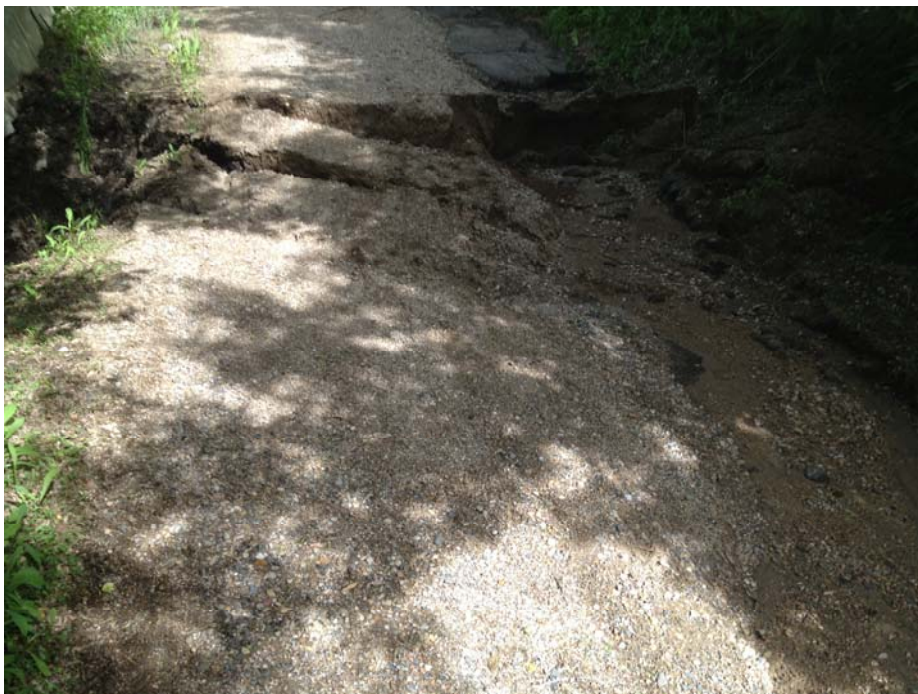
Photo C.15. Looking East at Severe Cracking across Cherry Lane, Pavement; Approx. 50 cm Drop (June 24, 2013)

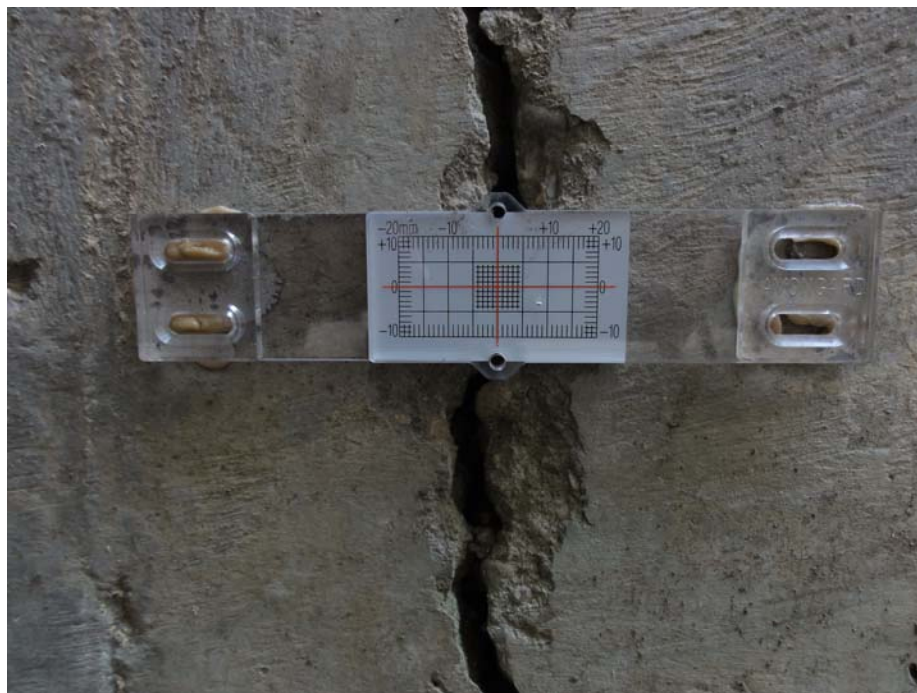
Photo F.2: Crack Meter Located on the Retaining Wall Behind 306 Sask. Cres. E. (CM1) (Sept 18, 2013)

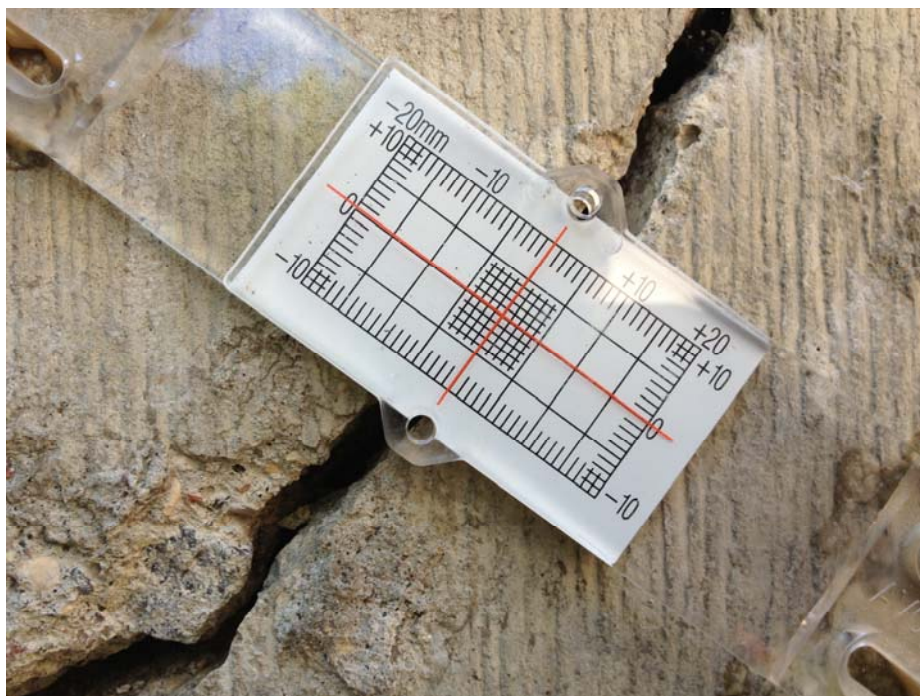
Photo F.3: Crack Meter Located on the East Face of the Retaining Wall Between 230 & 306 Sask. Cres. E. (CM2) (Aug 12, 2013)

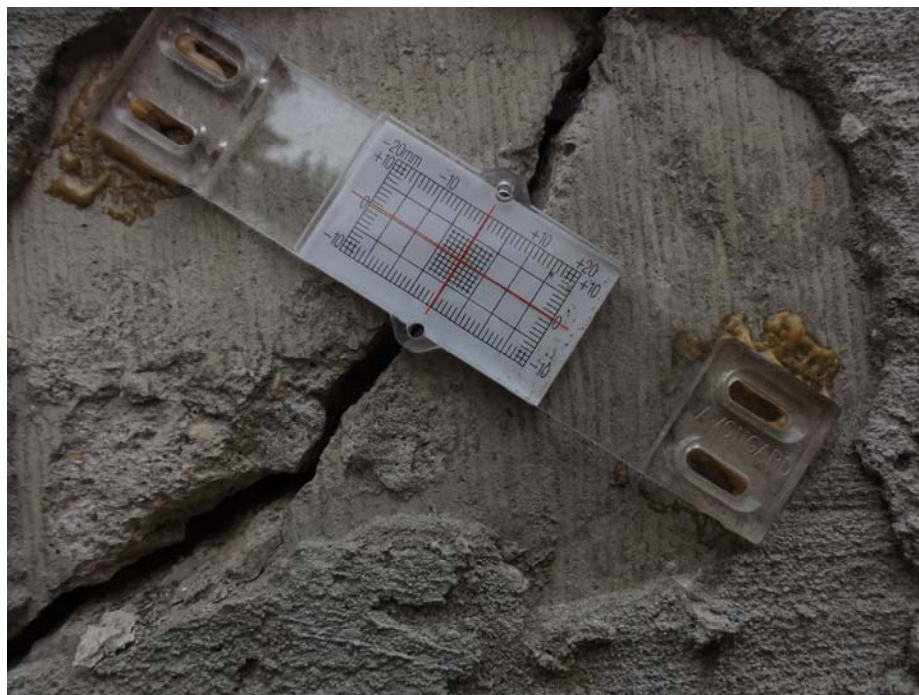
Photo F.4: Crack Meter Located on the East Face of the Retaining Wall Between 230 & 306 Sask. Cres. E. (CM2) (Sept 18, 2013)

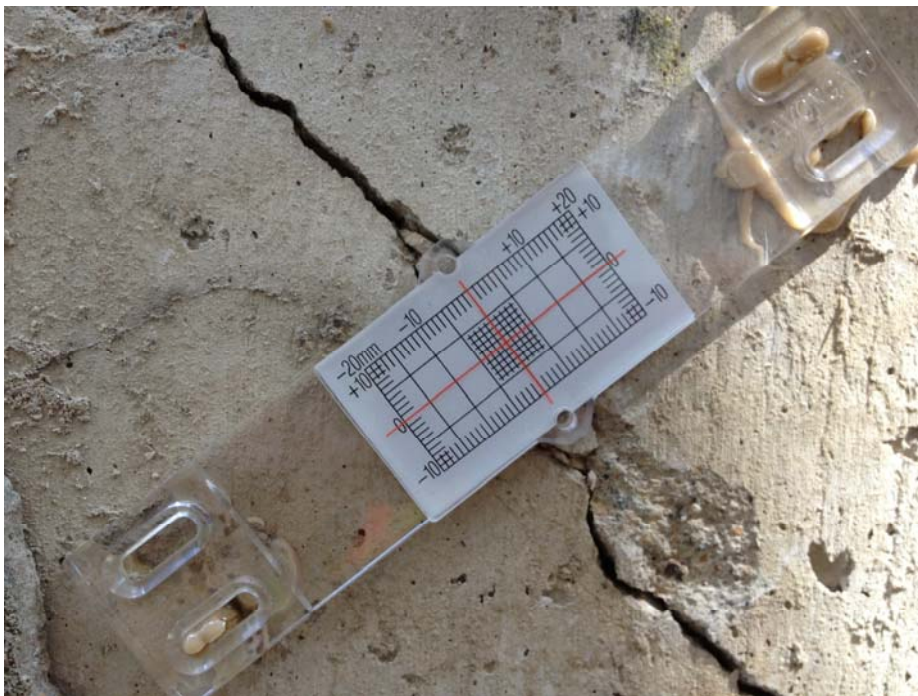
Photo F.5: Crack Meter Located on the West Face of the Retaining Wall Between 230 & 306 Sask. Cres. E. (CM3) (Aug 12, 2013)

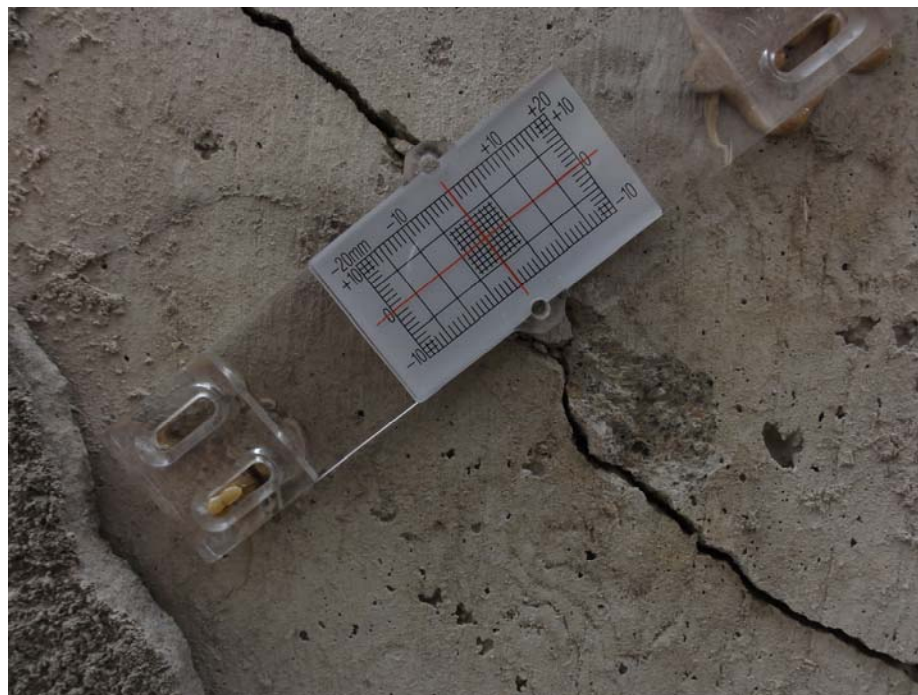
Photo F.6: Crack Meter Located on the West Face of the Retaining Wall Between 230 & 306 Sask. Cres. E. (CM3) (Sept 18, 2013)
