Span 5

Traffic Bridge  
Span #5 175'-0" Truss

## 2010 Traffic Bridge Inspection

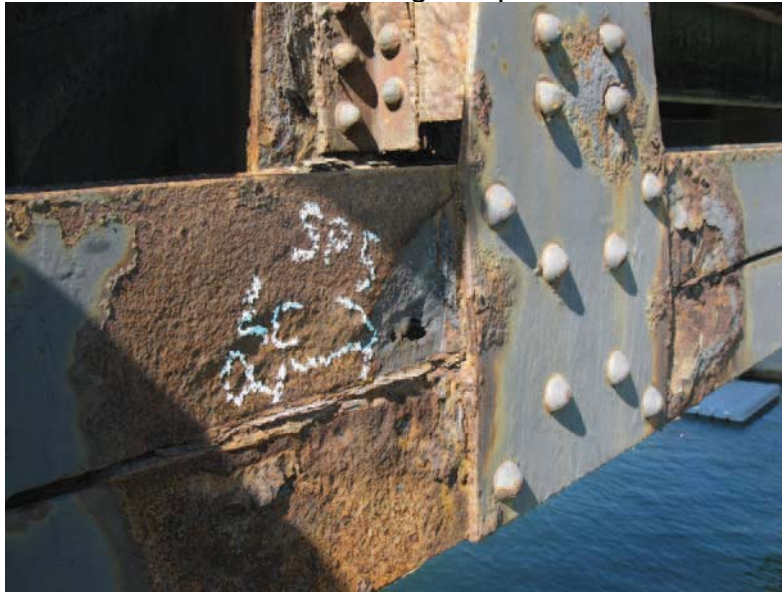
Photo 1

Right Truss, Span 5, Panel Point 2, Lower Chord L0-L1 - Note light to severe corrosion with perforations at connection with Panel Point 2

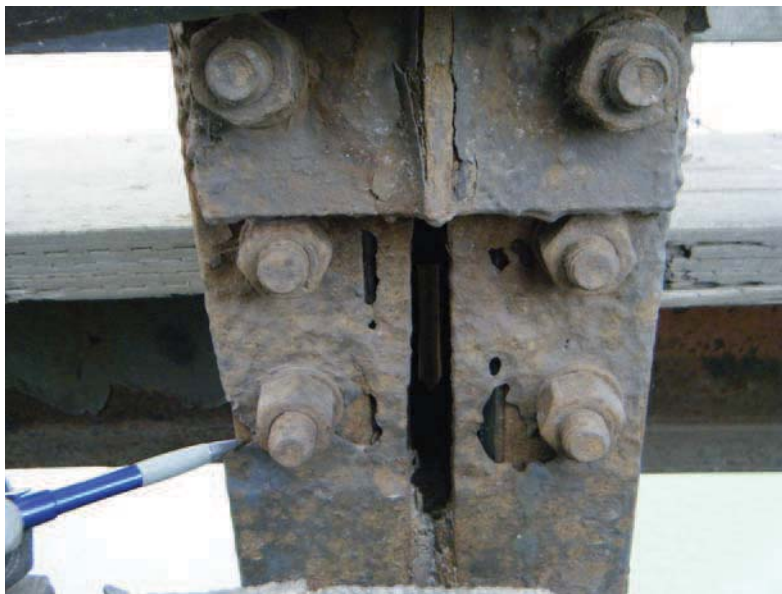
Photo 2

Span 5, LHS, L1 - U1 - Note very severe corrosion with perforations and complete section loss. New plates have been bolted to original angles but original angles are very severely corroded

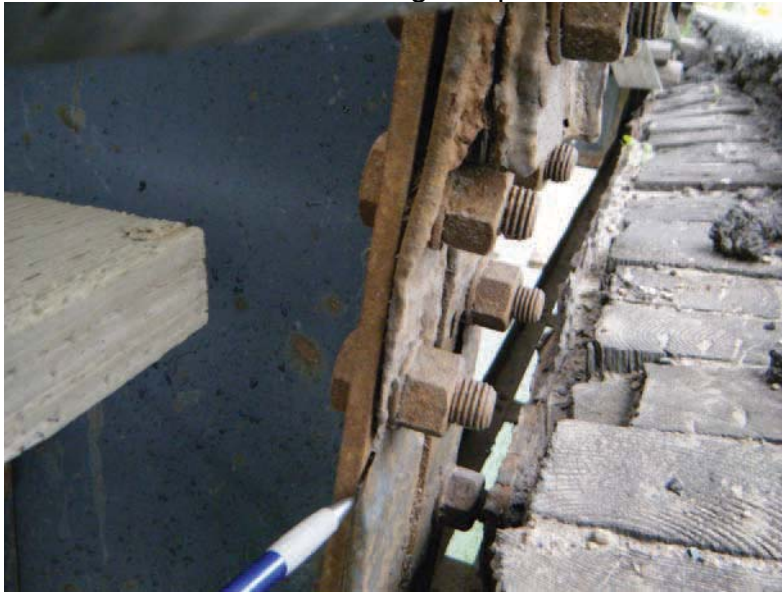
Photo 3

Span 5, LHS, L1 - U1 - Note very severe corrosion with perforations and complete section loss. New plates have been bolted to original angles but original angles are very severely corroded

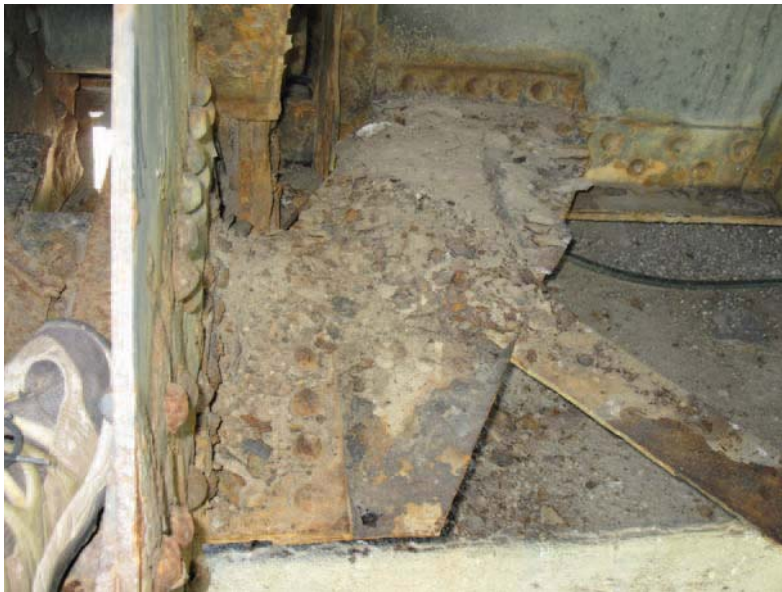
Photo 4

Right Truss, Span 5, Panel Point 0, below deck cross bracing - Note light to severe corrosion with perforations 0 - 100% section loss

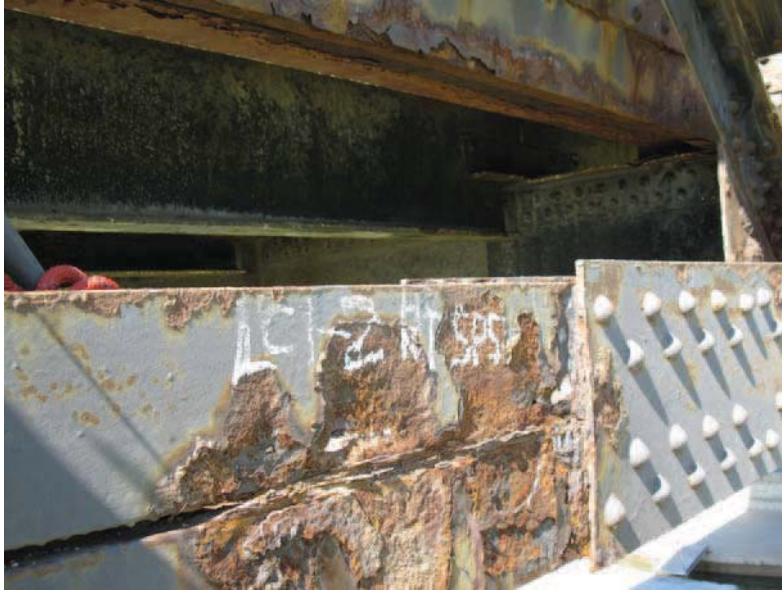
Photo 5

Right Truss, Span 5, Lower Chord L1-L2 - Note severe corrosion with six perforations near Panel Point 2 connection

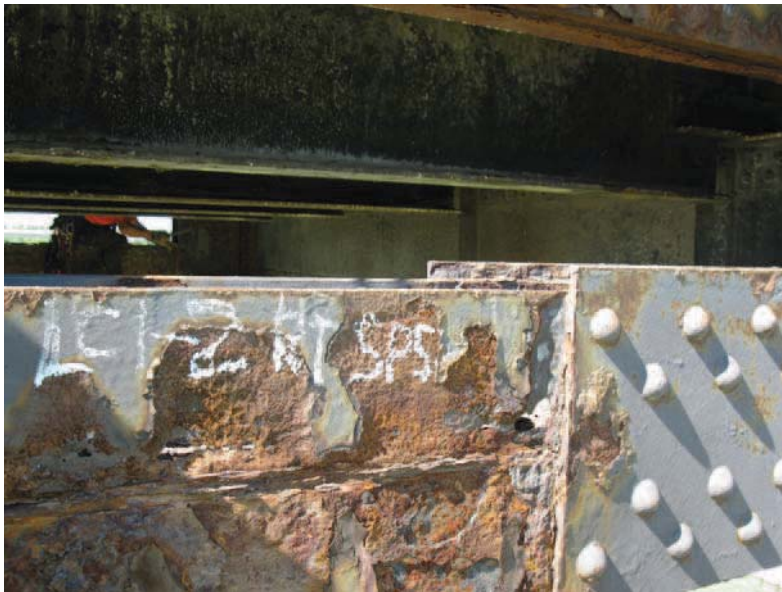
Photo 6

Right Truss, Span 5, Lower Chord L1-L2 - Note severe corrosion with six perforations near Panel Point 2 connection

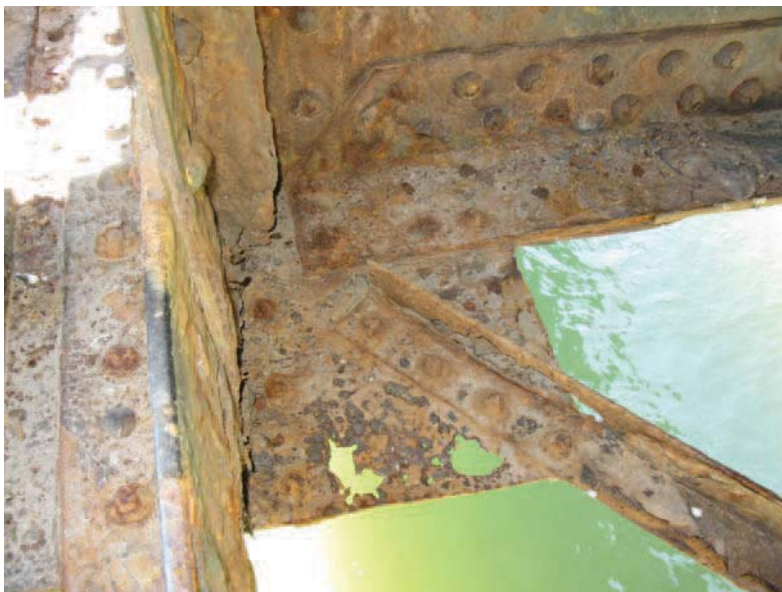
Photo 8

Right Truss, Span 5, Panel Point 2, below deck cross bracing - Note severe corrosion with perforations, 100% section loss

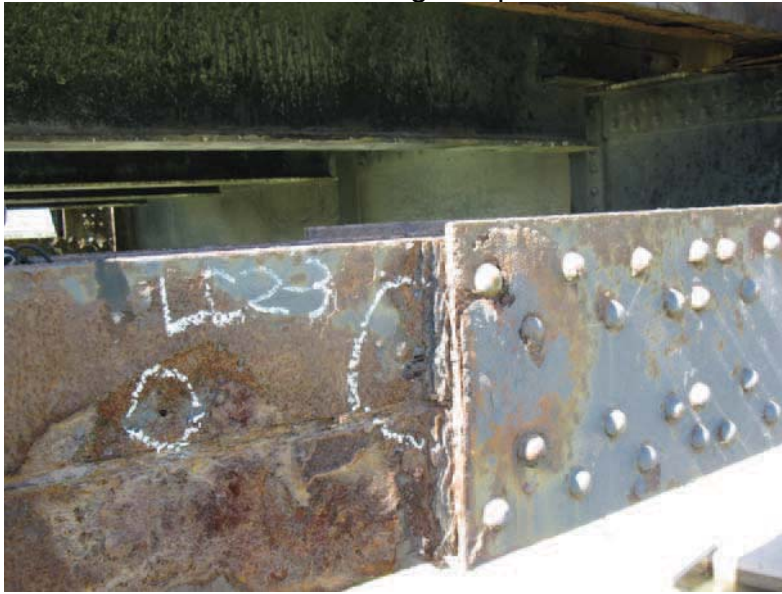
Photo 9

Right Truss, Span 5, Lower Chord L2-L3 - Note light to severe corrosion with perforations

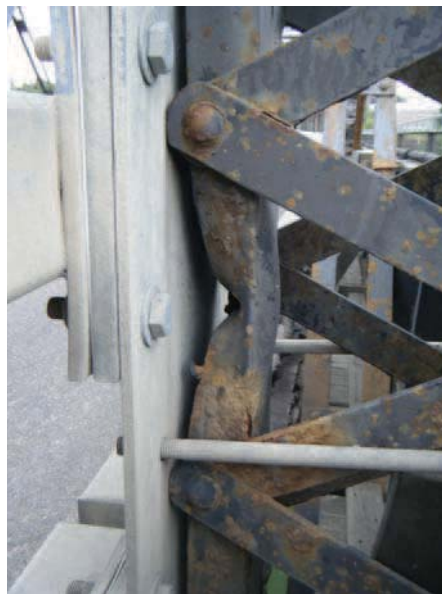
Photo 10

Span 5, LHS, L4 - U4 - Note permanent deformation

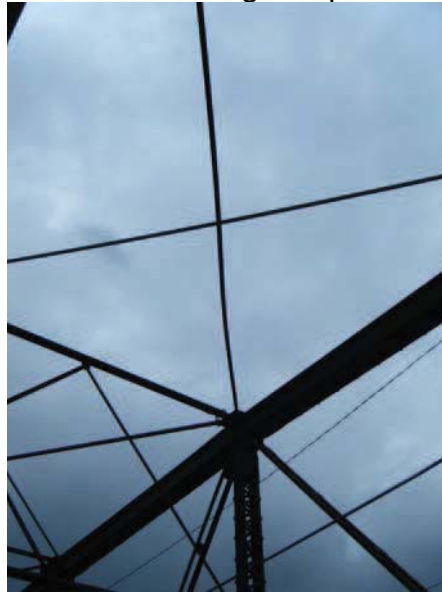
Photo 11

Top chord lateral bracing in span 5 between U4 & U5 - Note permanent deformation

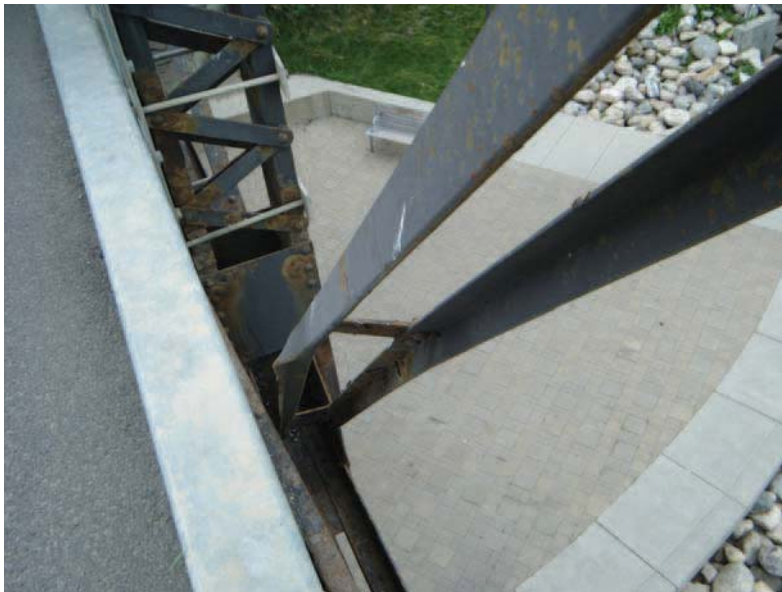
Photo 12

Span 5, RHS, U4 - L5 - Note permanent deformation and misalignment

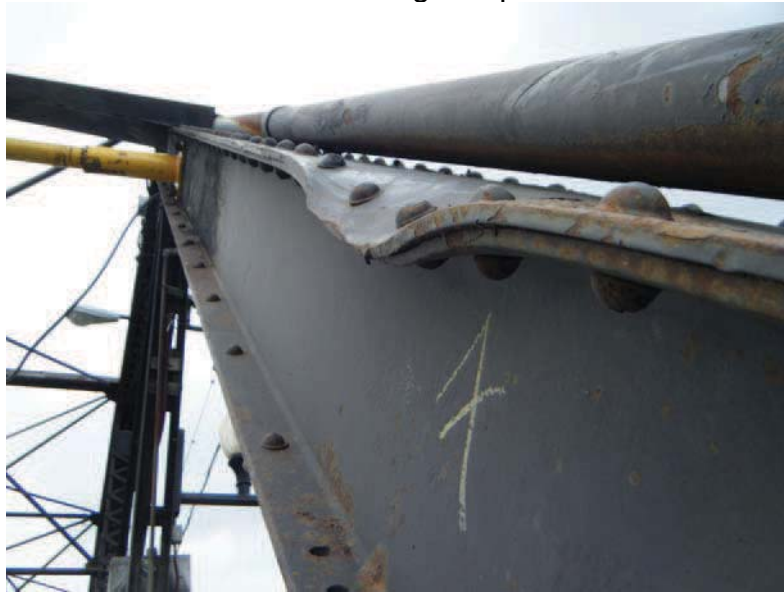
Photo 13

Span 5, LHS, U6 - L7 - Note permanent deformation
