## TECHNICAL MEMORANDUM

**Reference No.** CA0029692.2934-TM-05-Rev0

### NUTANA SLOPE STABILITY UPDATE – SEPTEMBER 2025

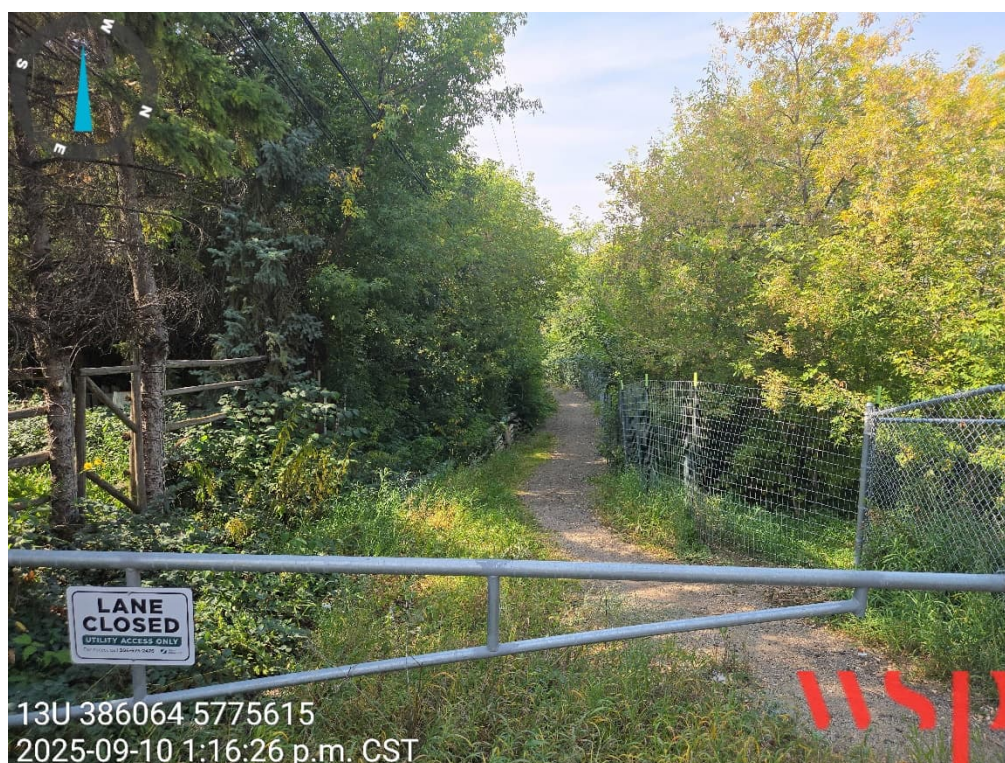
**Photograph 1: Looking west down the back alley at the East Failure (September 10, 2025)**

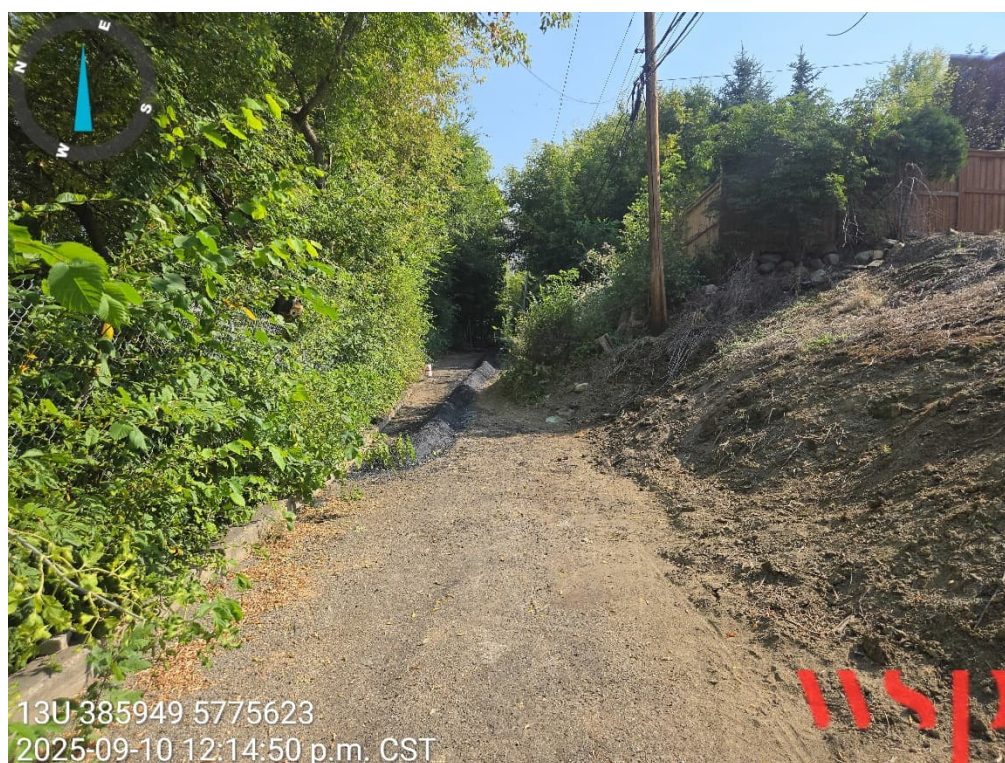
**Photograph 2: Looking east down the back alley at the West Failure (September 10, 2025)**

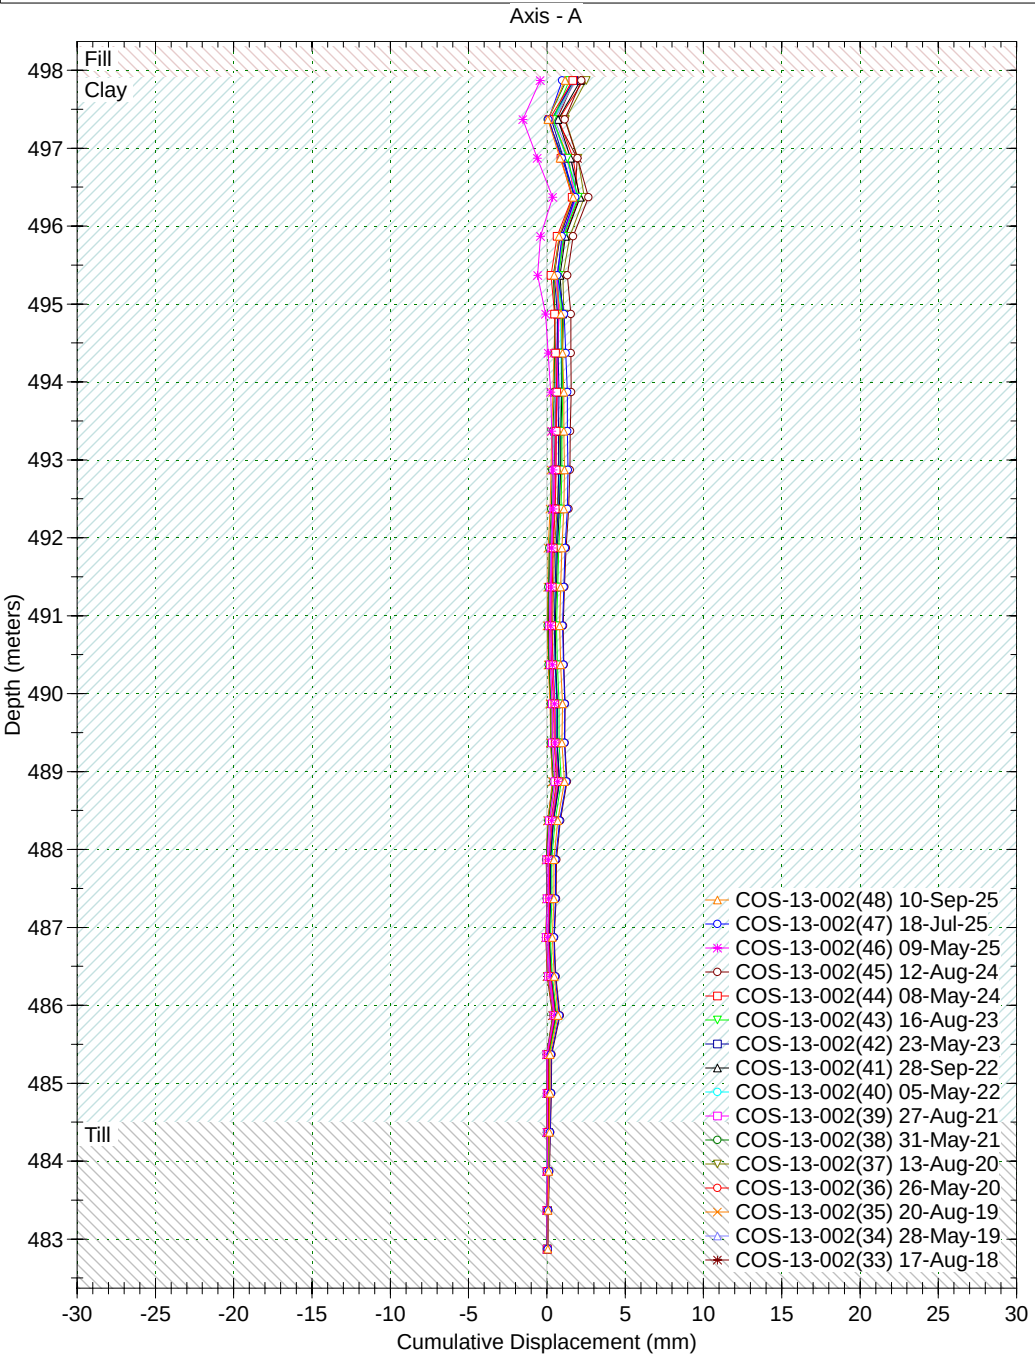
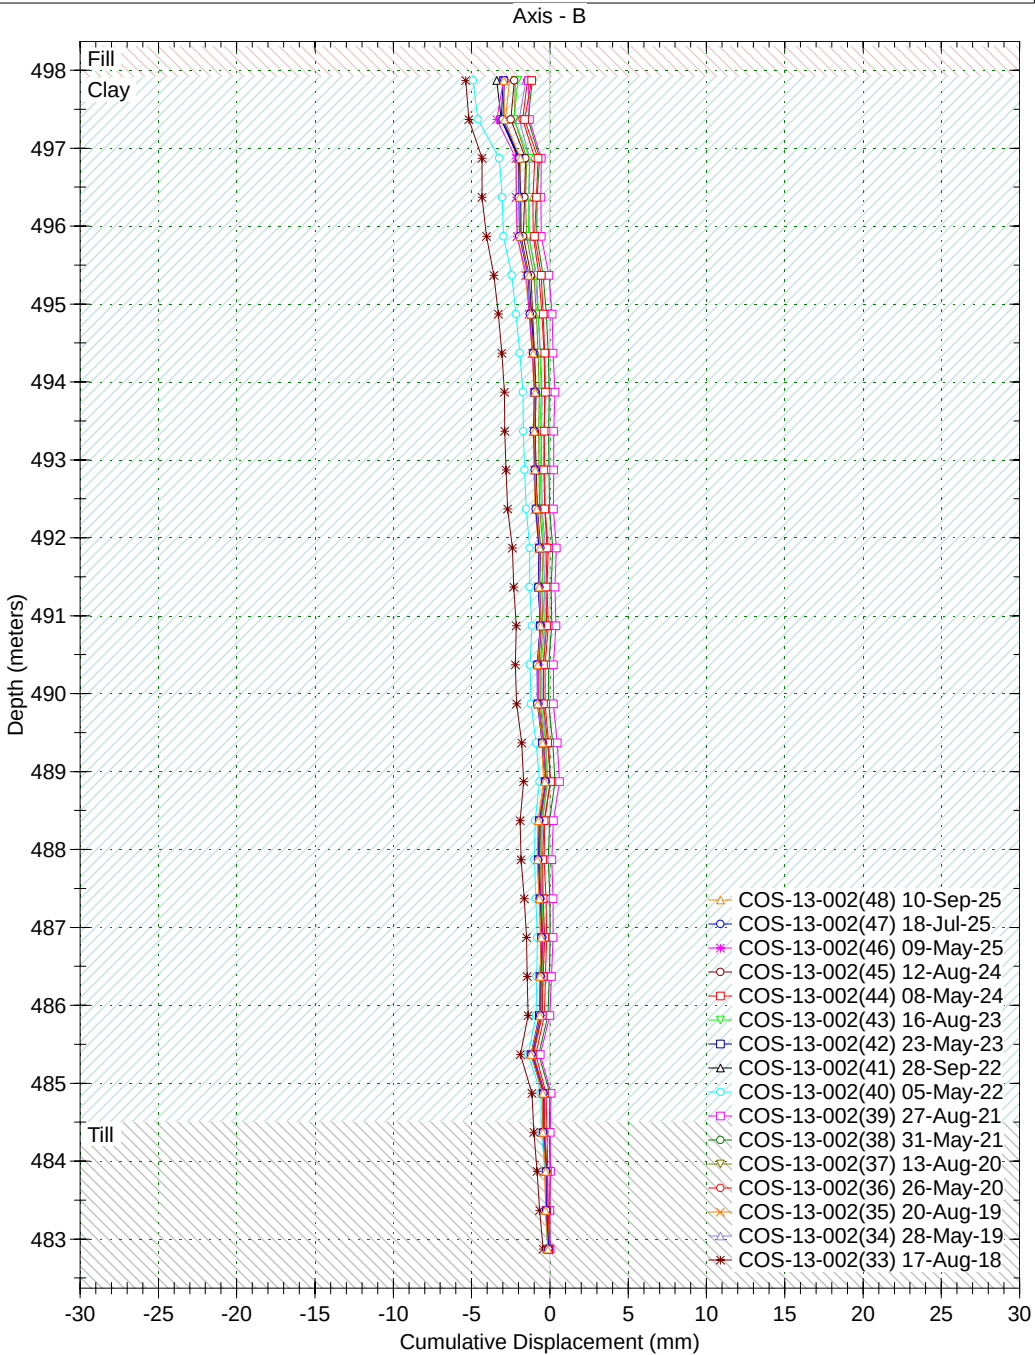
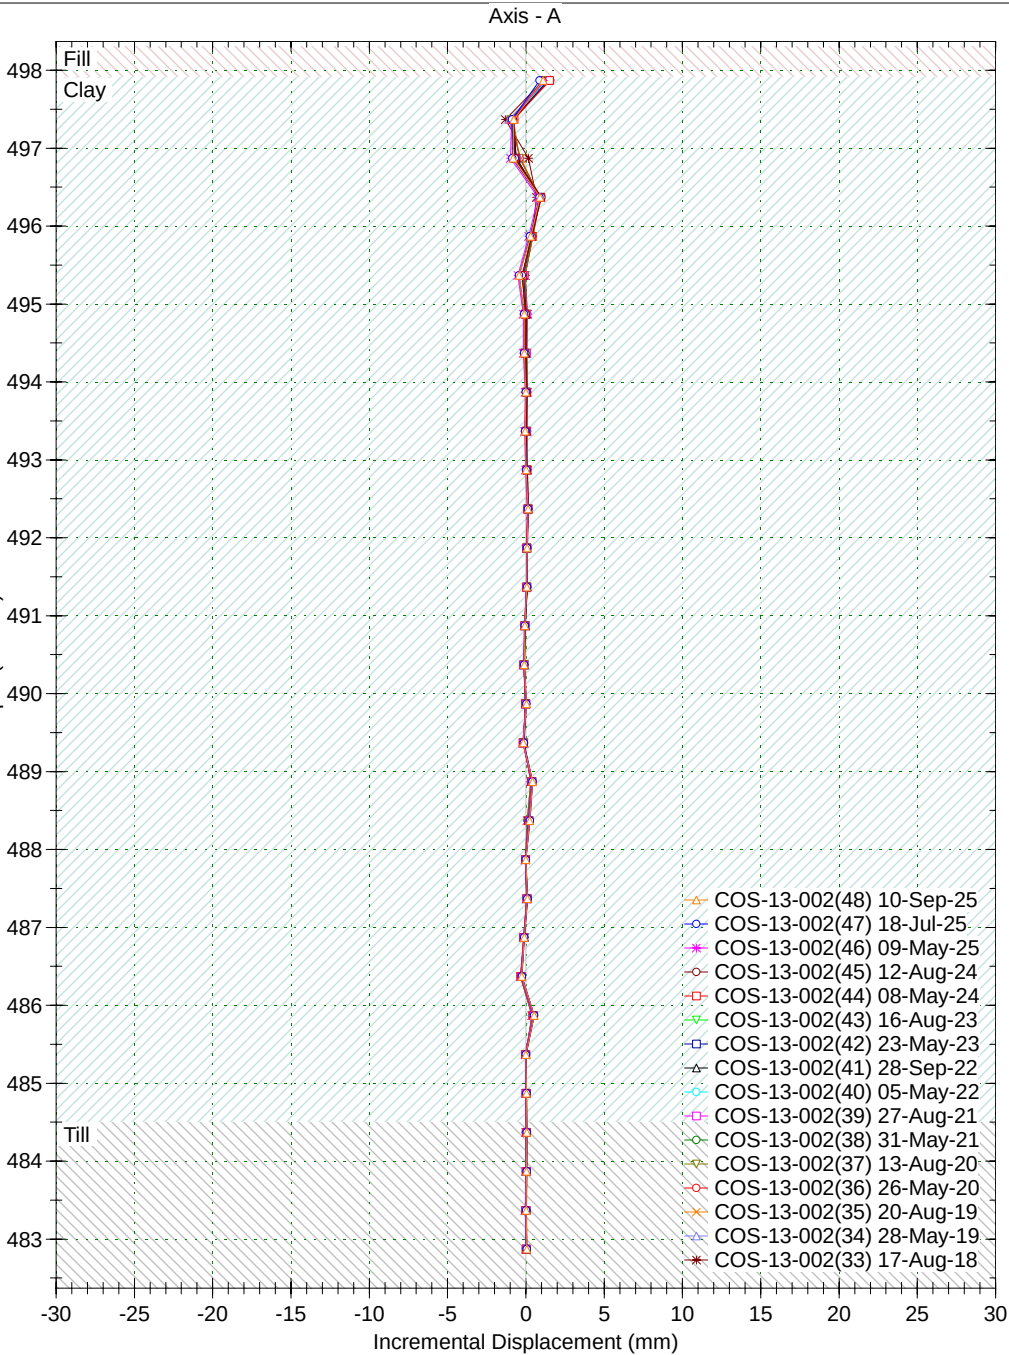
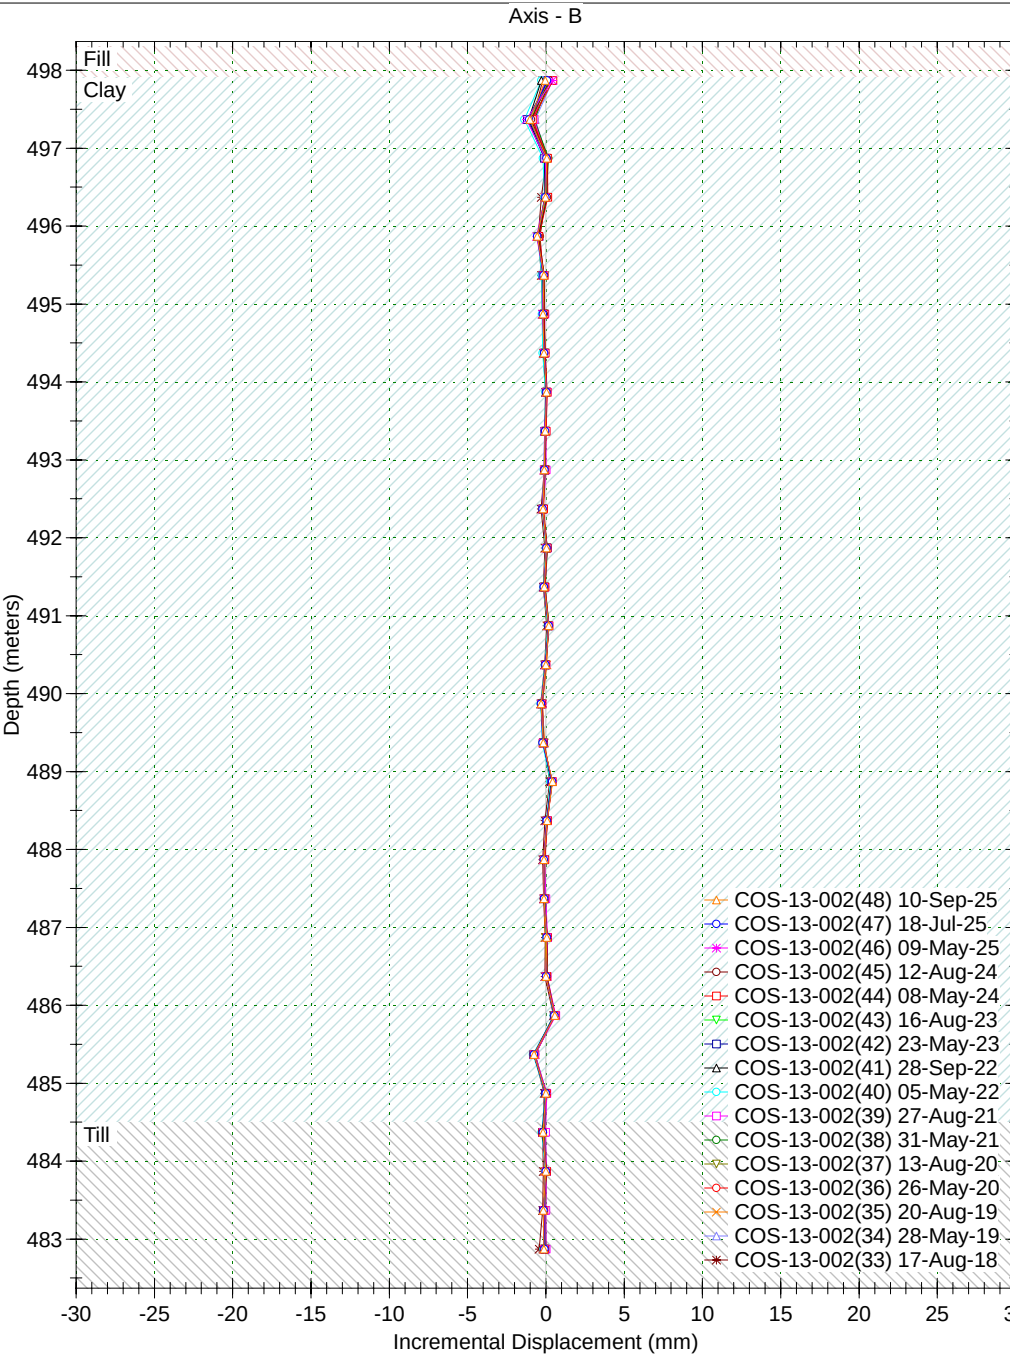
Borehole : COS-13-002  
Project : Nutana Slope  
Location : 307 11th St. E. (Front)  
Northing : 5775567.41  
Easting : 386043.54  
Collar : -0.113

- Inclinometer COS-13-002 plots continue to show a slight drift, with insignificant movement (less than 2 mm or 0.08 in) between July 18 and September 10, 2025, and overall insignificant movement since July 30, 2013.

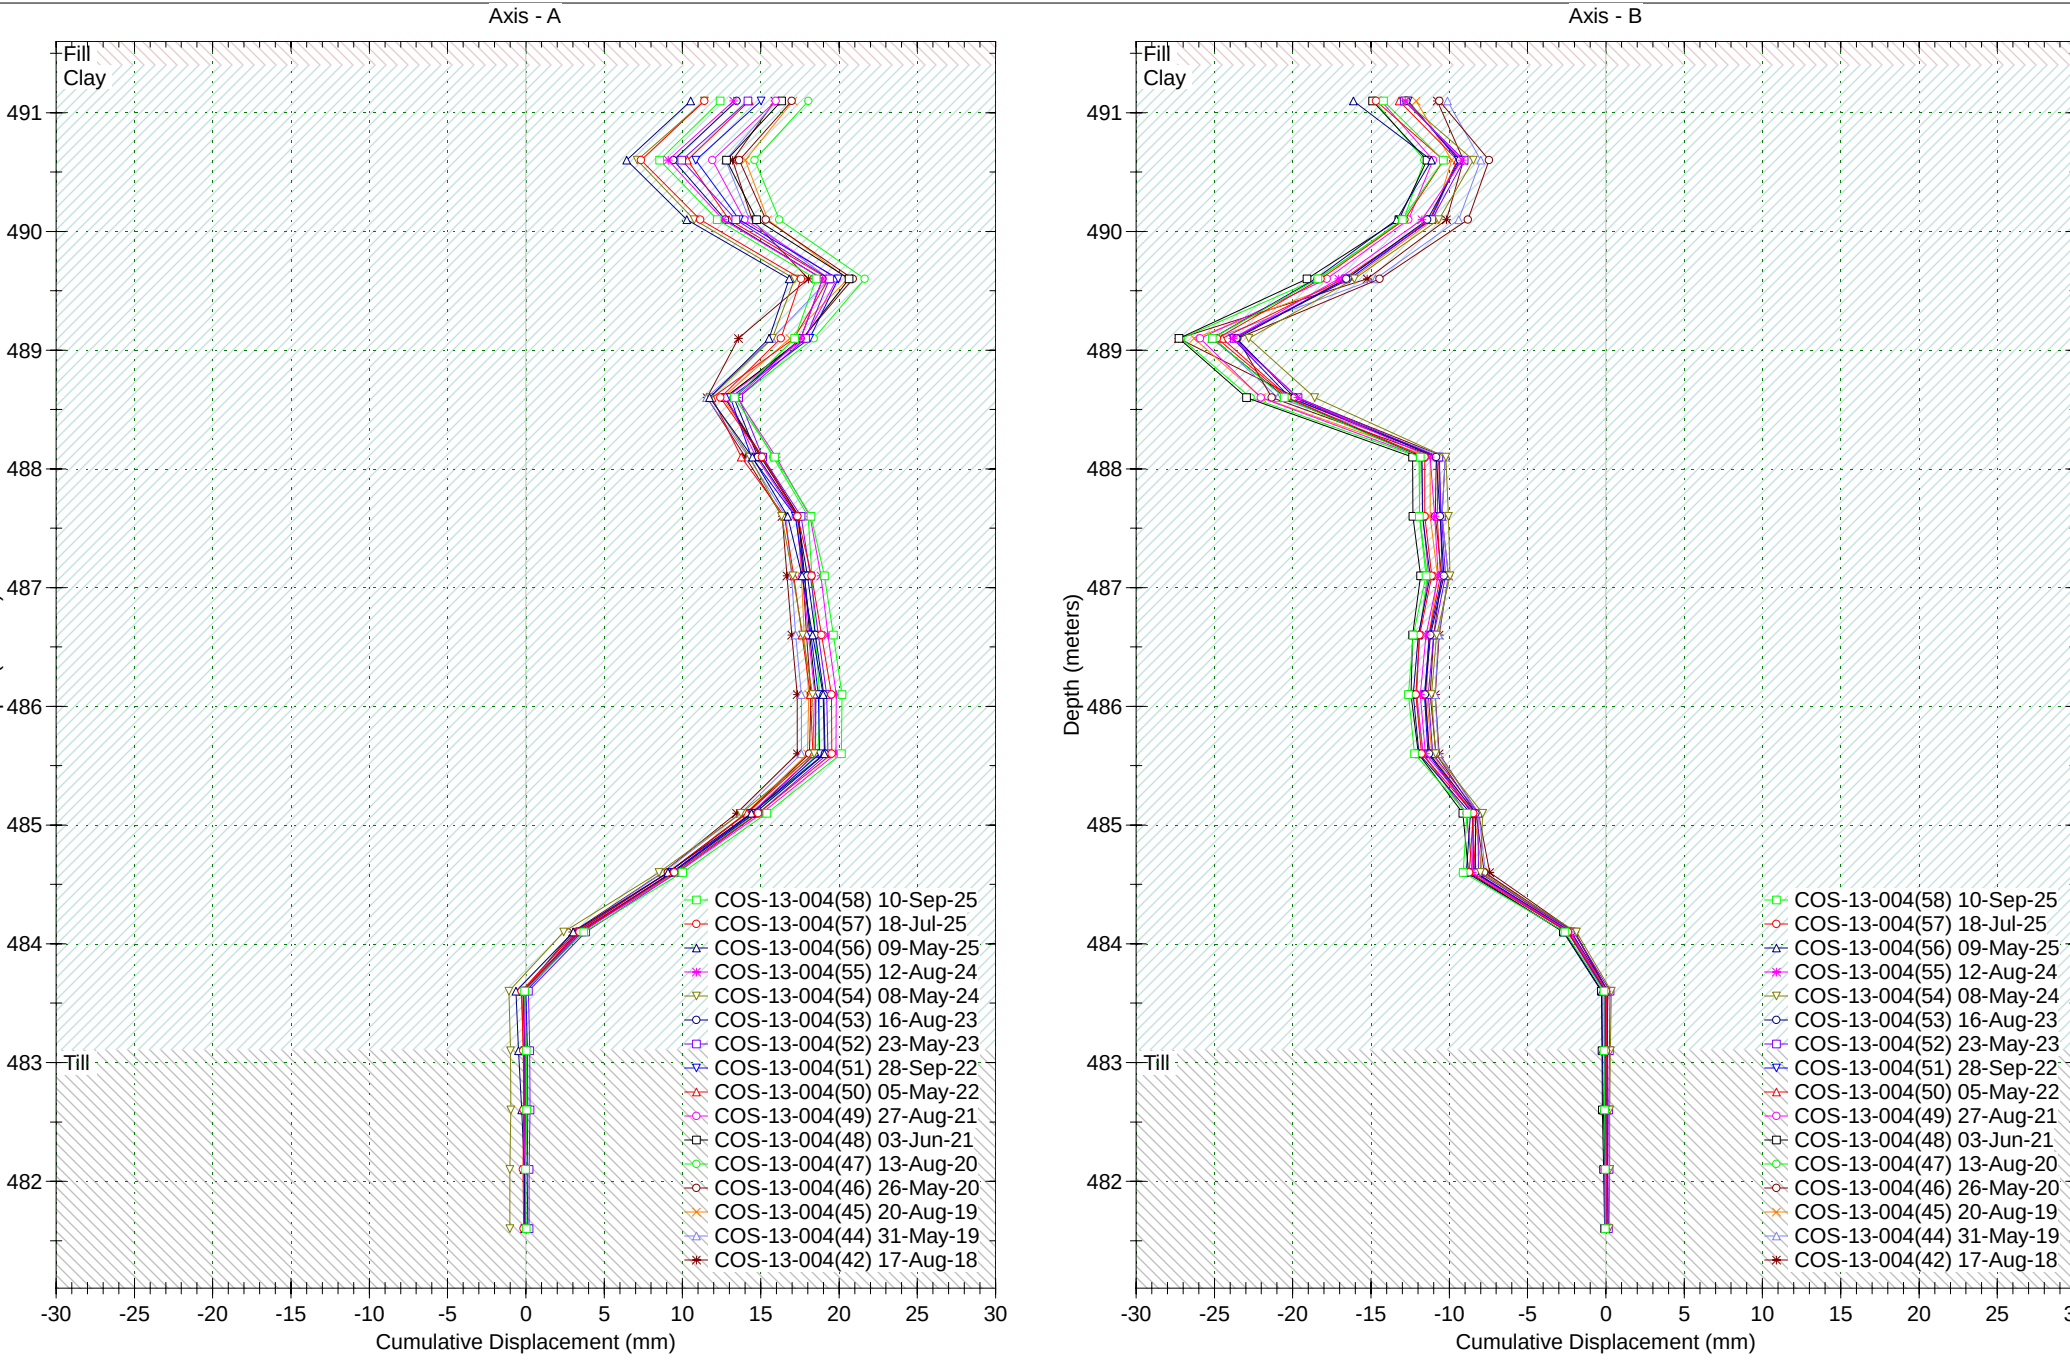
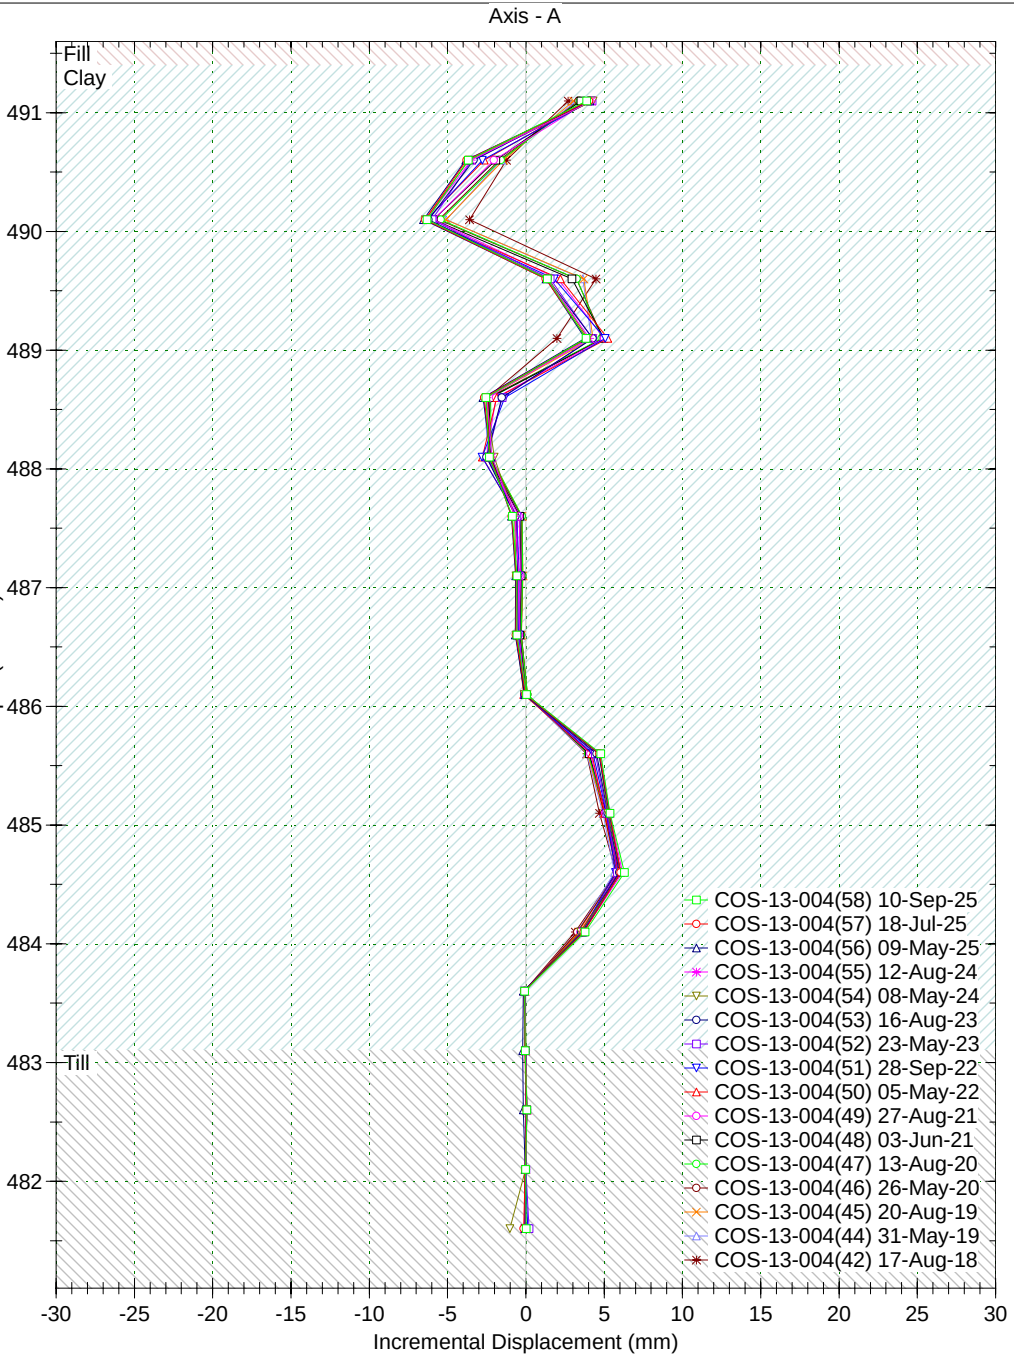
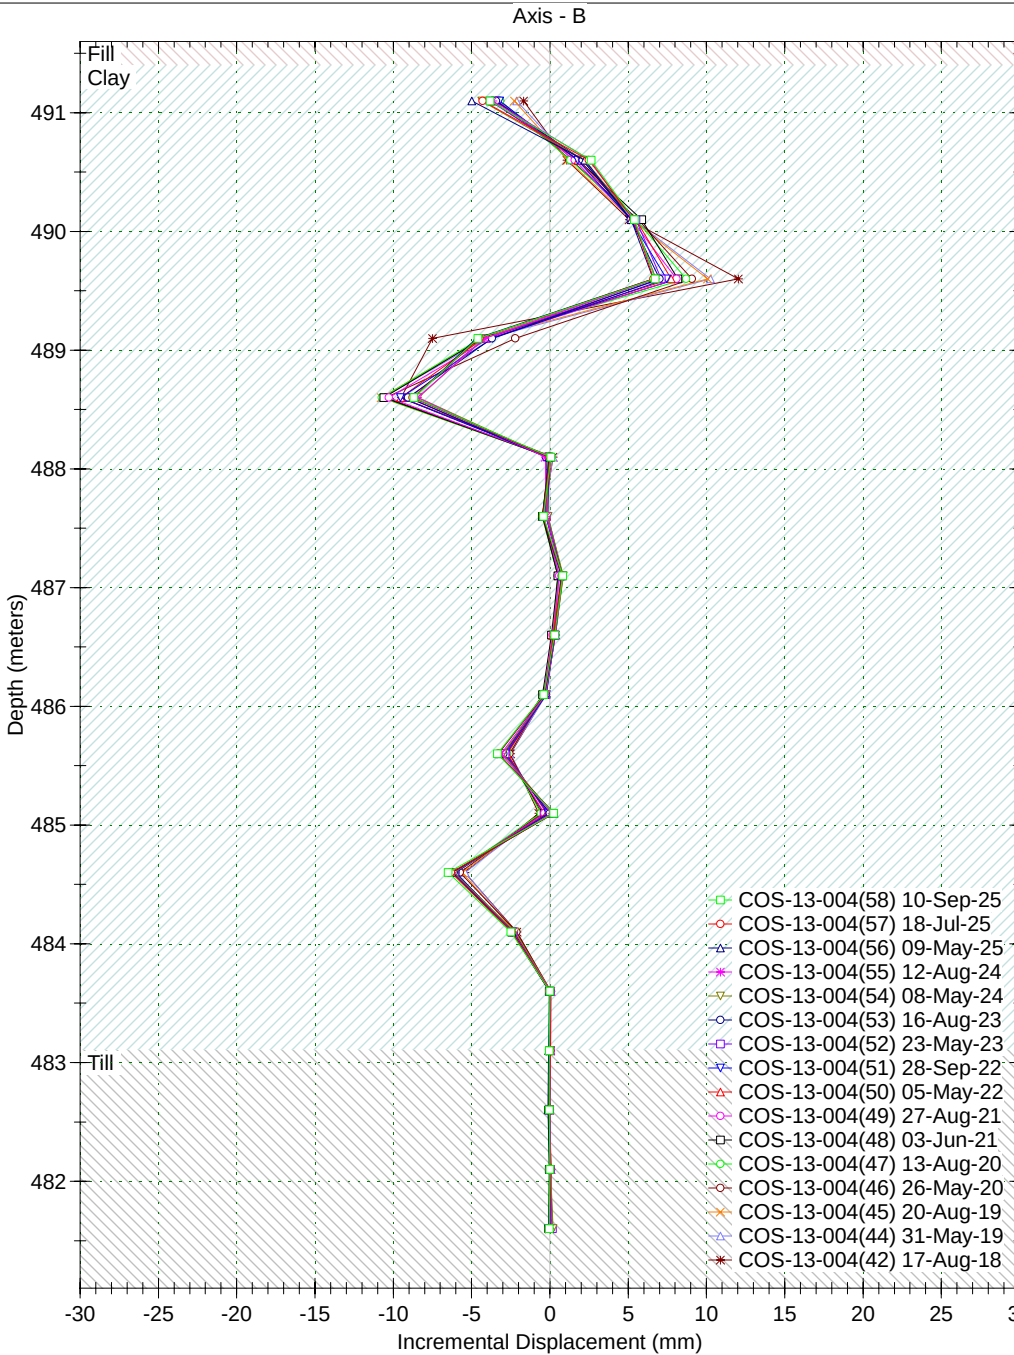
Borehole : COS-13-004  
Project : Nutana Slope  
Location : 307 11th. St. E. (back)  
Northing : 5775604.97  
Easting : 386050.63  
Collar : -0.677

- Inclinometer COS-13-004 has in recent years indicated drift both in the direction parallel to and along the direction of the laneway. The inclinometer plots indicate insignificant movement (less than 2.0 mm or 0.04 in) between July 18 and September 10, 2025.

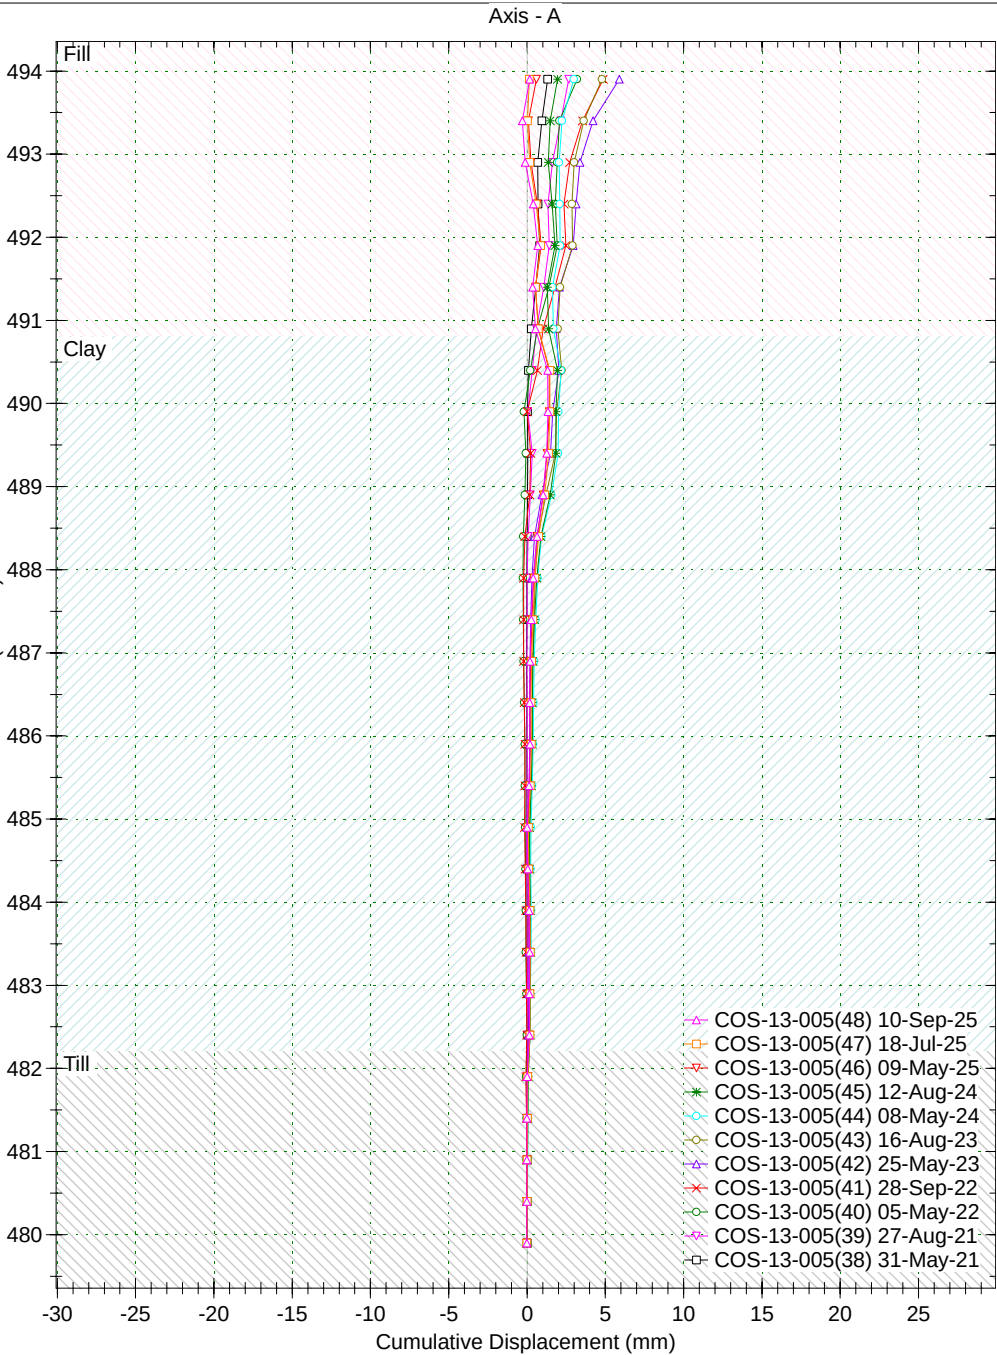
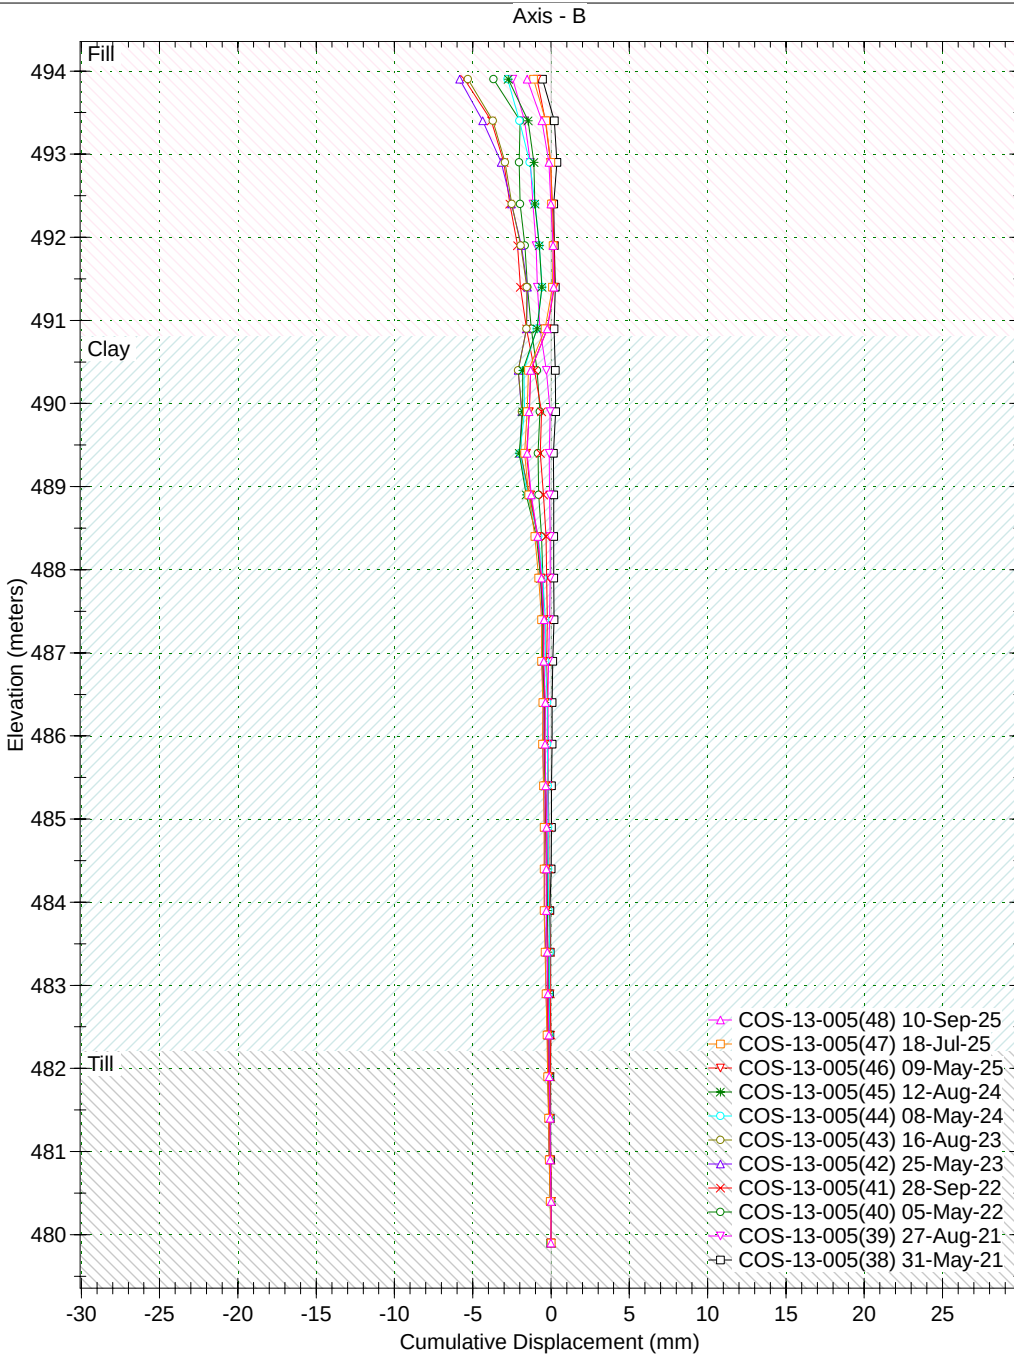
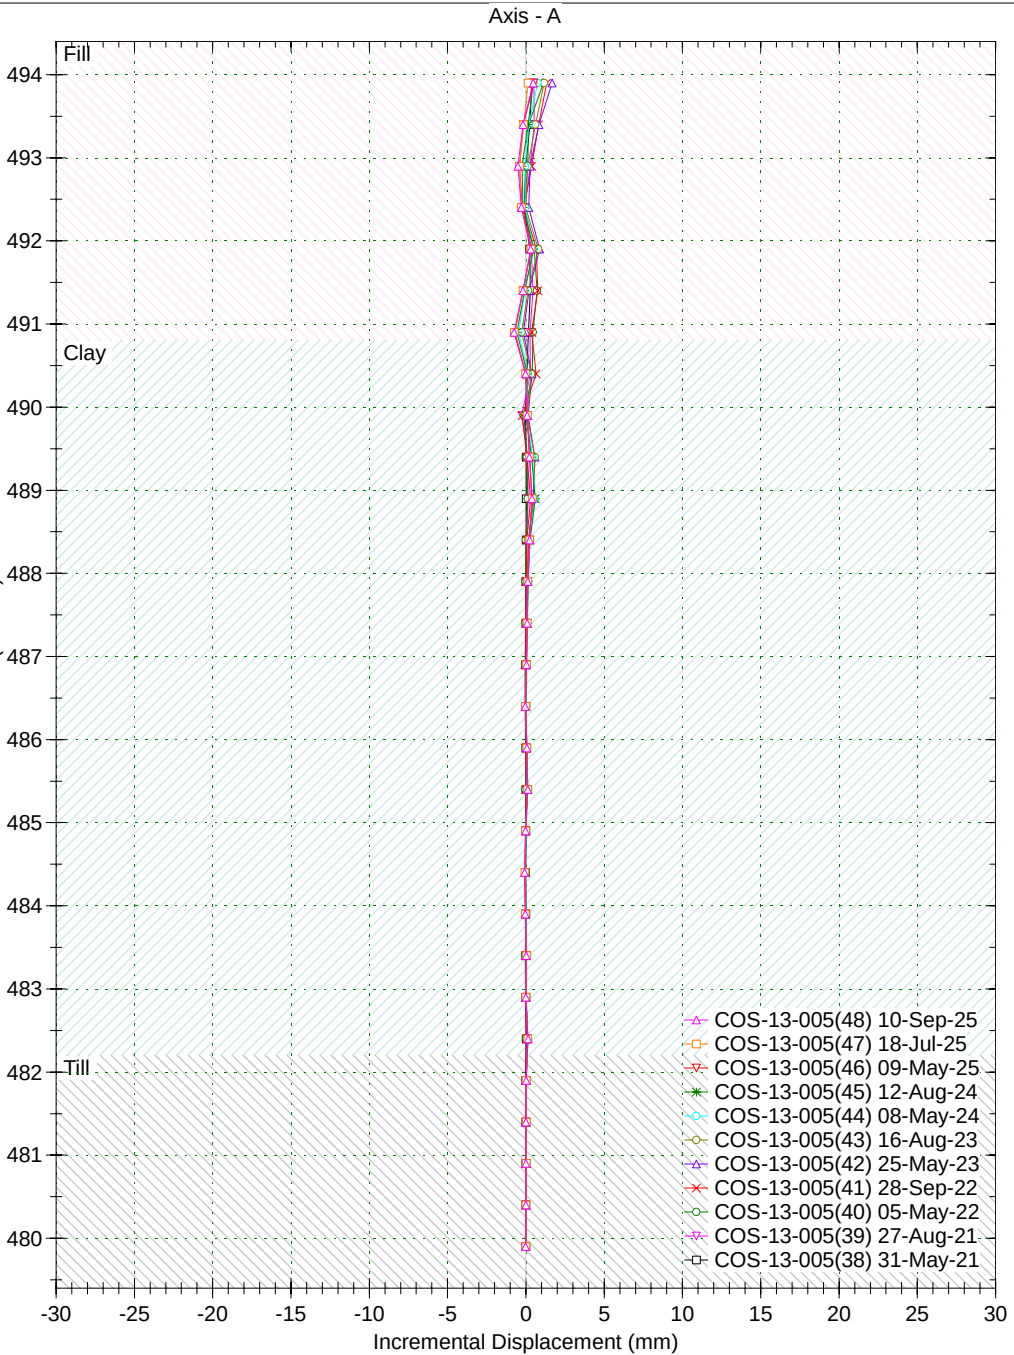
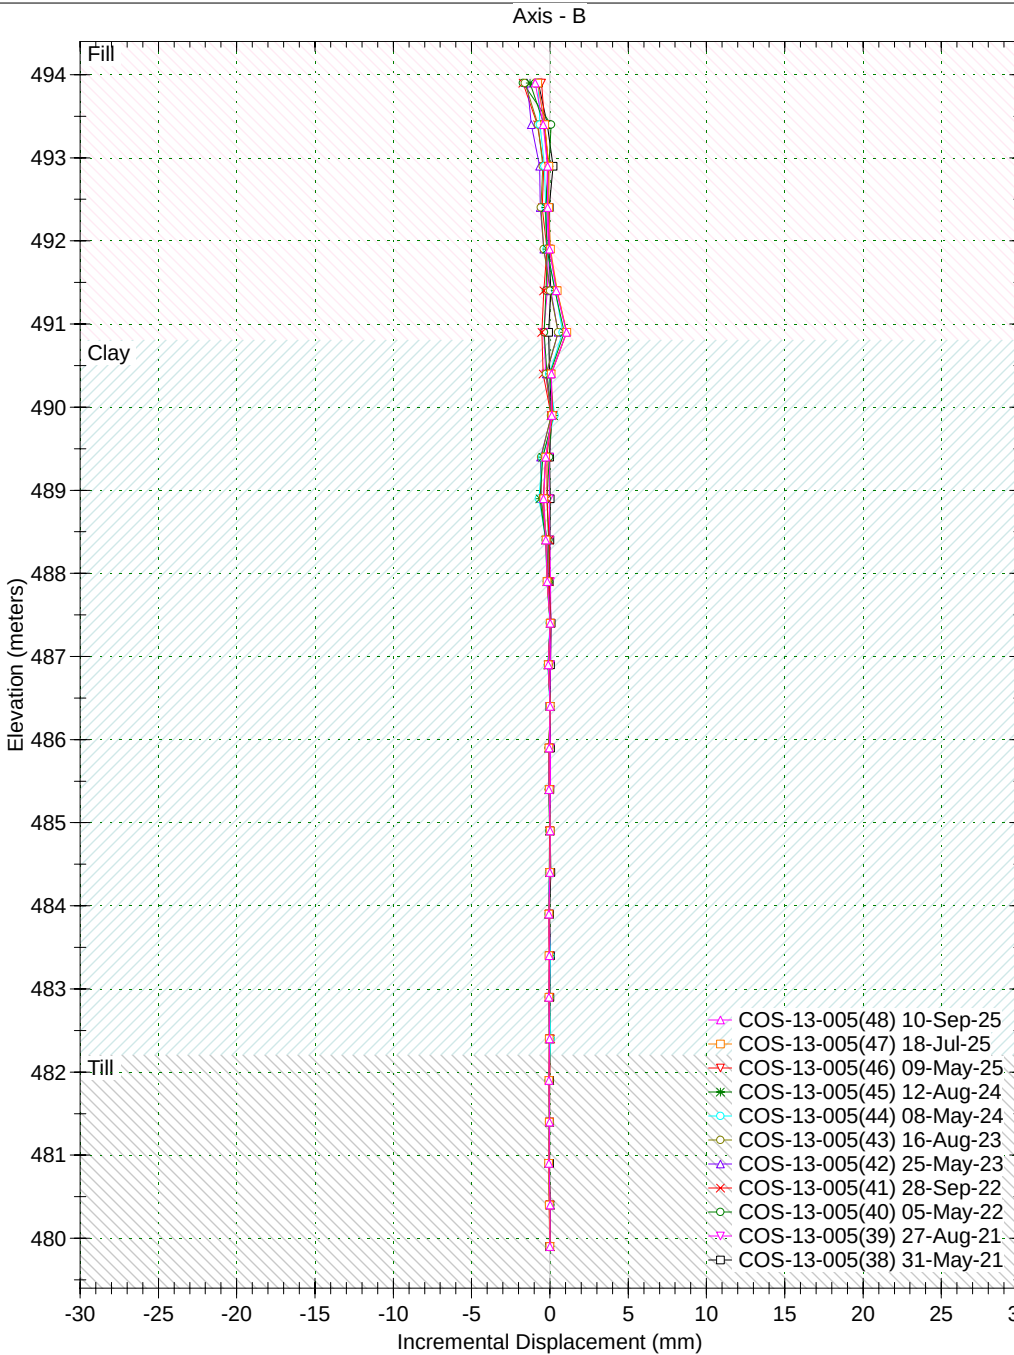
Borehole : COS-13-005 (Aug 13 2020 Baseline)  
Project : Nutana Slope  
Location : 316 Sask. Cres. E.  
Northing : 5775631.299  
Easting : 386078.8467  
Collar : -0.1

- Inclinometer COS-13-005 indicated insignificant movement (less than 2 mm or 0.08 in) between July 18 and September 10, 2025.
- Inclinometer 20-109 has indicated approximately 27 mm of cumulative downslope movement between October 28, 2020 and September 10, 2025, with insignificant movement (less than 2.0 mm or 0.04 in) between May 9 and September 10, 2025. The zone of movement is approximately 2.5 m below the top of casing. The rate of slope movement has increased from approximately 1 mm/yr between October 28, 2020 and May 5, 2022, to approximately 5 mm/yr between May 5, 2022 and May 9, 2025.
