## TECHNICAL MEMORANDUM

**Reference No.** CA0029692.2934-TM-05-Rev0

### NUTANA SLOPE STABILITY UPDATE – SEPTEMBER 2025

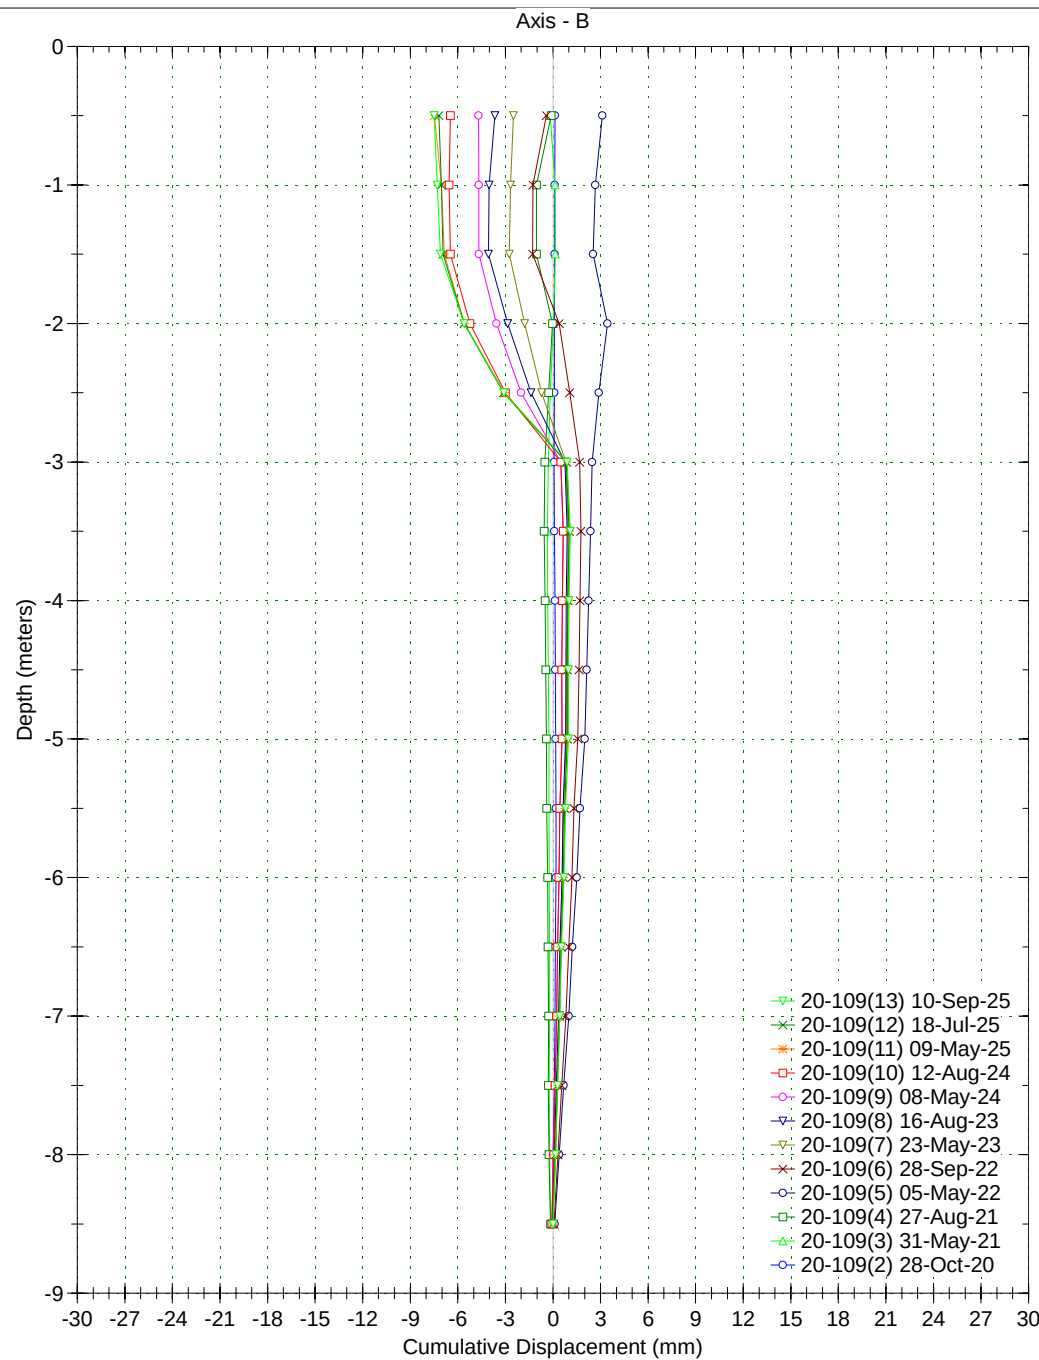
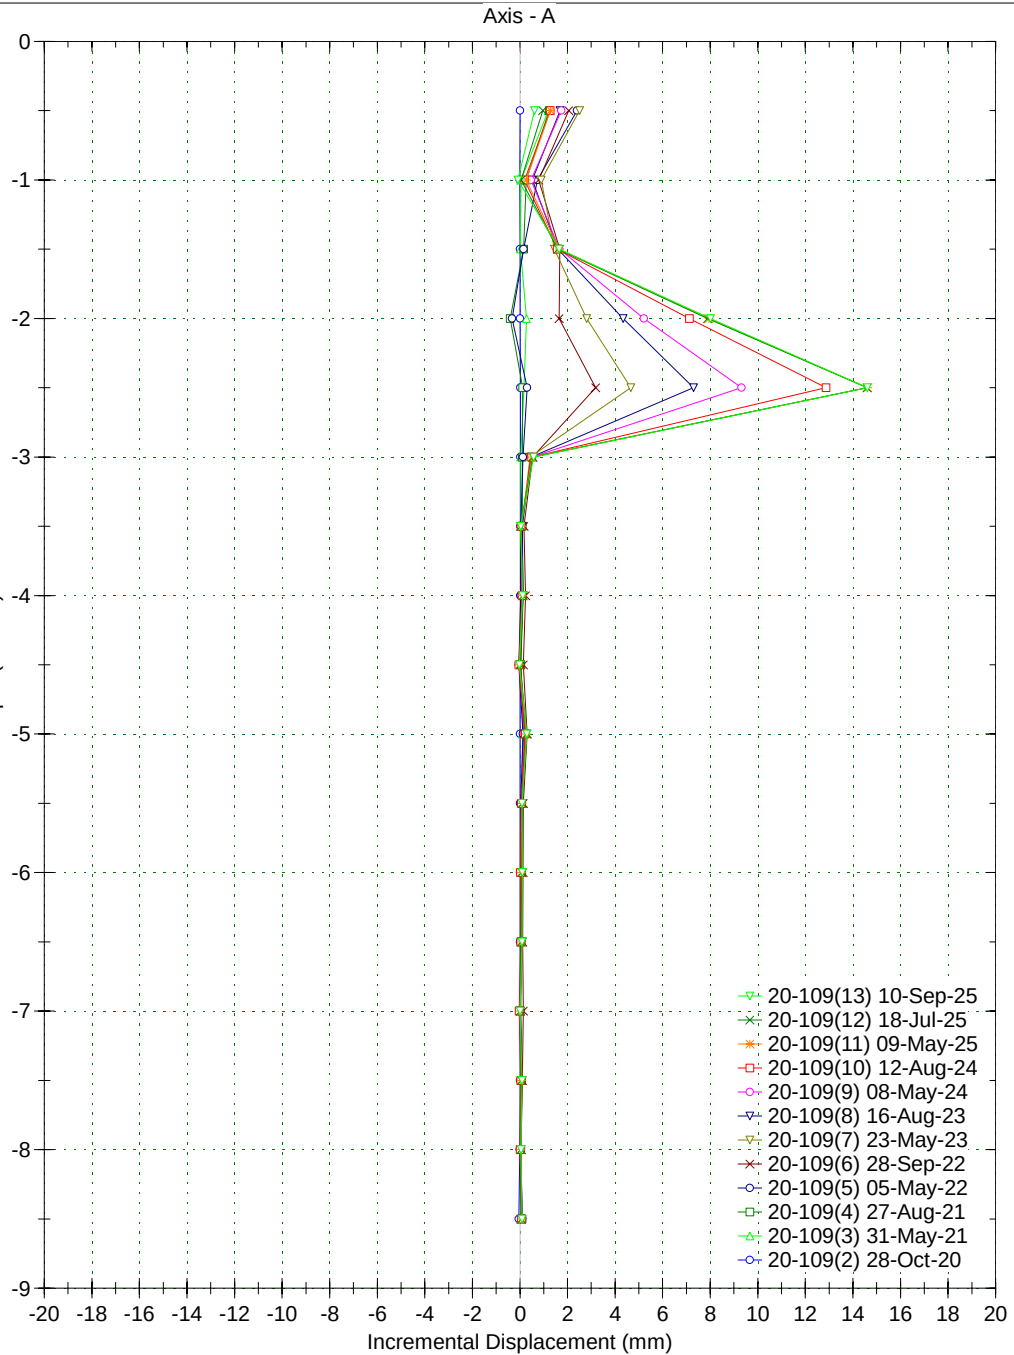
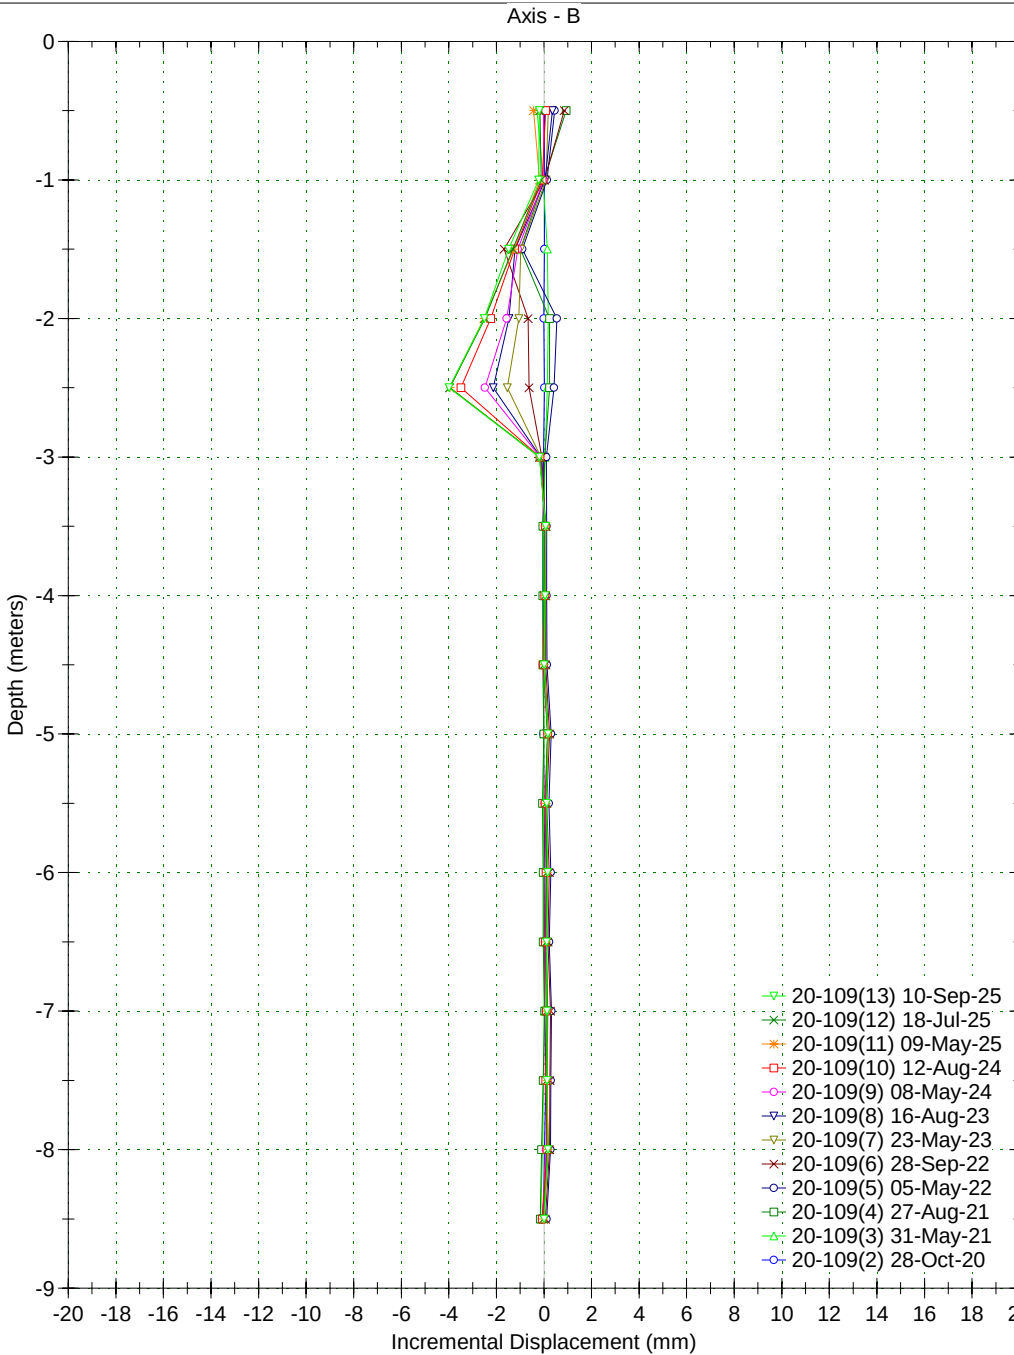
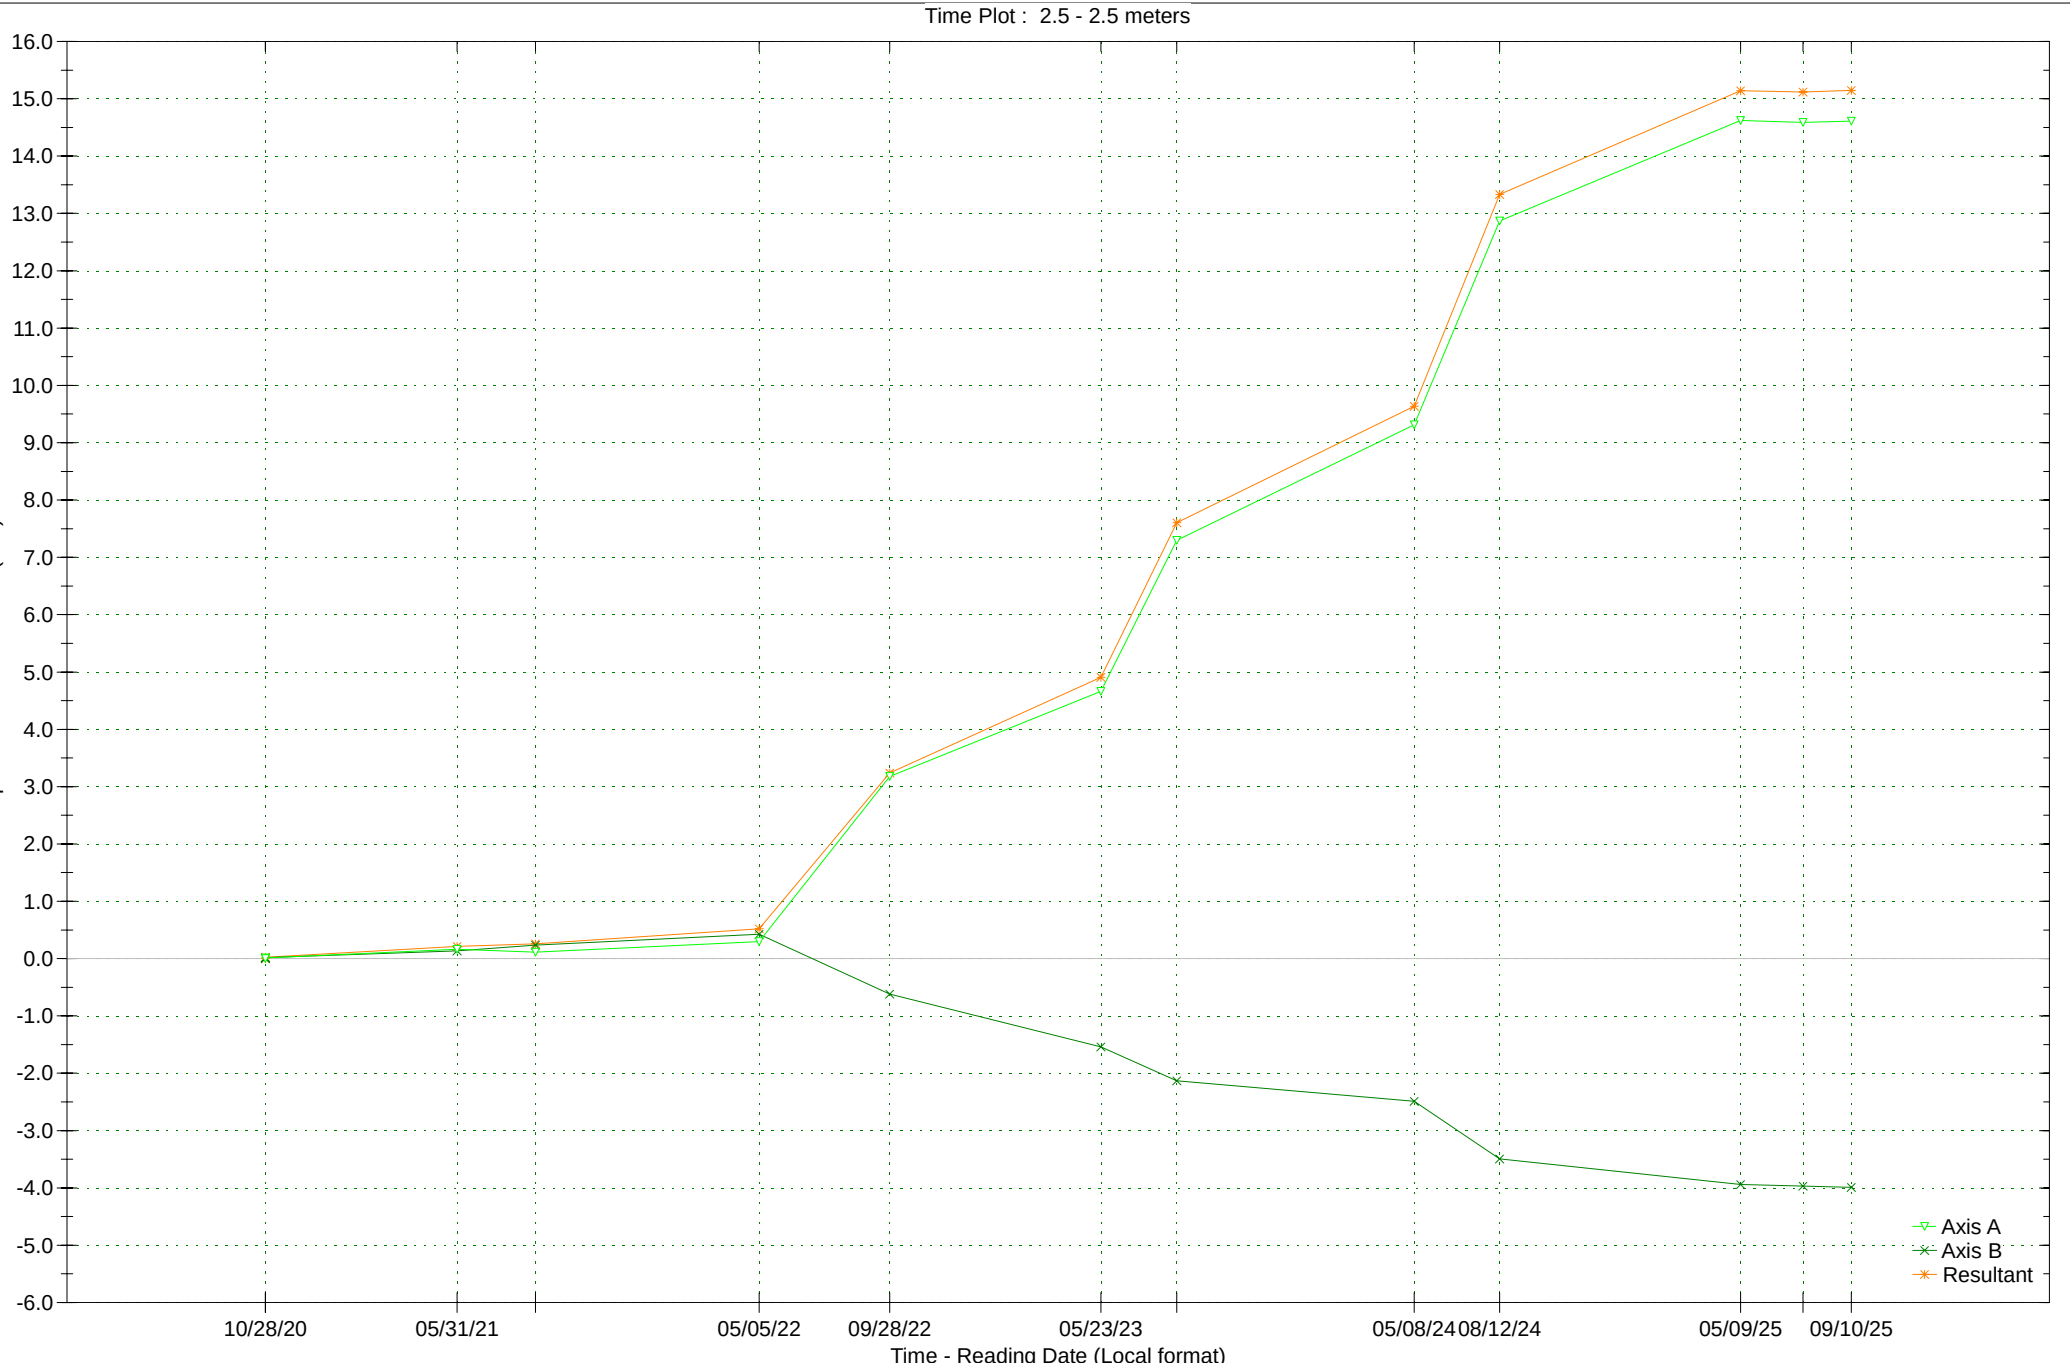
Borehole : 20-109  
Project : Nutana Slope  
Location :  
Northing : 5775622  
Easting : 385977  
Collar :

- Inclinometer COS-13-005 indicated insignificant movement (less than 2 mm or 0.08 in) between July 18 and September 10, 2025.
- Inclinometer 20-109 has indicated approximately 27 mm of cumulative downslope movement between October 28, 2020 and September 10, 2025, with insignificant movement (less than 2.0 mm or 0.04 in) between May 9 and September 10, 2025. The zone of movement is approximately 2.5 m below the top of casing. The rate of slope movement has increased from approximately 1 mm/yr between October 28, 2020 and May 5, 2022, to approximately 5 mm/yr between May 5, 2022 and May 9, 2025.

Slope inclinometer 20-109 indicates a zone of movement a depth of approximately 2.5 m below the top of casing with a rate of movement approximately 5 mm/yr between May 5, 2022 and September 10, 2025, an increase from 1 mm/yr for the period between October 2020 and May 2022. In 2024 inclinometer 20-109 indicated approximately 3.5 mm of movement between May 8 and August 12, 2024, while insignificant movement was observed between May 9 and September 10, 2025. Inclinometer 20-111 plots continue to show drifts in upslope direction, with approximately 4.0 mm (0.18 in) of cumulative movement between October 28, 2020 and September 10, 2025.

WSP recommends completing the same number of monitoring events in 2026 for the instrumentation installed at the west slide.

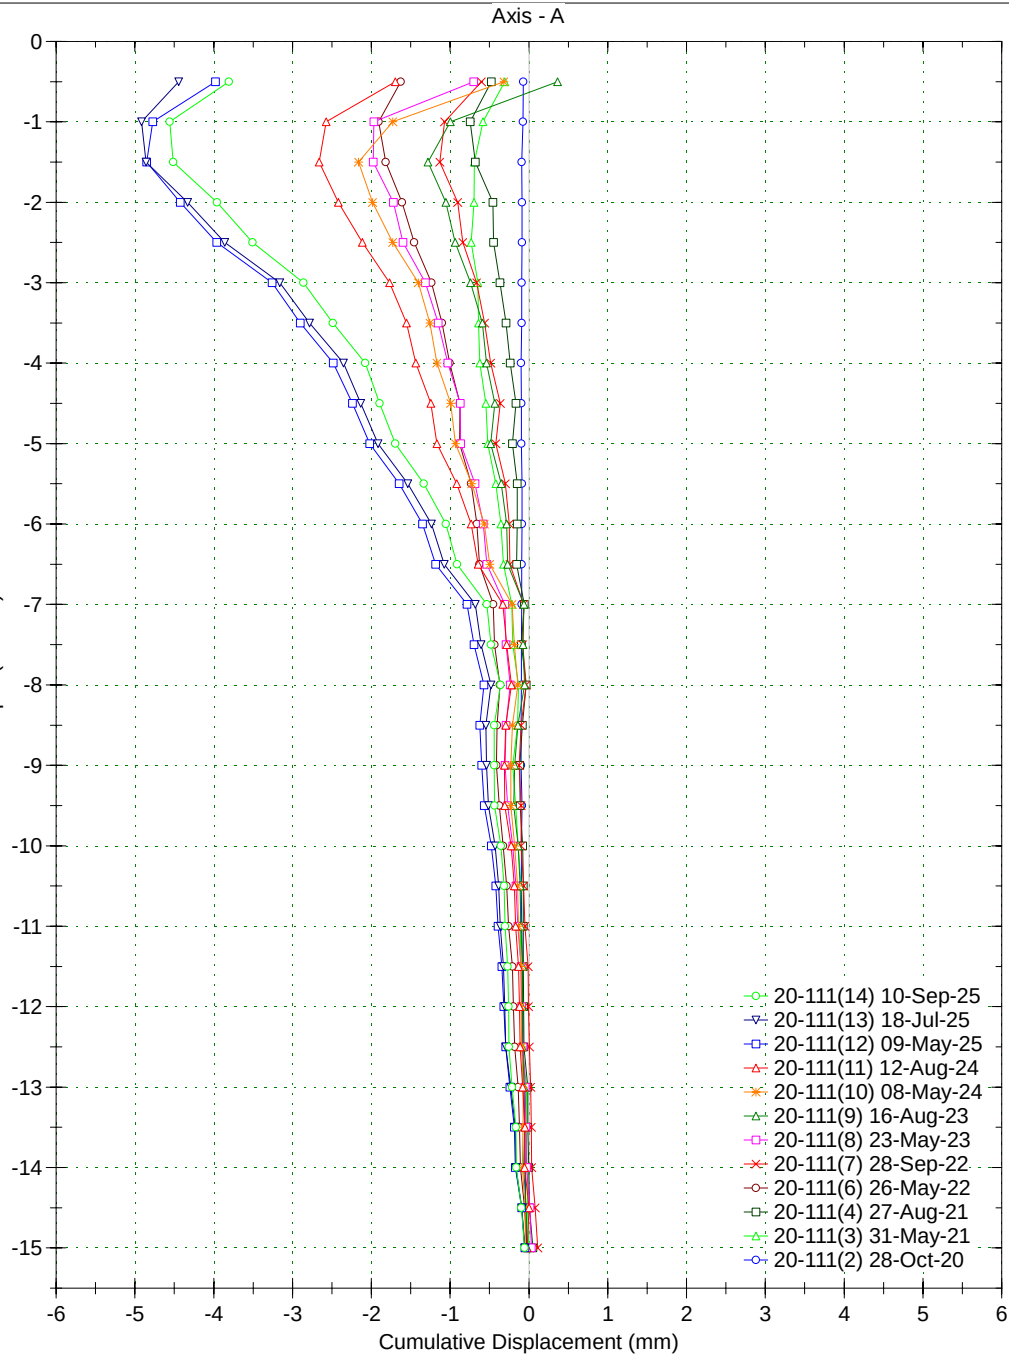
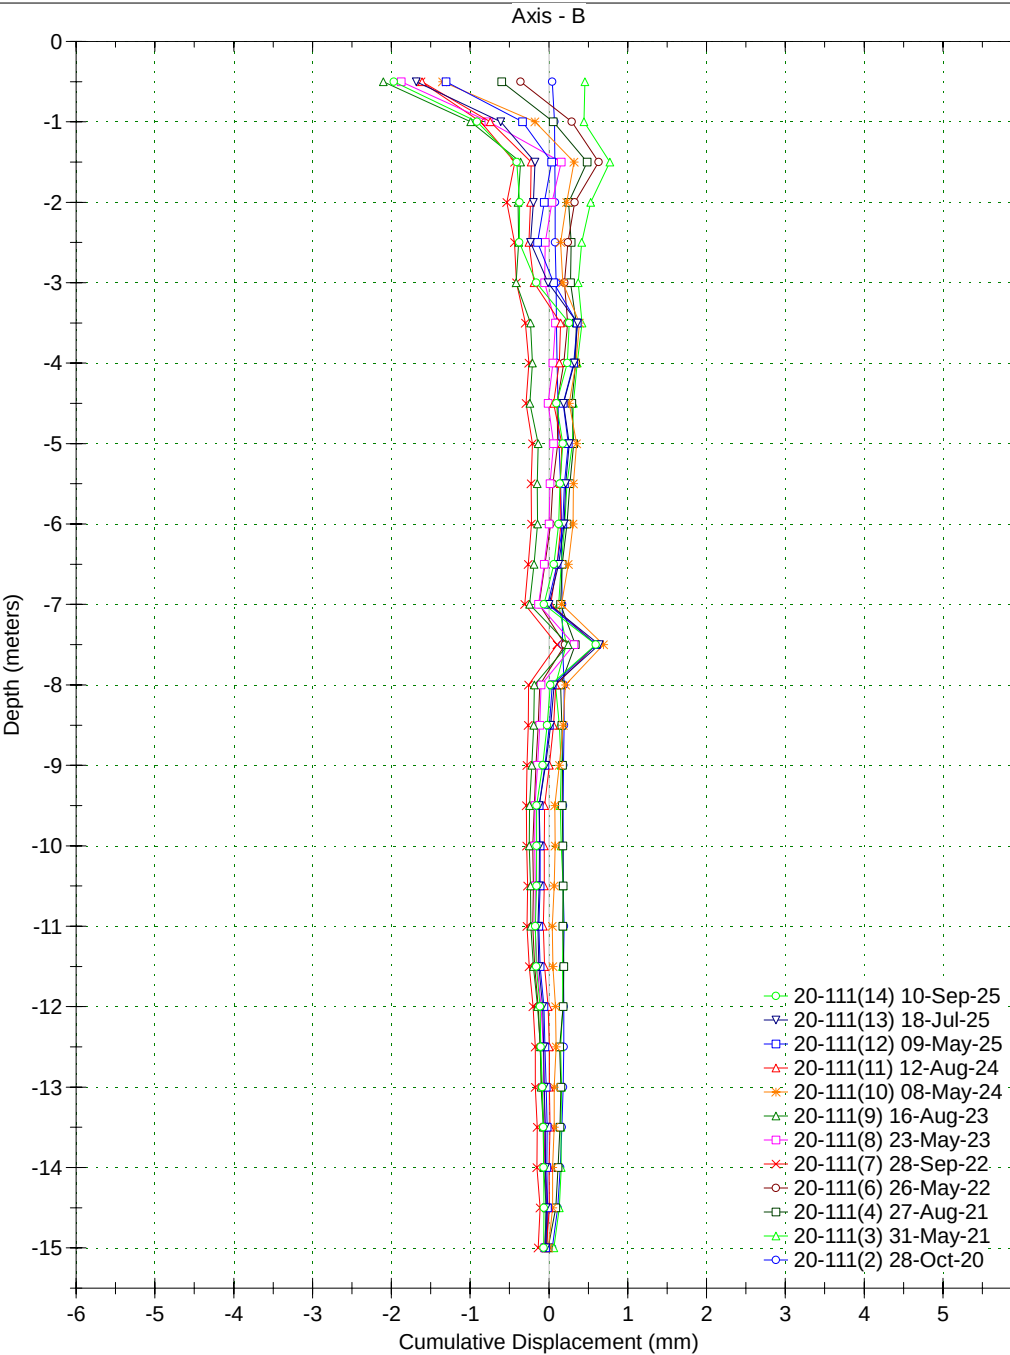
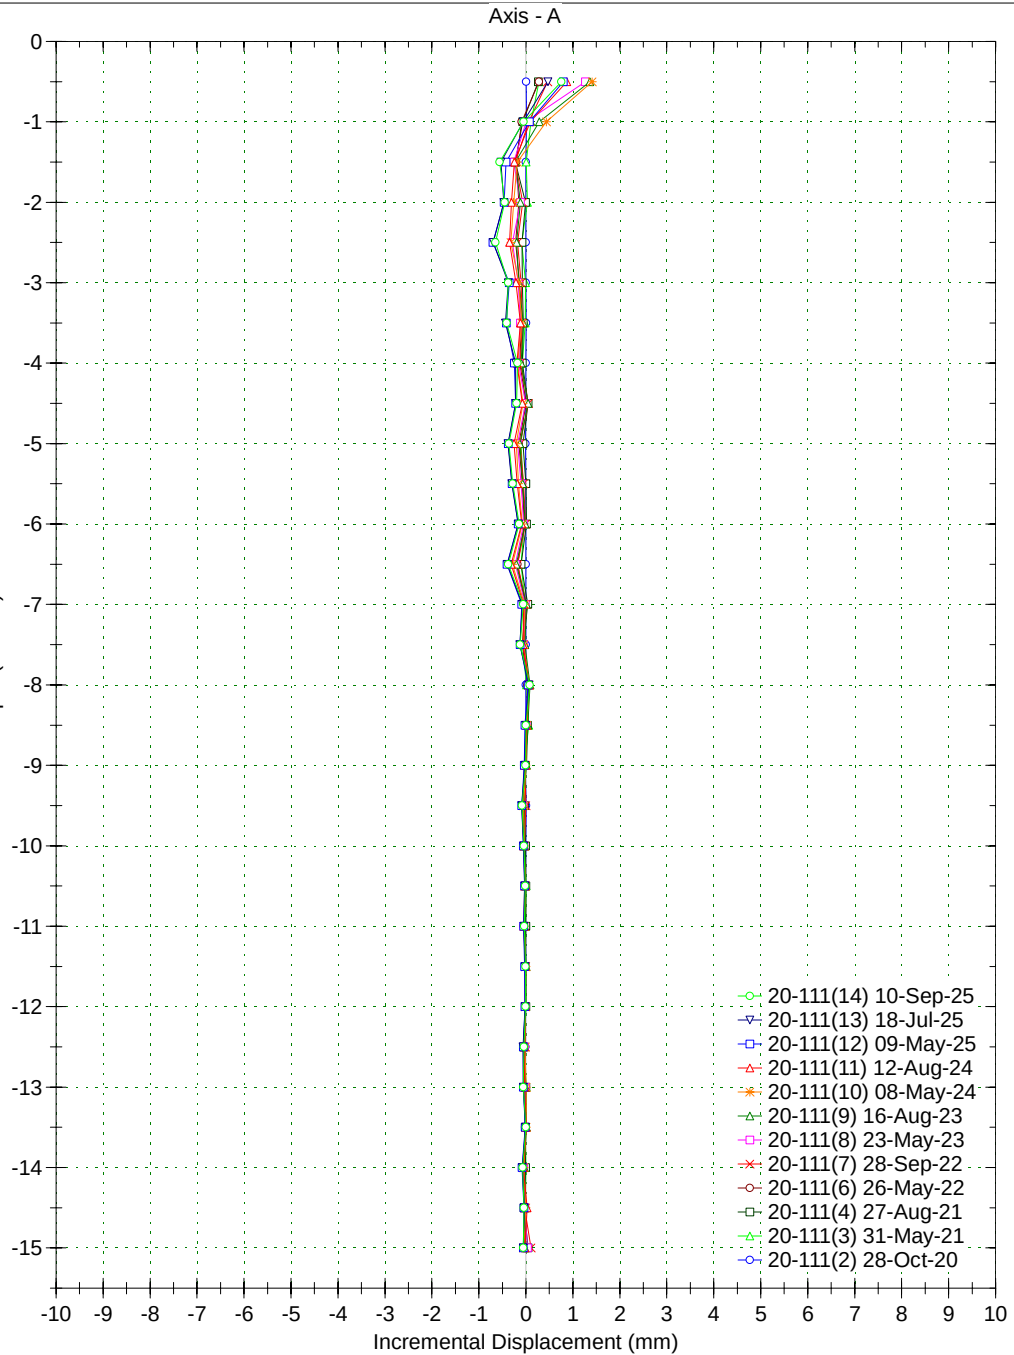
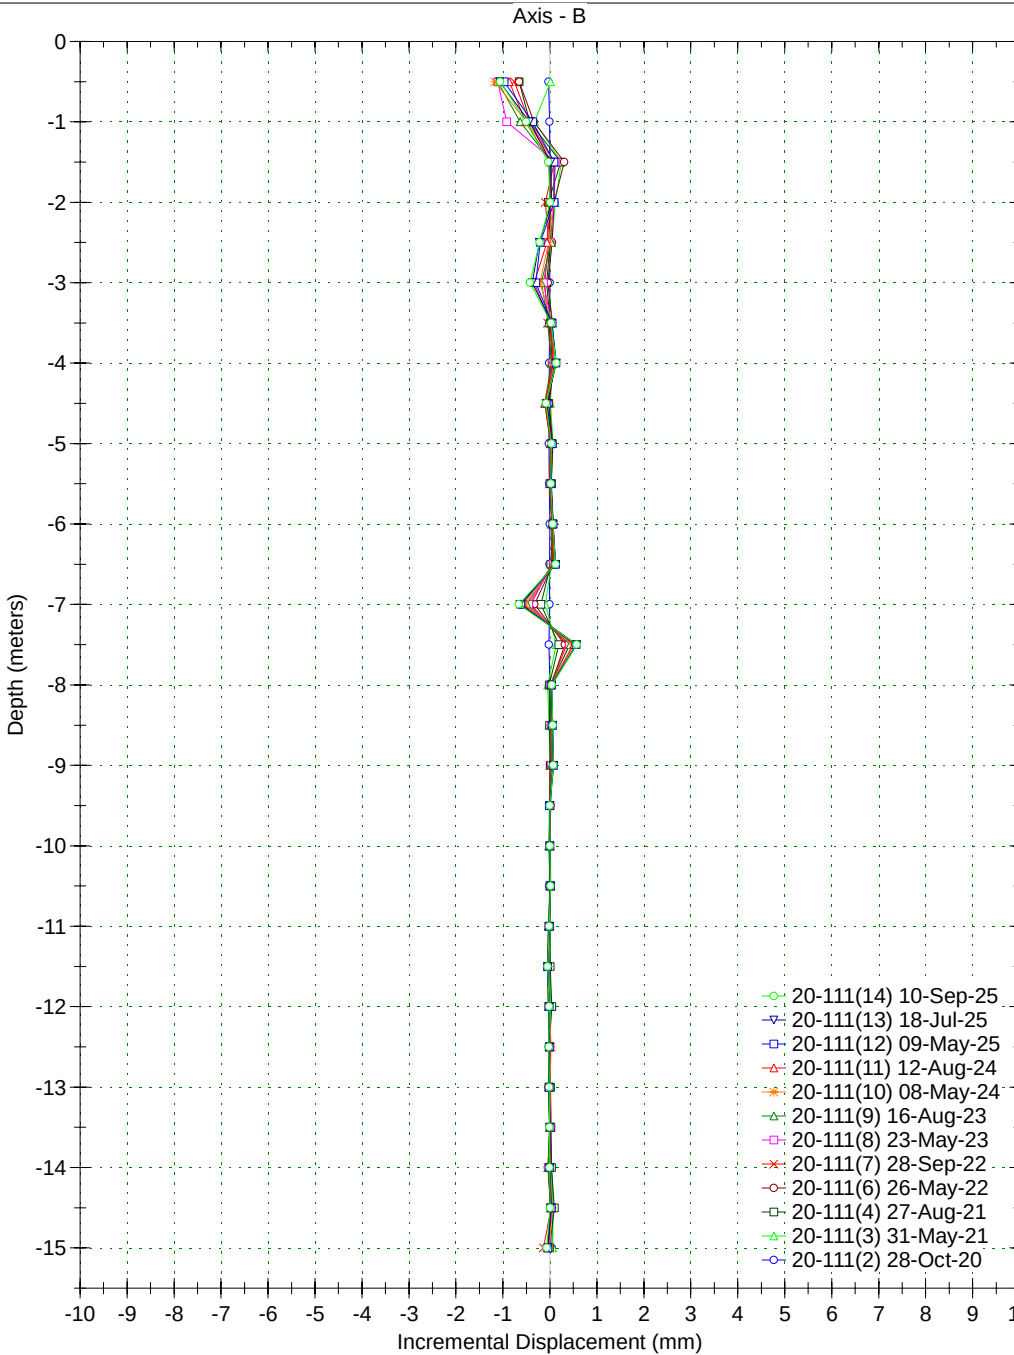
Borehole : 20-111  
Project : Nutana Slope  
Location :  
Northing : 5775568  
Easting : 385953  
Collar :

- Inclinometer 20-111 plots have in the past shown drifts in upslope direction, but in September 2025 show drift in the downslope direction when compared to July 2025. Approximately 4.0 mm (0.18 in) of cumulative movement between October 28, 2020 and September 10, 2025.

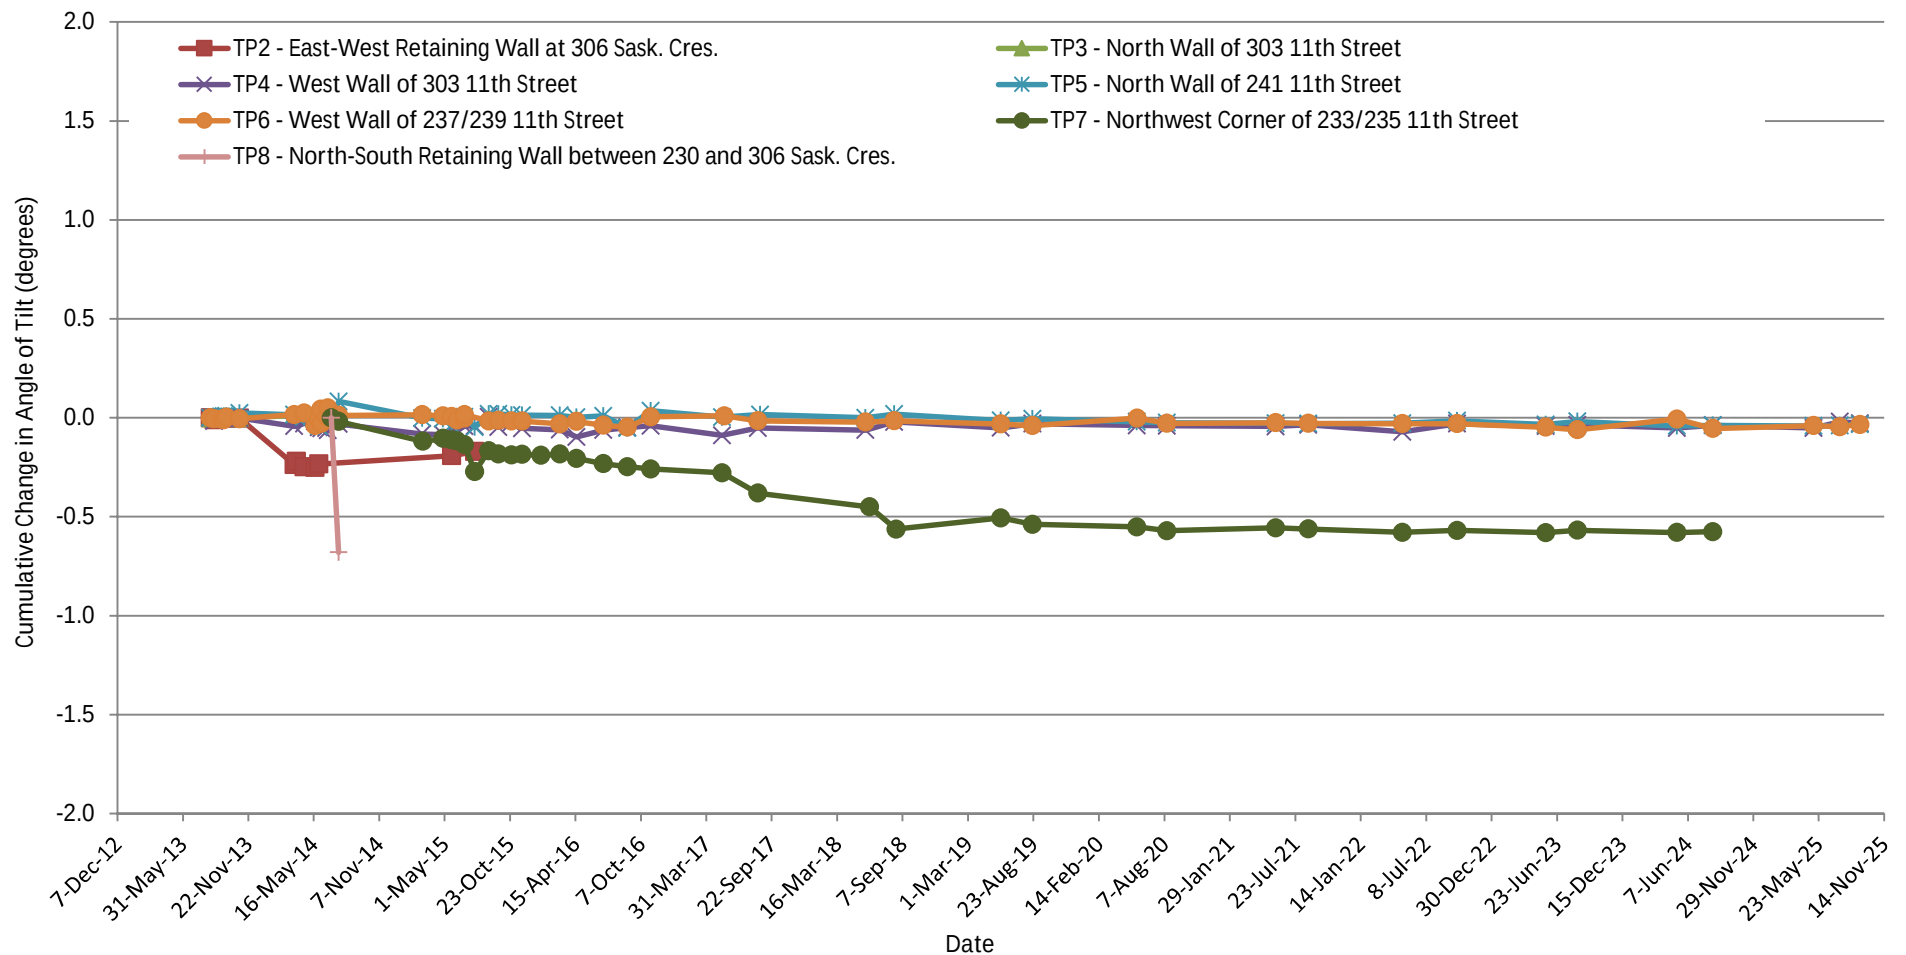
| | CHECK | | | FIGURE: B1 | |

- Tilt plates TP4, TP5, and TP6 indicate insignificant changes in angle of tilt (less than 0.05 degrees) between August 23, 2013 and September 2025.
- Tilt plate TP7 could not be accessed at the time of instrumentation monitoring and will be read during a future visit. Tilt plate TP7 was unable to be accessed during any of the 2025 monitoring trips.

- 1) Positive changes in tilt indicate tilting toward the monitoring structure.
- 2) TP1, located on the retaining wall between 230 and 306 Sask. Cres., is not monitored for health and safety reasons; monitoring results for this tilt plate show a change in angle of tilt of approximately 9 degrees between August 2013 and June 2014.
- 3) TP3 and TP8 are destroyed, and TP2 is buried.

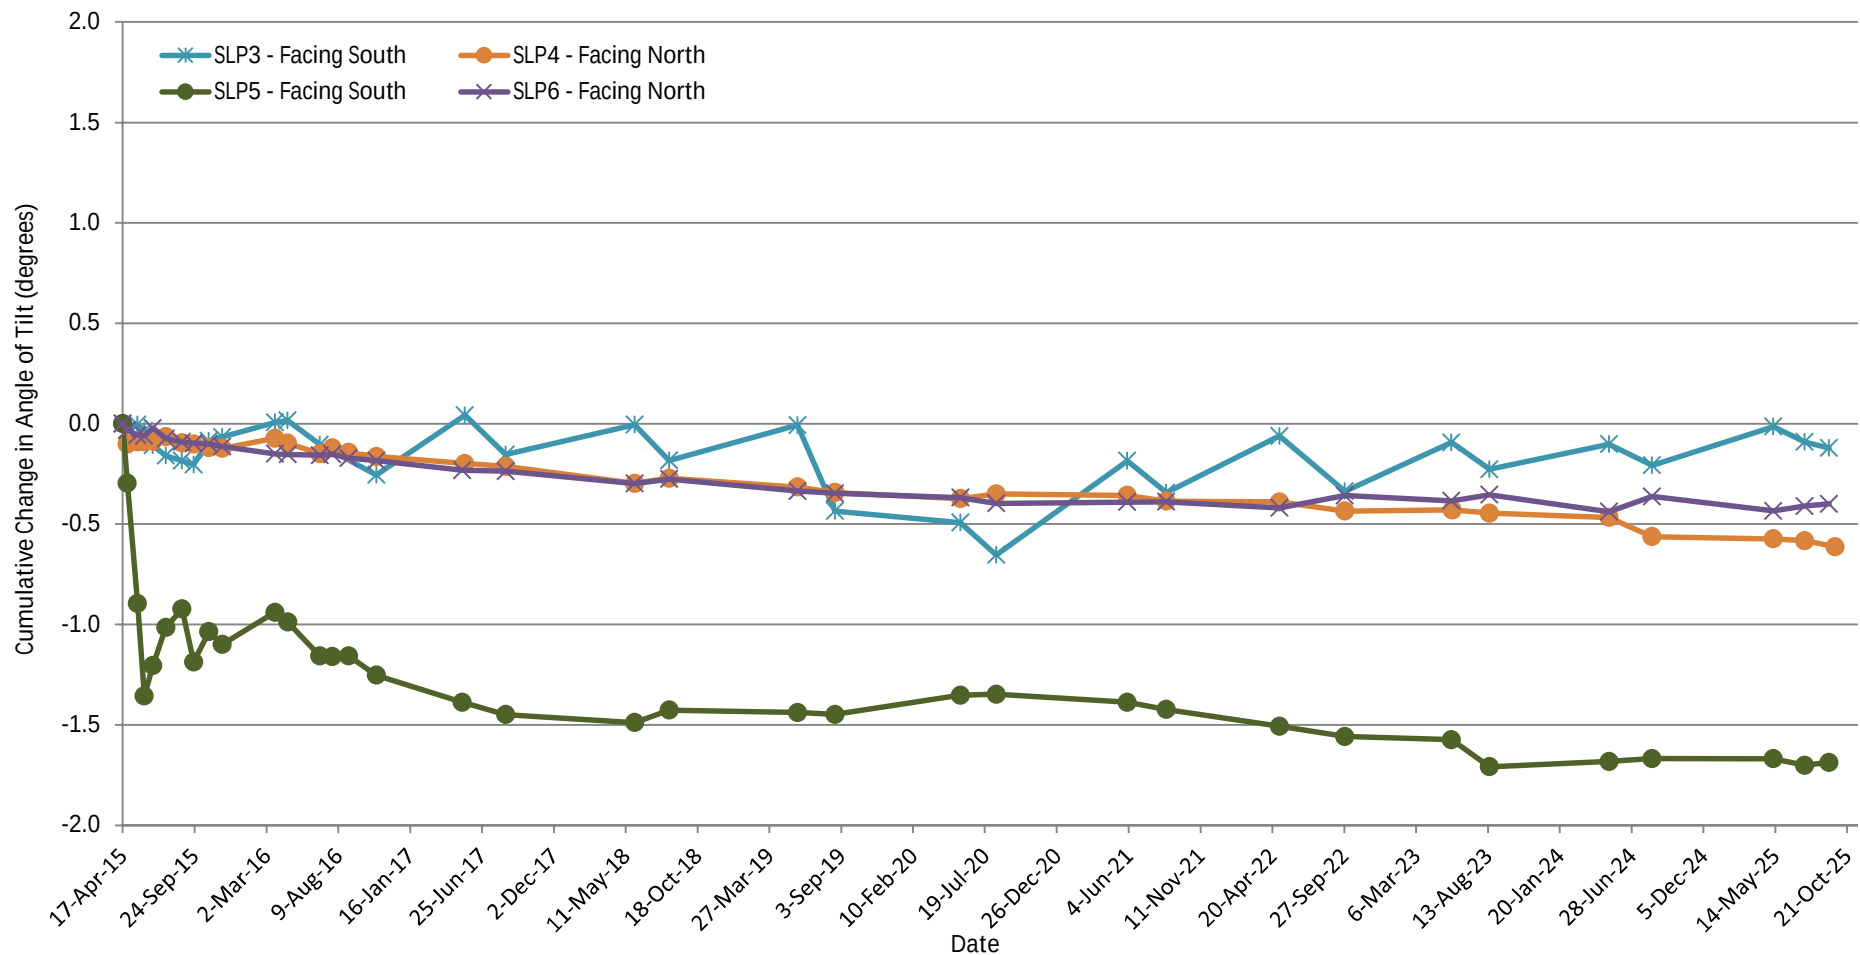
FIGURE: B2

- Tilt Plate SLP3 indicated an insignificant change in angle of tilt (less than 0.05 degrees) between July 18 and September 10, 2025. Past readings for SLP3 have been erratic and appear to be affected by seasonal changes.

- Tilt Plate SLP4 indicated an insignificant change in angle of tilt (less than 0.05 degrees) between July 18 and September 23, 2025. The cumulative change in angle of tilt from May 2019 to September 2025 is approximately 0.30 degrees towards the north.

- Tilt plate SLP5 indicated an insignificant change in angle of tilt (less than 0.05 degrees) between July 18 and September 10, 2025.
- Tilt plate SLP6 indicated an insignificant change in angle of tilt (less than 0.05 degrees) between July 18 and September 10, 2025.
