## TECHNICAL MEMORANDUM

**Reference No.** CA0029692.2934-TM-04-Rev0

### NUTANA SLOPE STABILITY UPDATE – JULY 2025

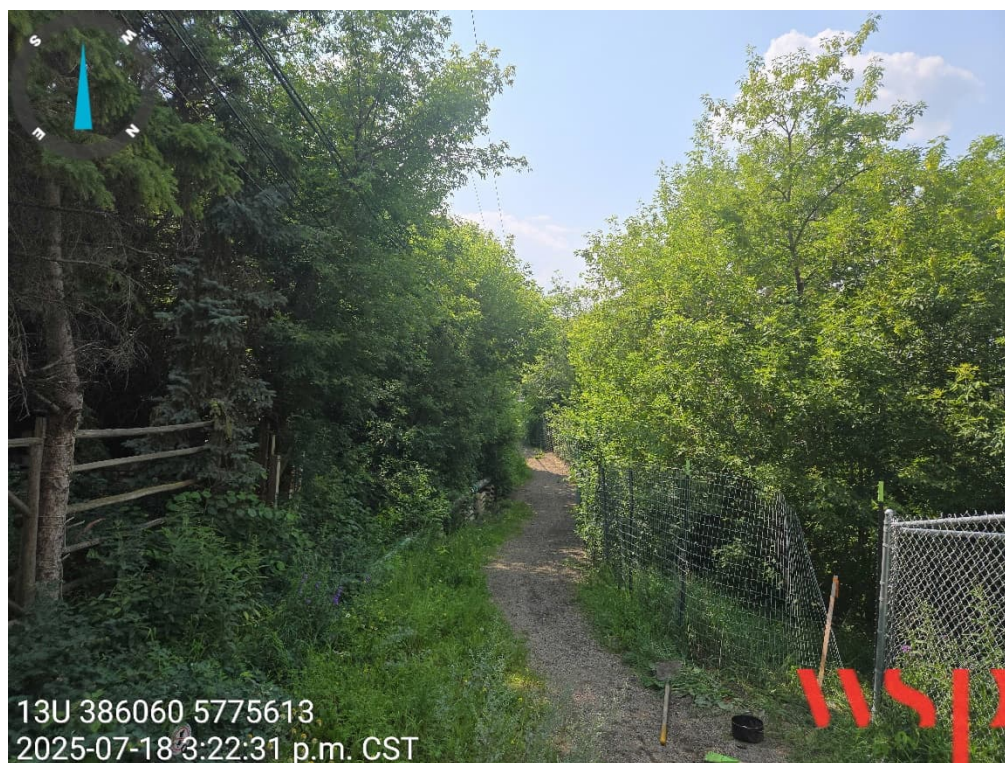
**Photograph 1: Looking west down the back alley at the East Failure (July 18, 2025)**

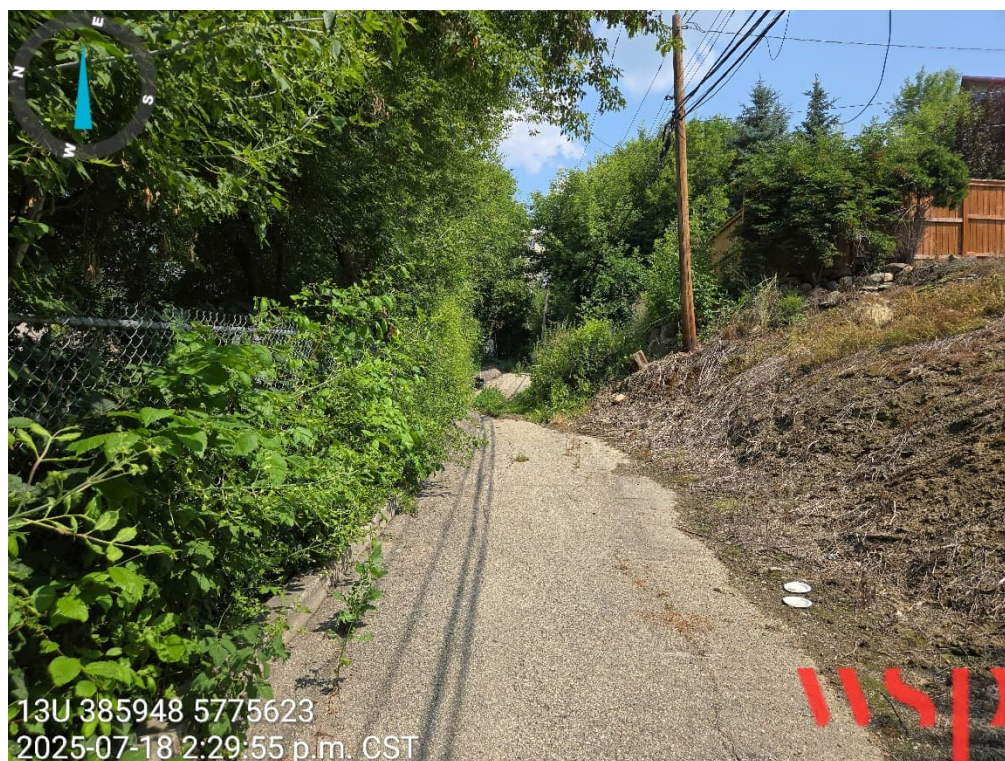
**Photograph 2: Looking east down the back alley at the West Failure (July 18, 2025)**

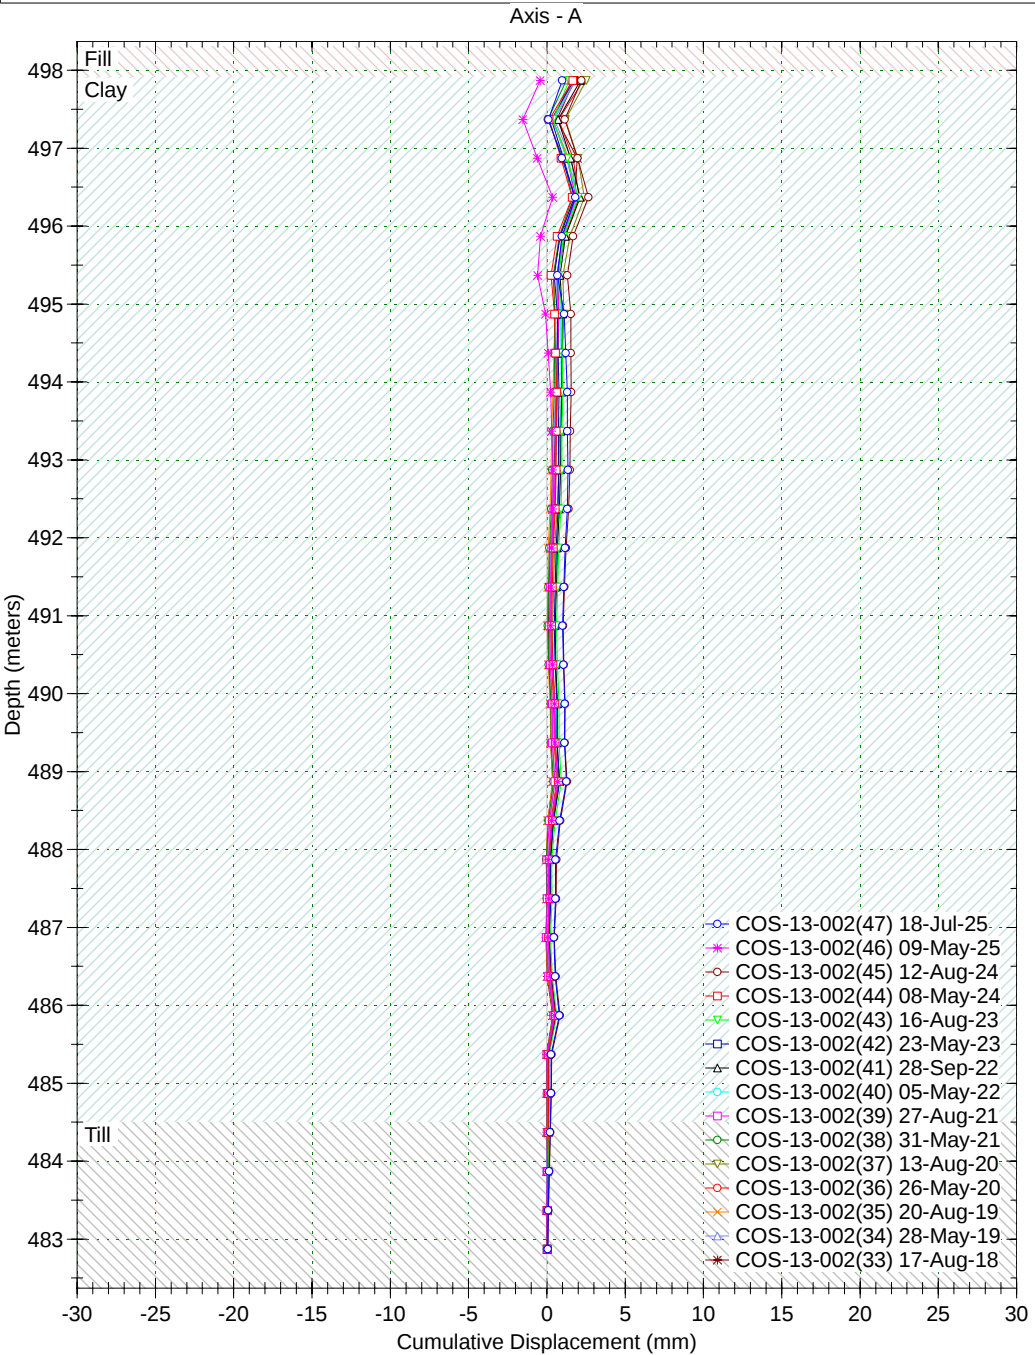
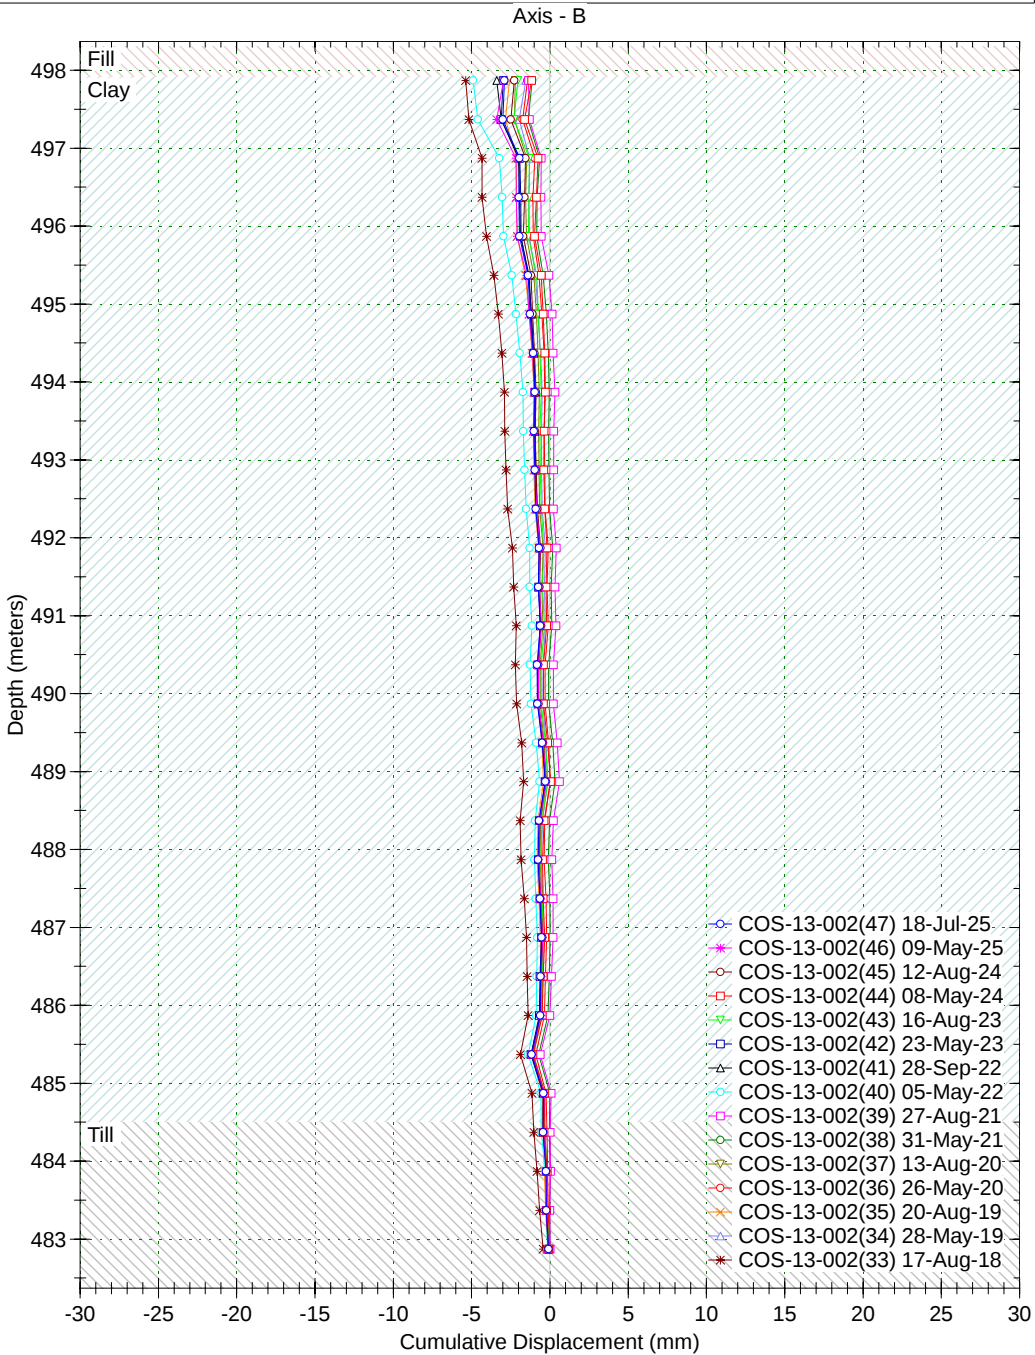
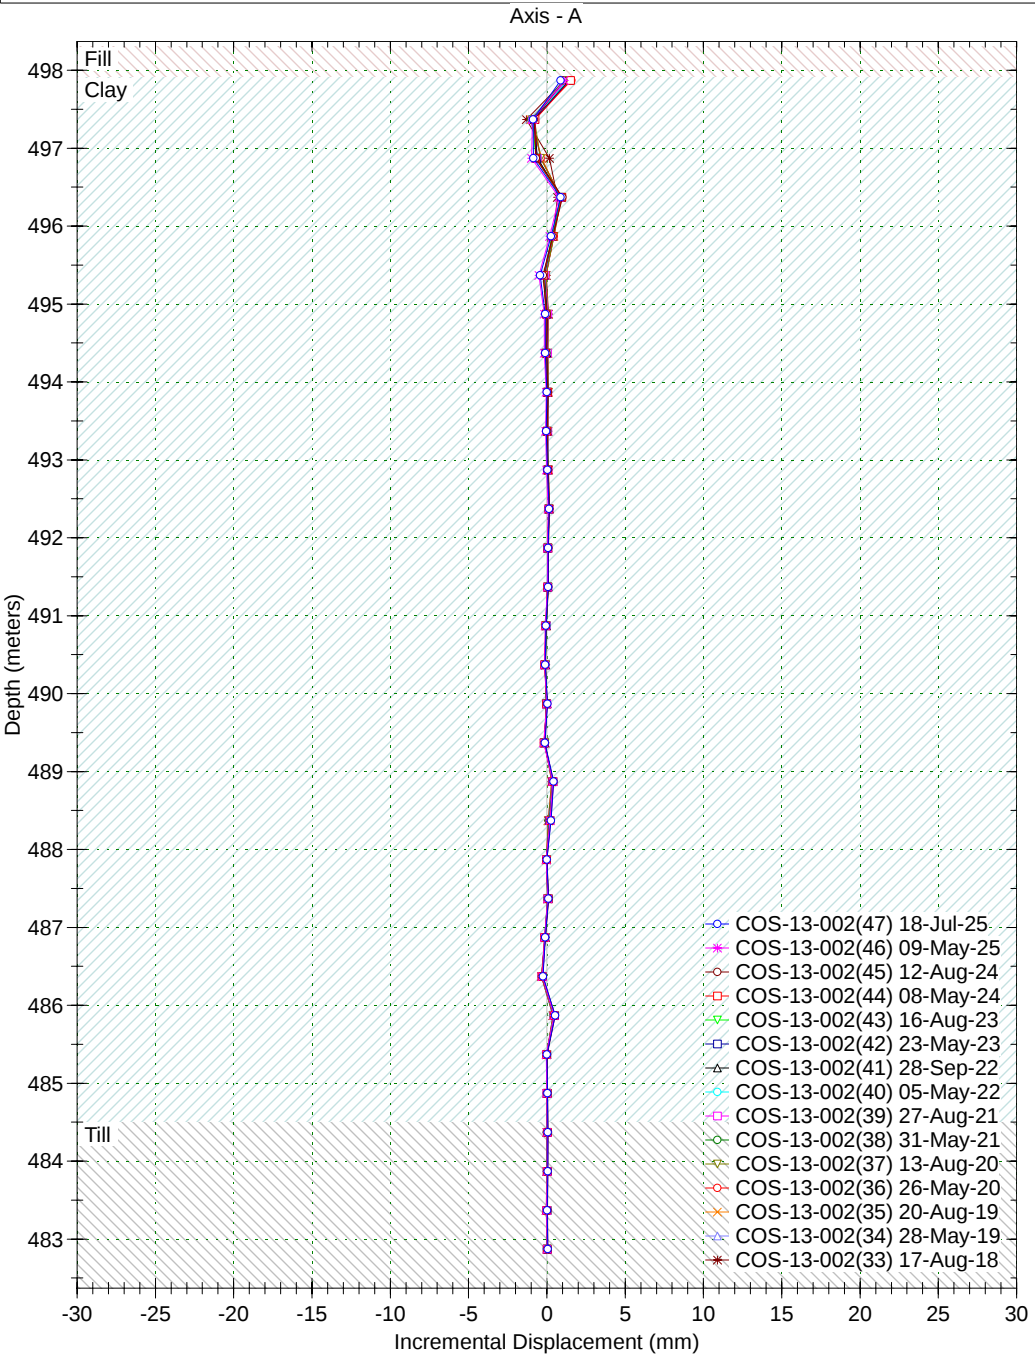
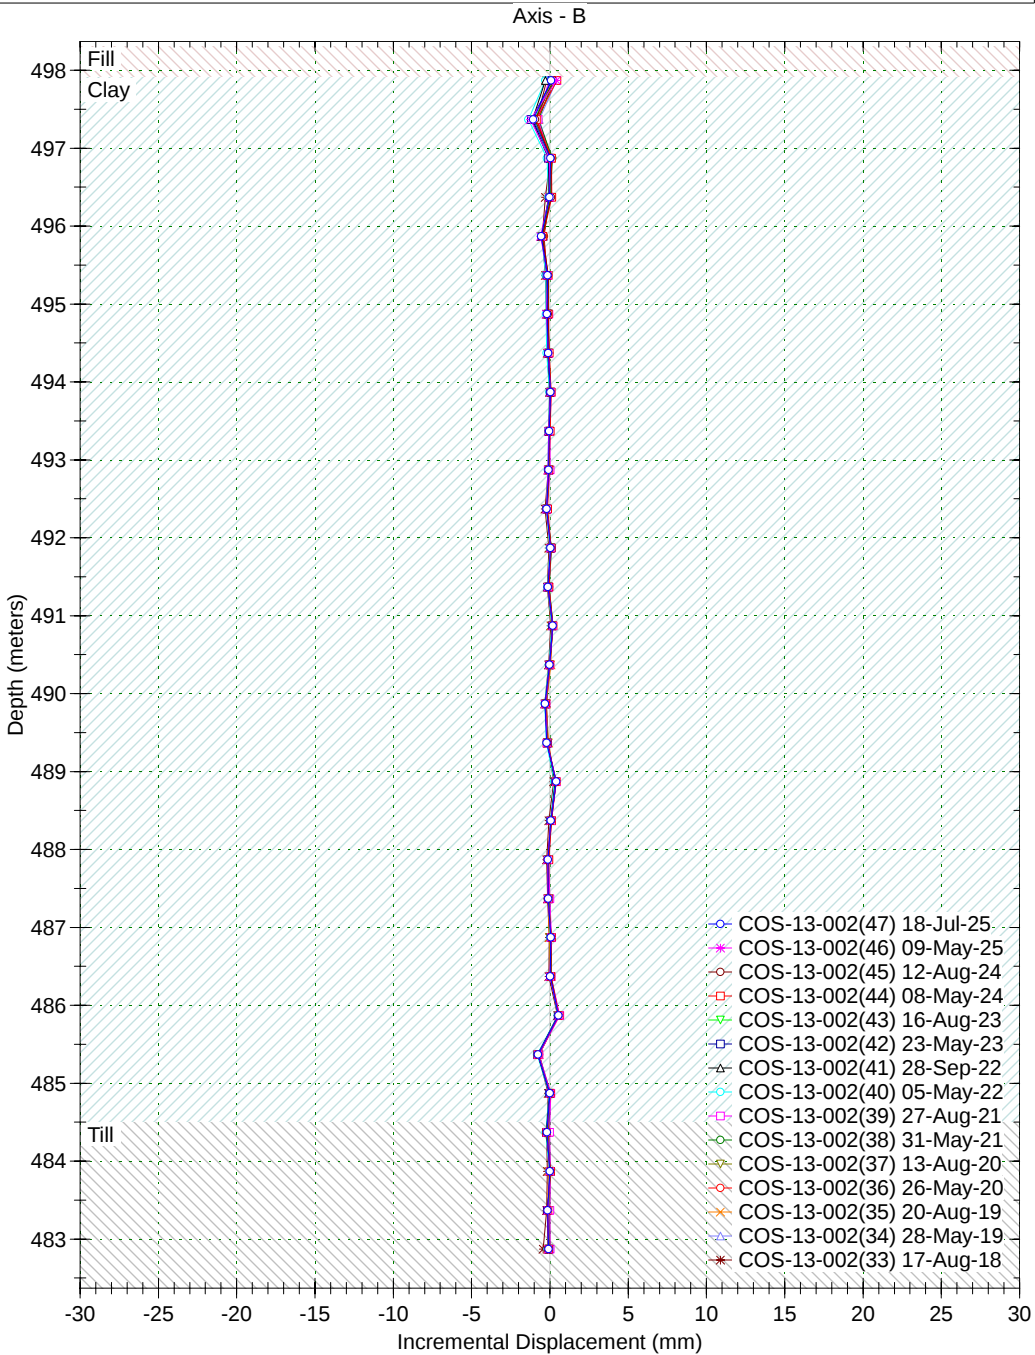
Borehole : COS-13-002  
Project : Nutana Slope  
Location : 307 11th St. E. (Front)  
Northing : 5775567.41  
Easting : 386043.54  
Collar : -0.113

- Inclinometer COS-13-002 plots continue to show a slight drift, with insignificant movement (less than 2 mm or 0.08) between July 30, 2013 and July 18, 2025.

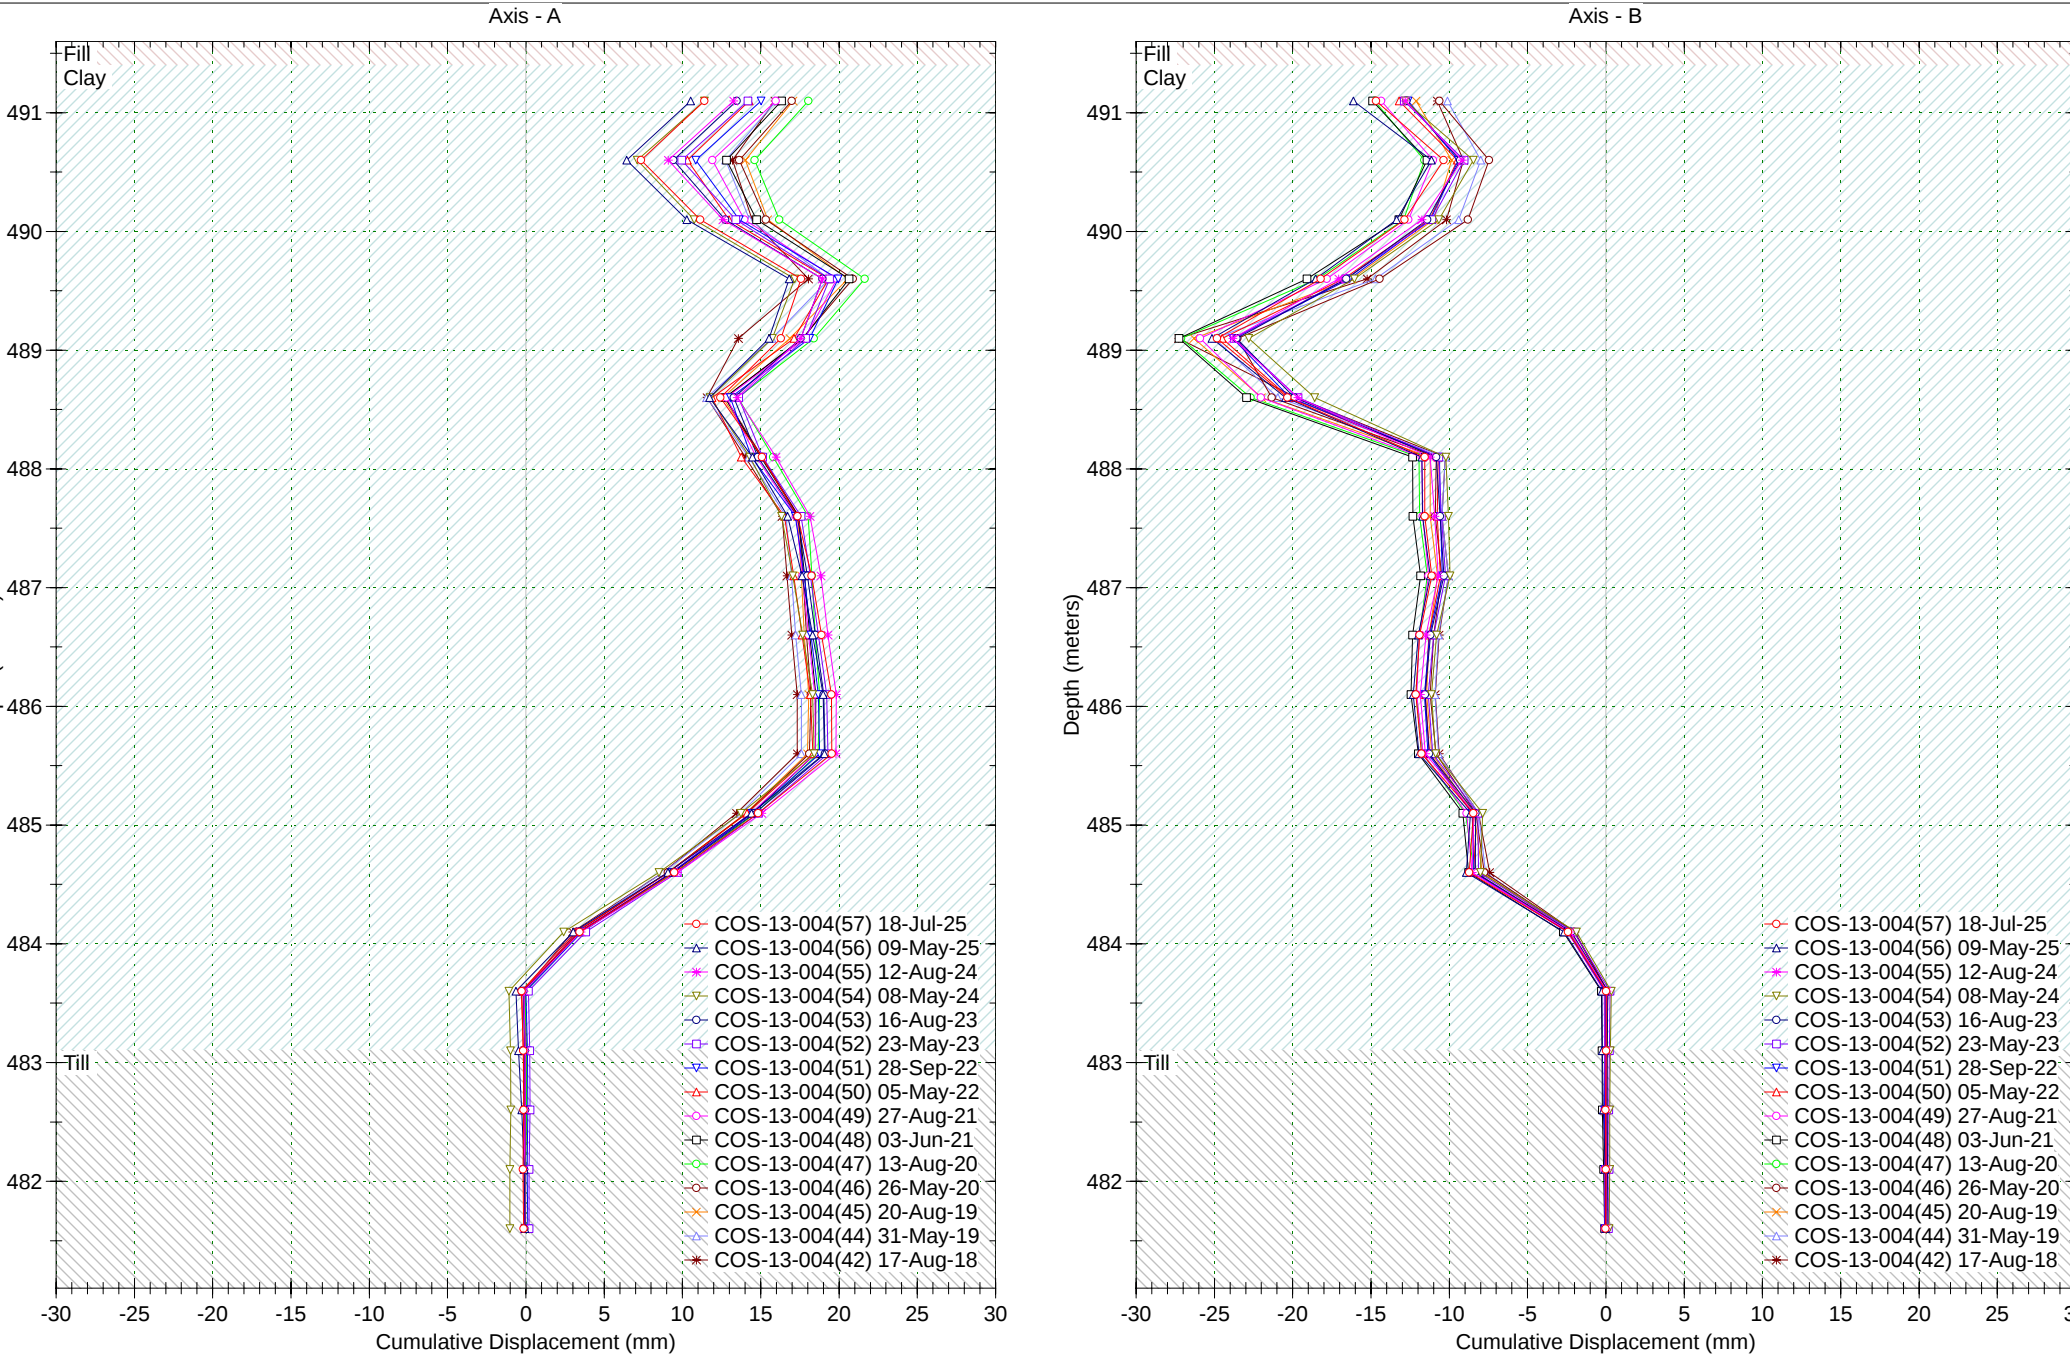
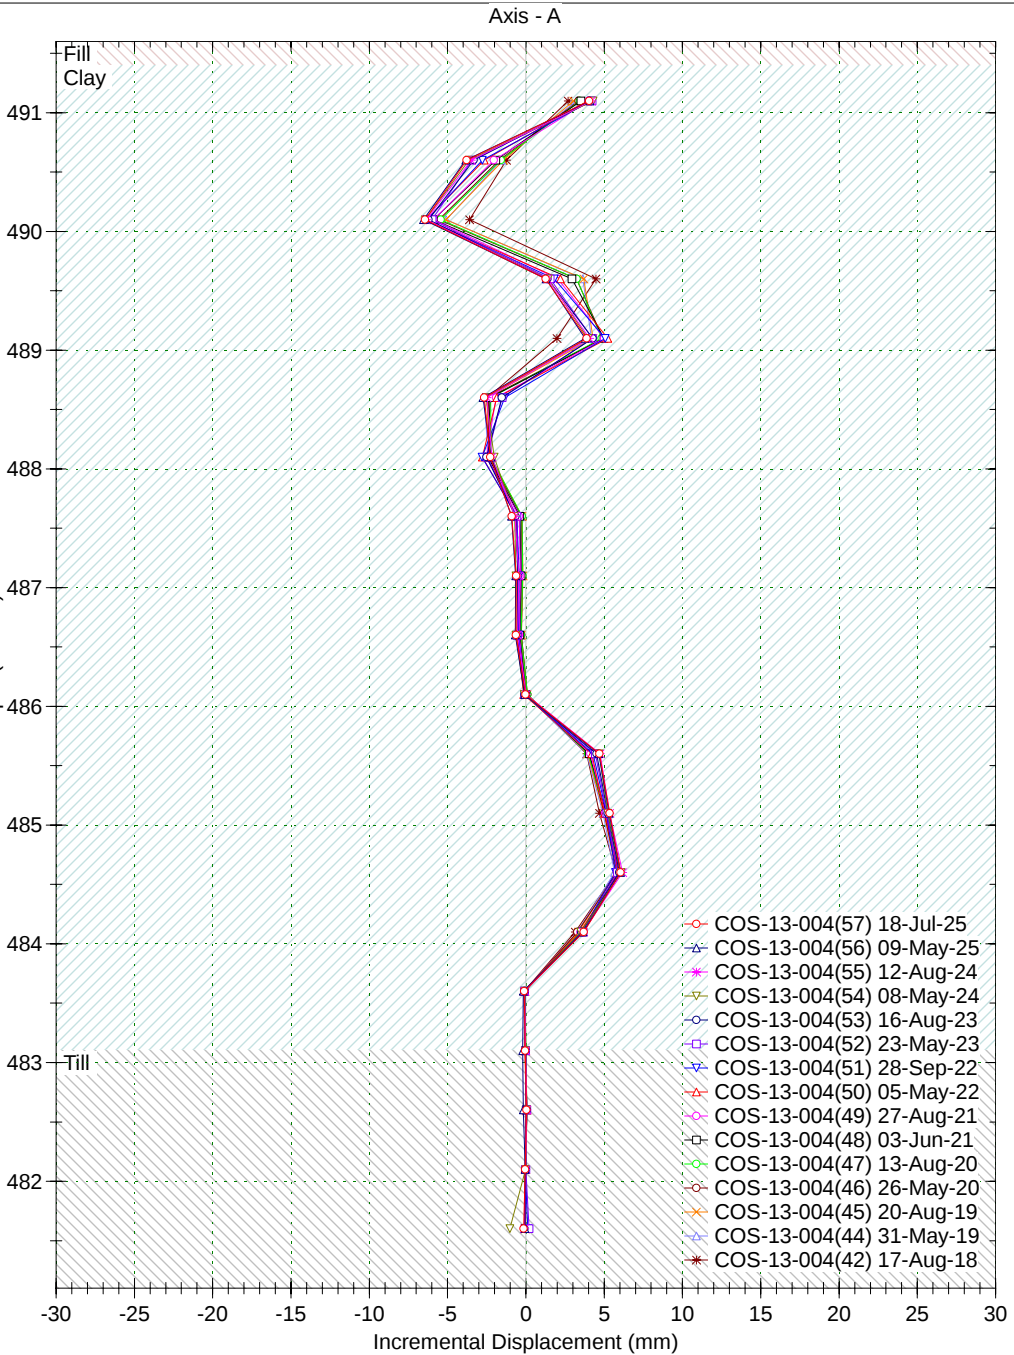
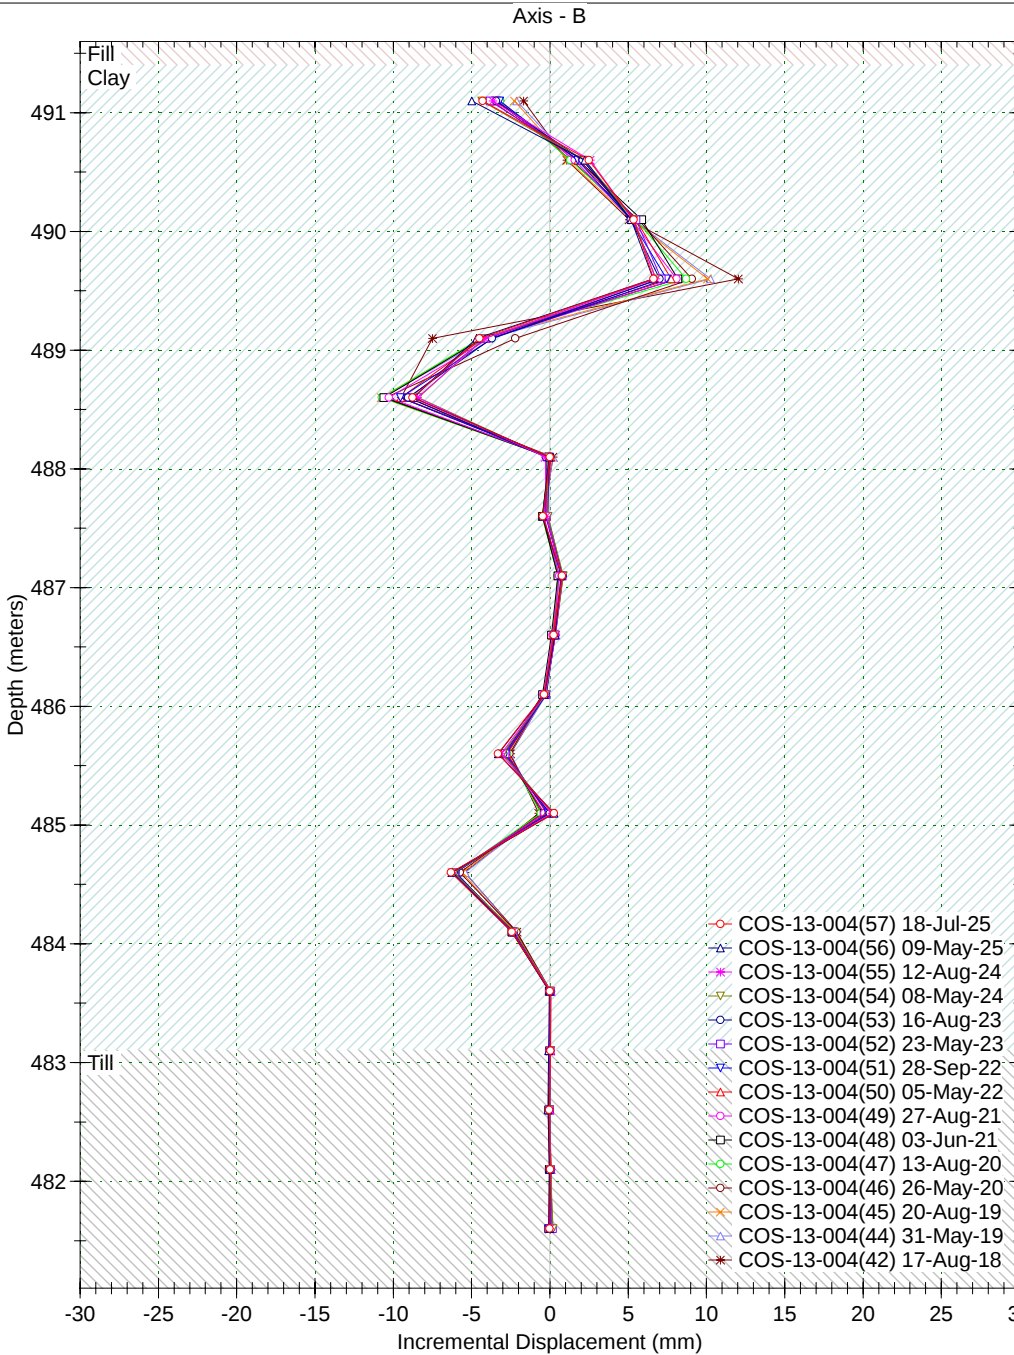
Borehole : COS-13-004  
Project : Nutana Slope  
Location : 307 11th. St. E. (back)  
Northing : 5775604.97  
Easting : 386050.63  
Collar : -0.677

- Inclinometer COS-13-004 has in recent years indicated drift both in the direction parallel to and along the direction of the laneway. The inclinometer plots indicate insignificant movement (less than 2.0 mm or 0.04 in) between May 9 and July 18, 2025.

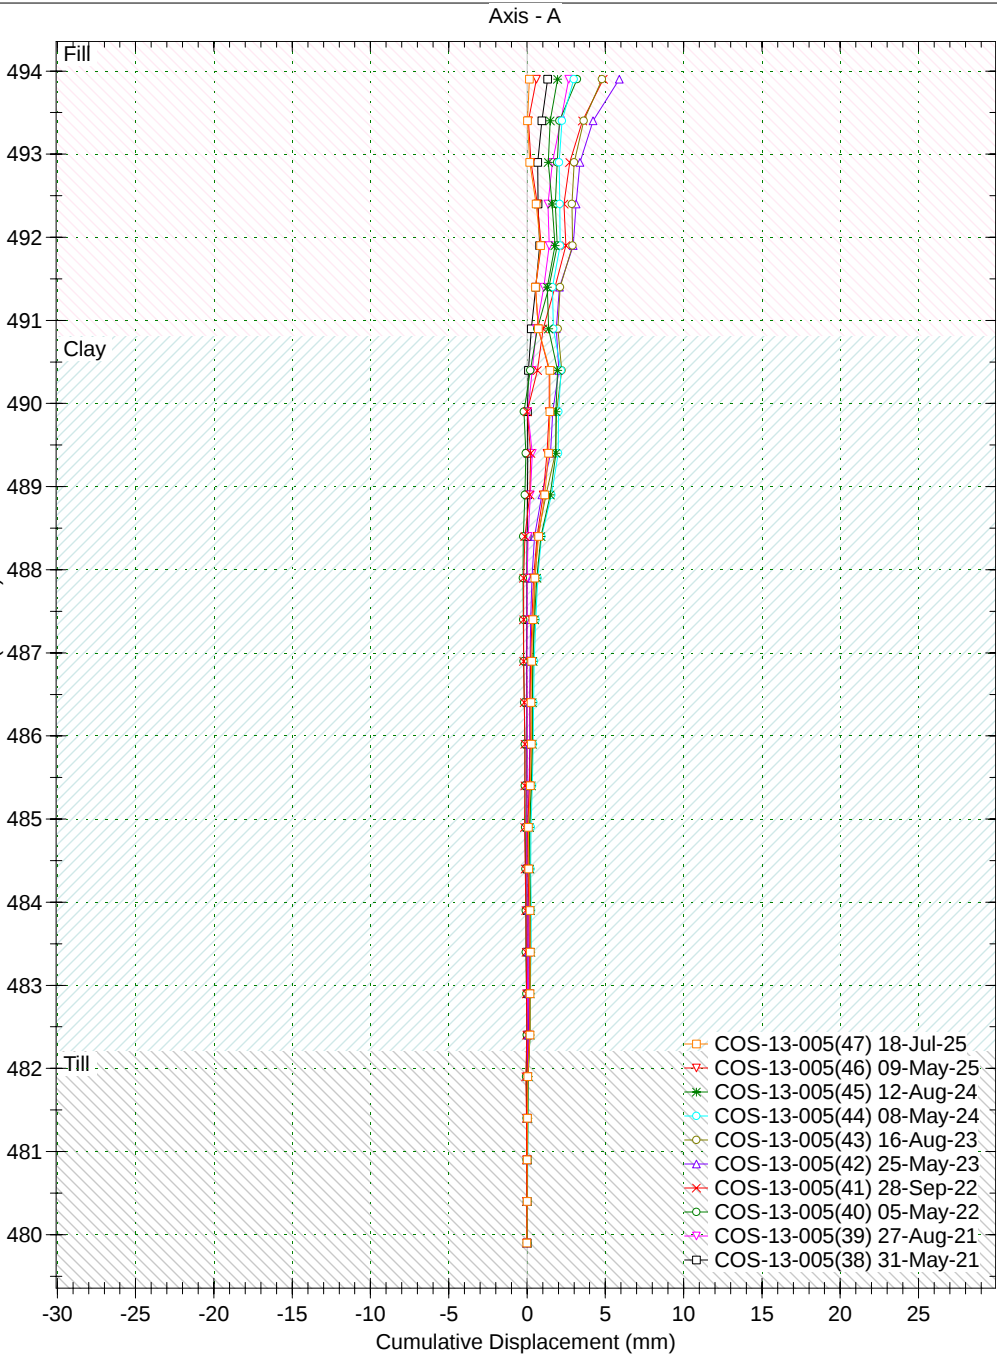
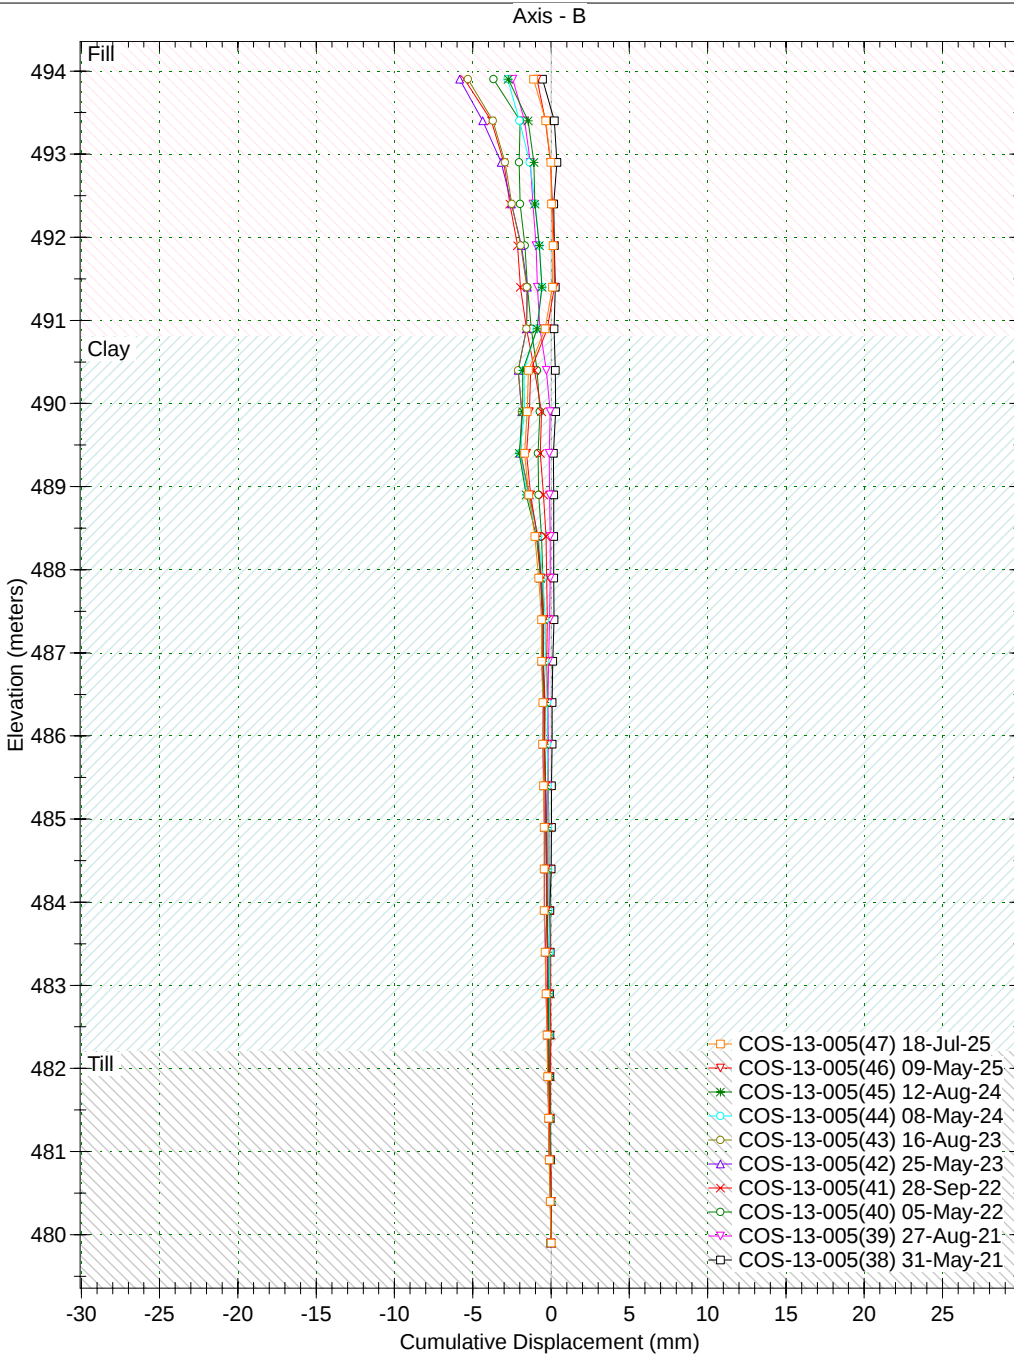
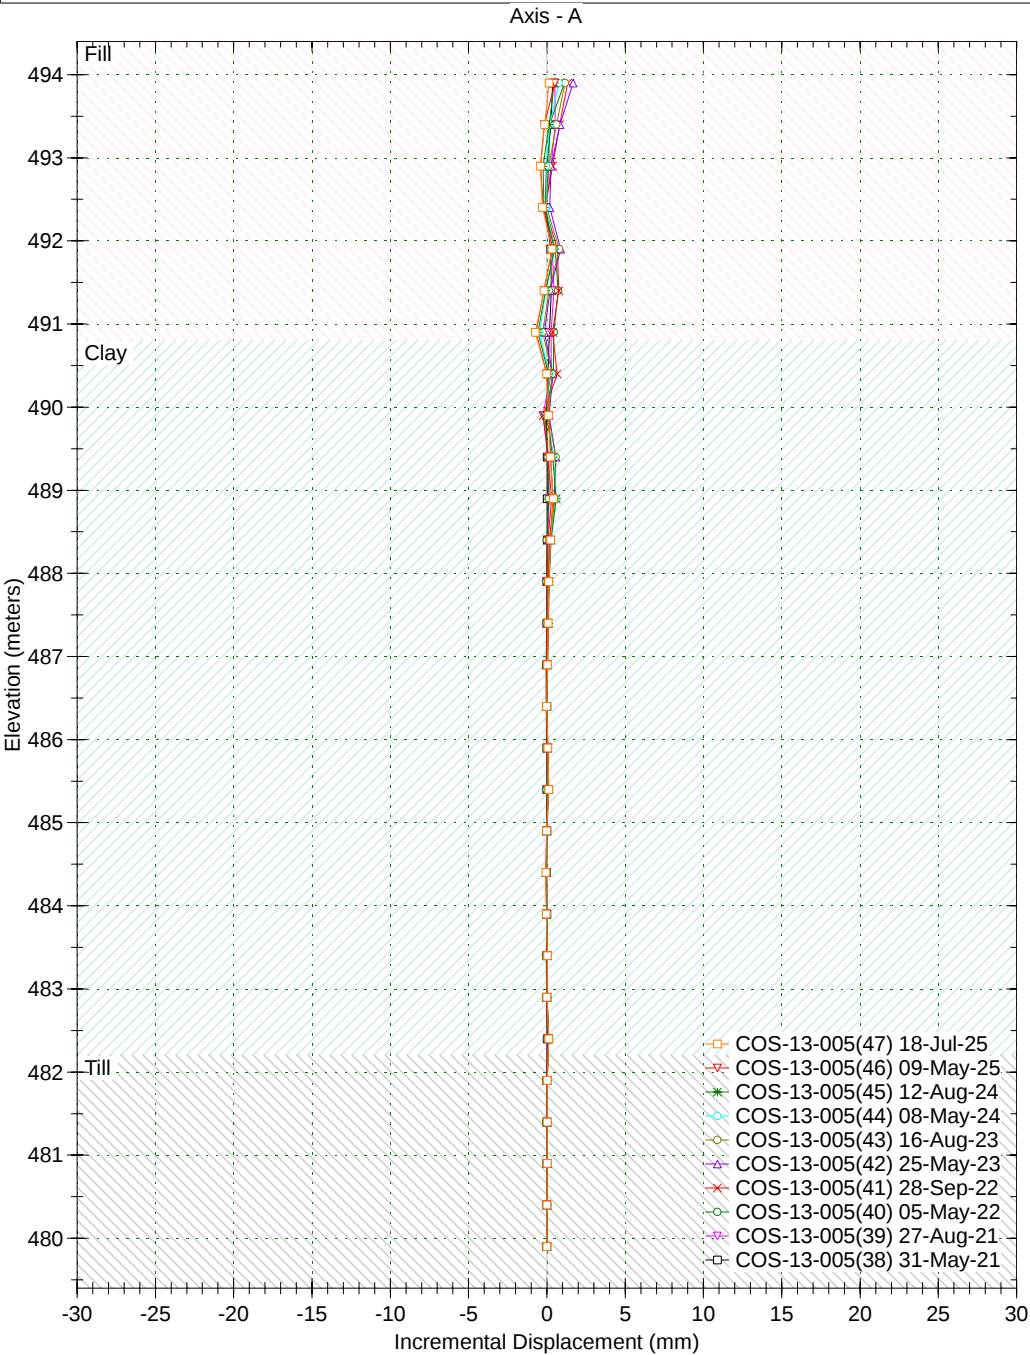
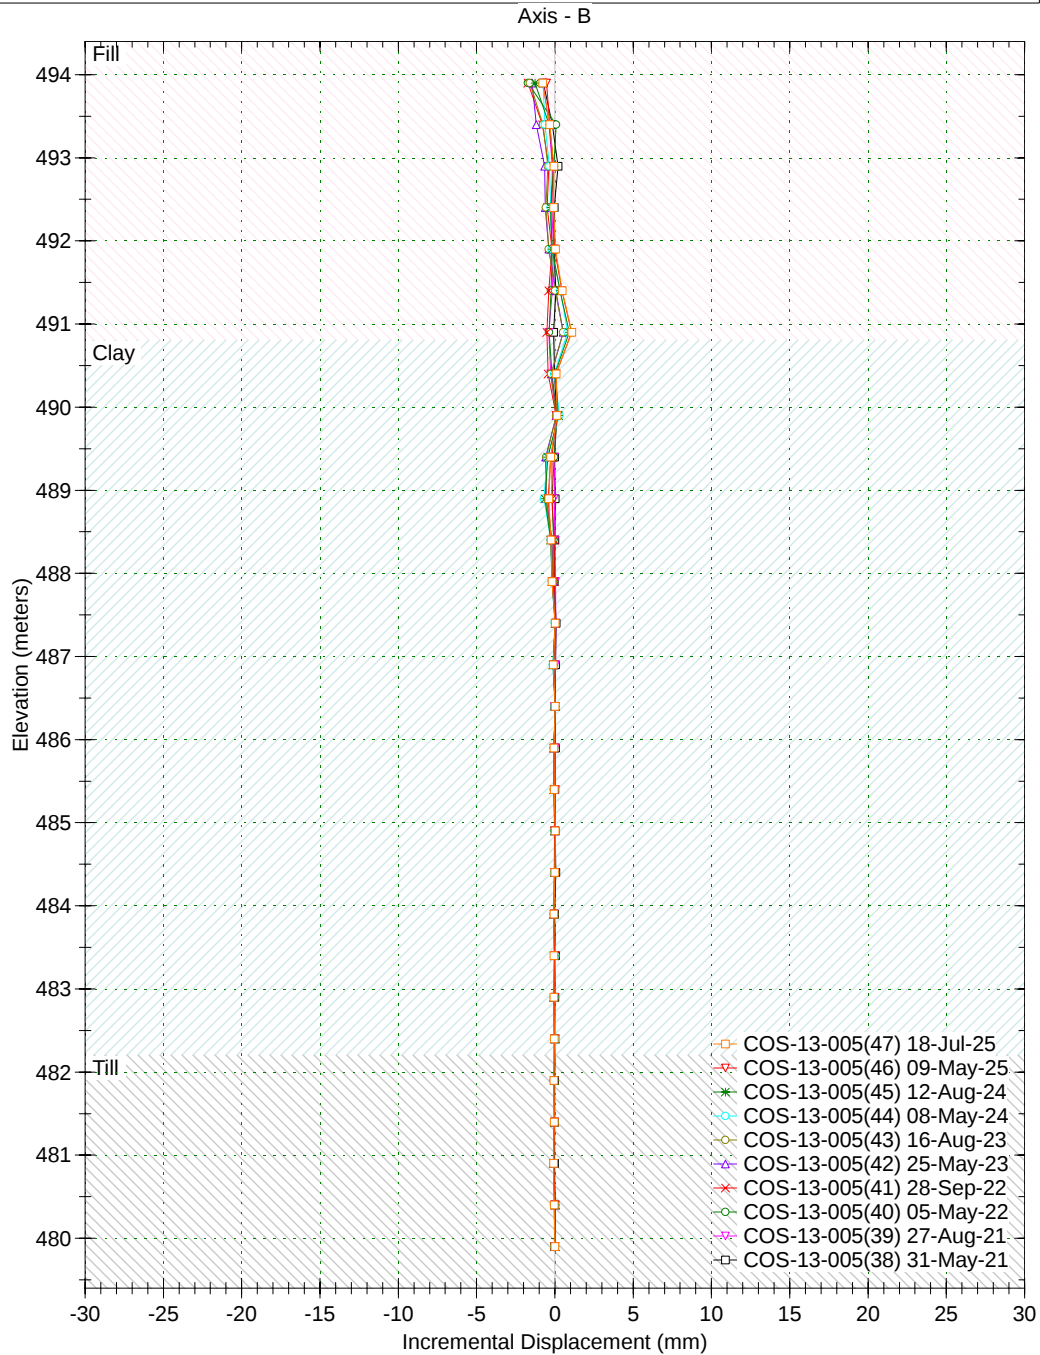
Borehole : COS-13-005 (Aug 13 2020 Baseline)  
Project : Nutana Slope  
Location : 316 Sask. Cres. E.  
Northing : 5775631.299  
Easting : 386078.8467  
Collar : -0.1

- Inclinometer COS-13-005 indicated insignificant movement (less than 2 mm or 0.08 in) between May 9 and July 18, 2025.
- Inclinometer 20-109 has indicated approximately 27 mm of cumulative downslope movement between October 28, 2020 and July 18, 2025, with insignificant movement (less than 2.0 mm or 0.04 in) between May 9 and July 18, 2025. The zone of movement is approximately 2.5 m below the top of casing. The rate of slope movement has increased from approximately 1 mm/yr between October 28, 2020 and May 5, 2022, to approximately 5 mm/yr between May 5, 2022 and May 9, 2025.
