## TECHNICAL MEMORANDUM

**Reference No.** CA0029692.2934-TM-04-Rev0

### NUTANA SLOPE STABILITY UPDATE – JULY 2025

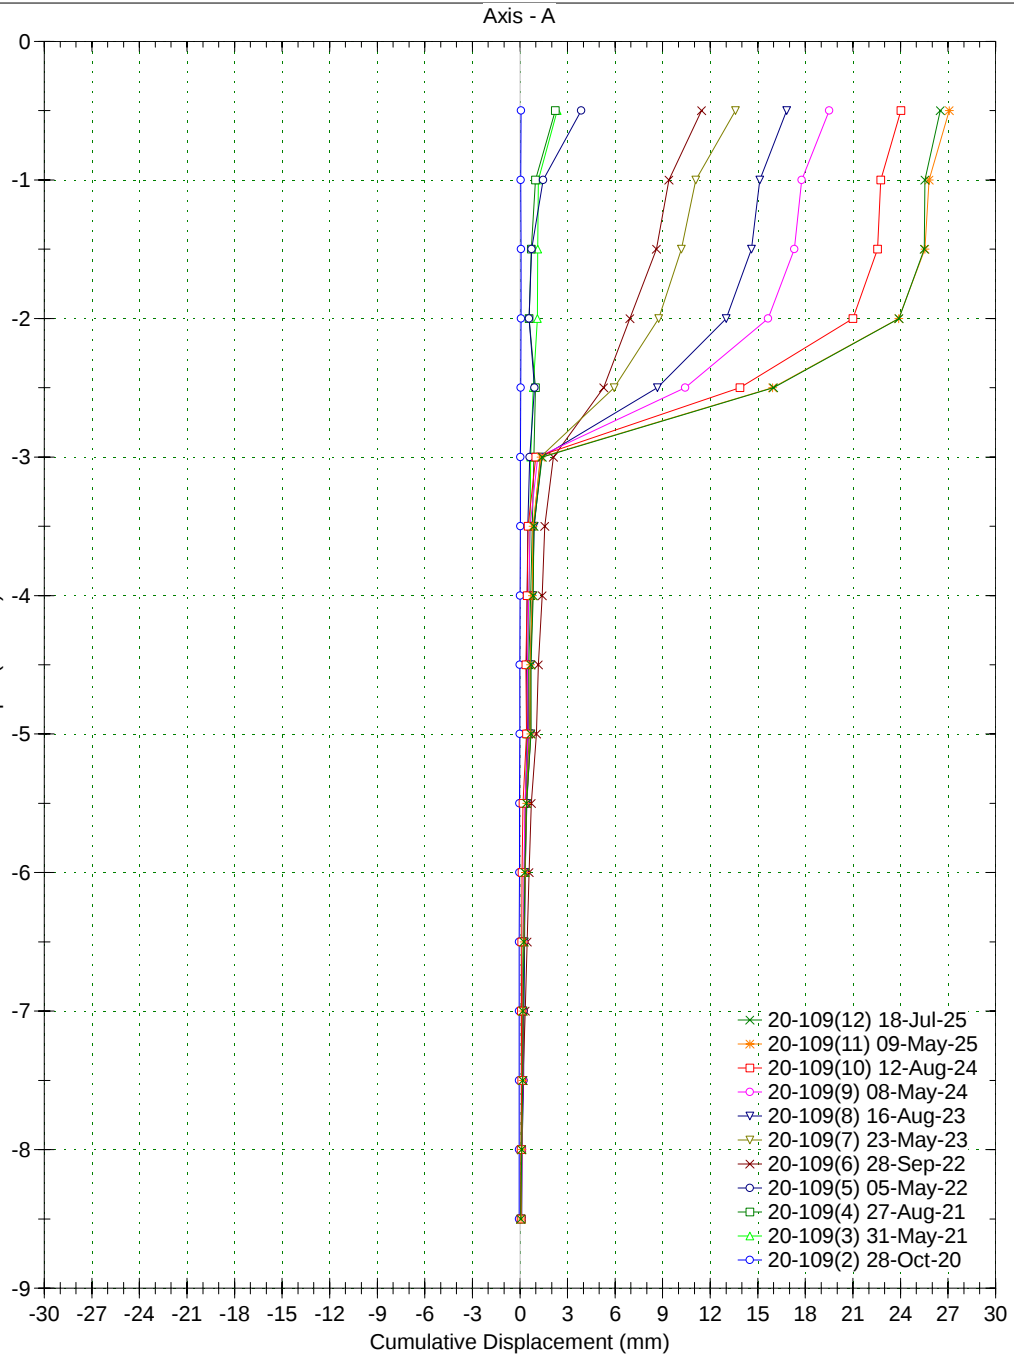
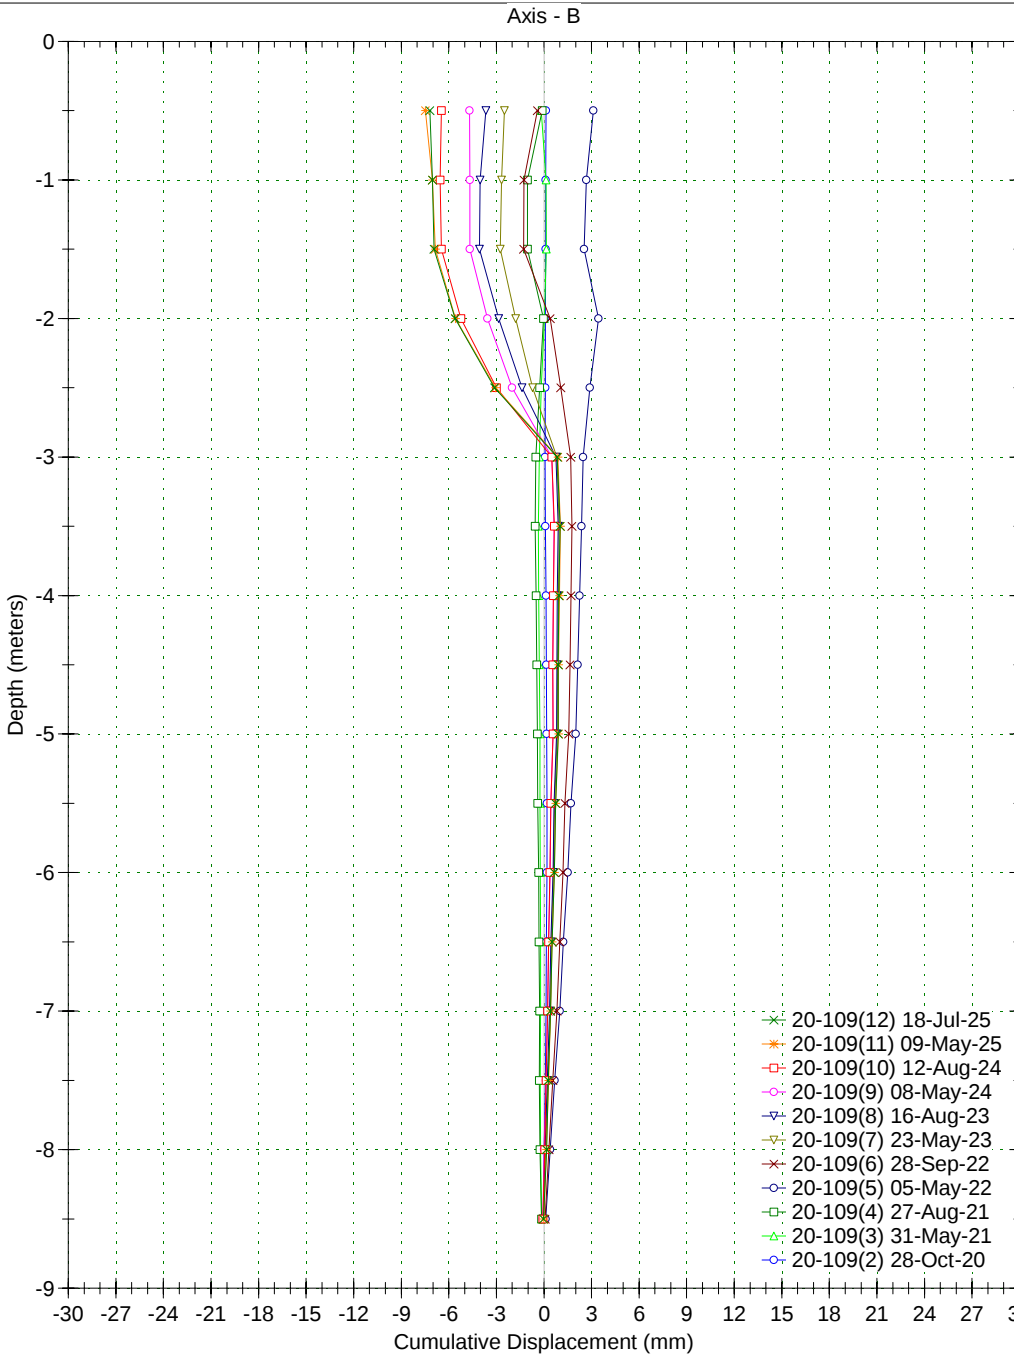
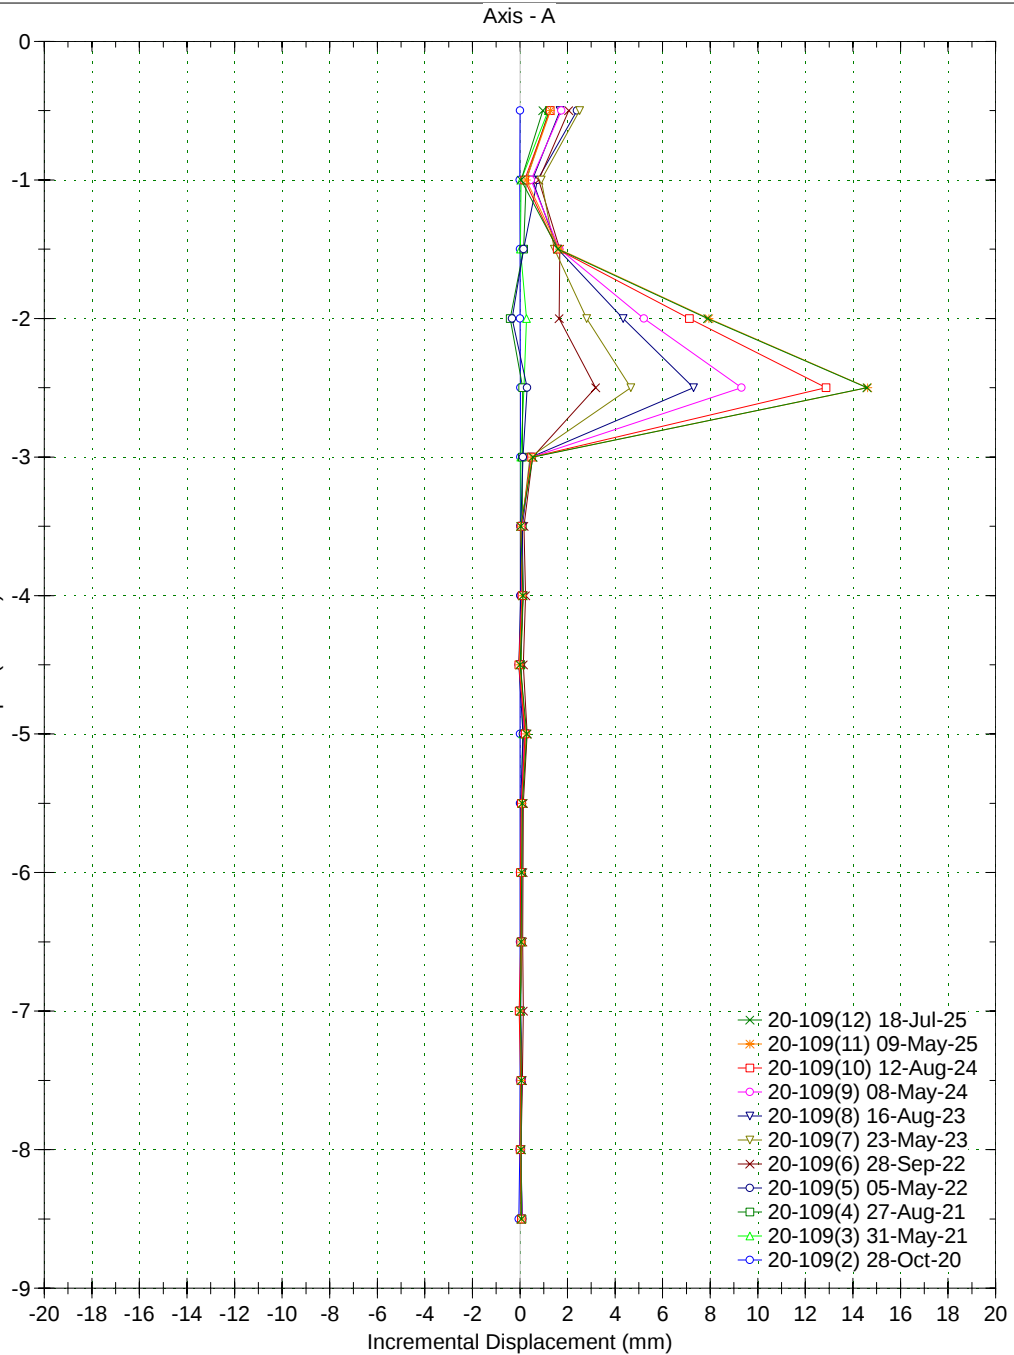
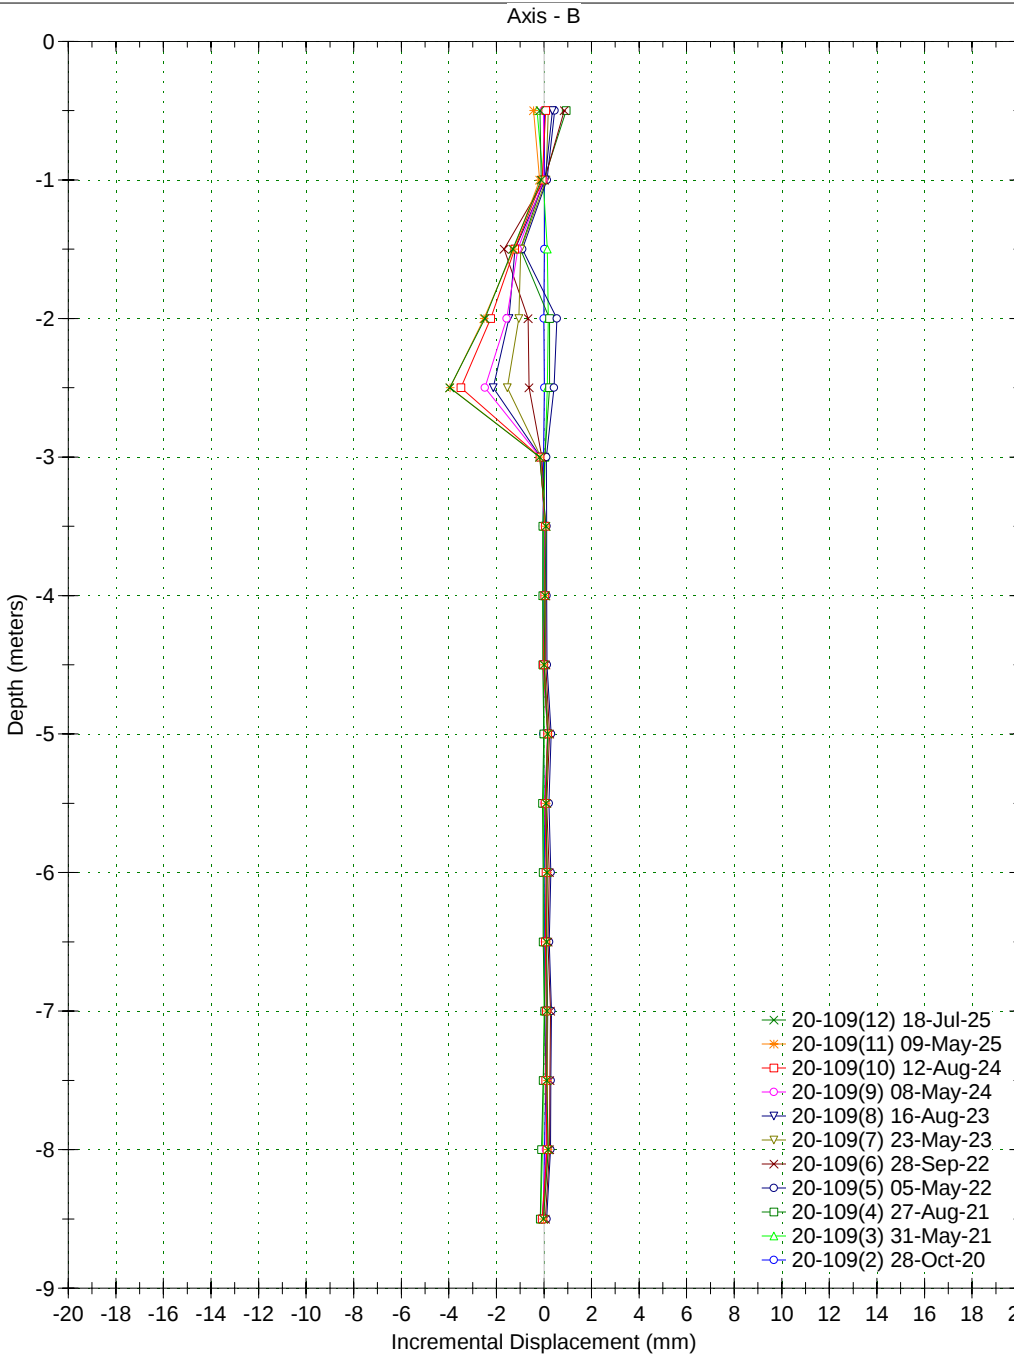
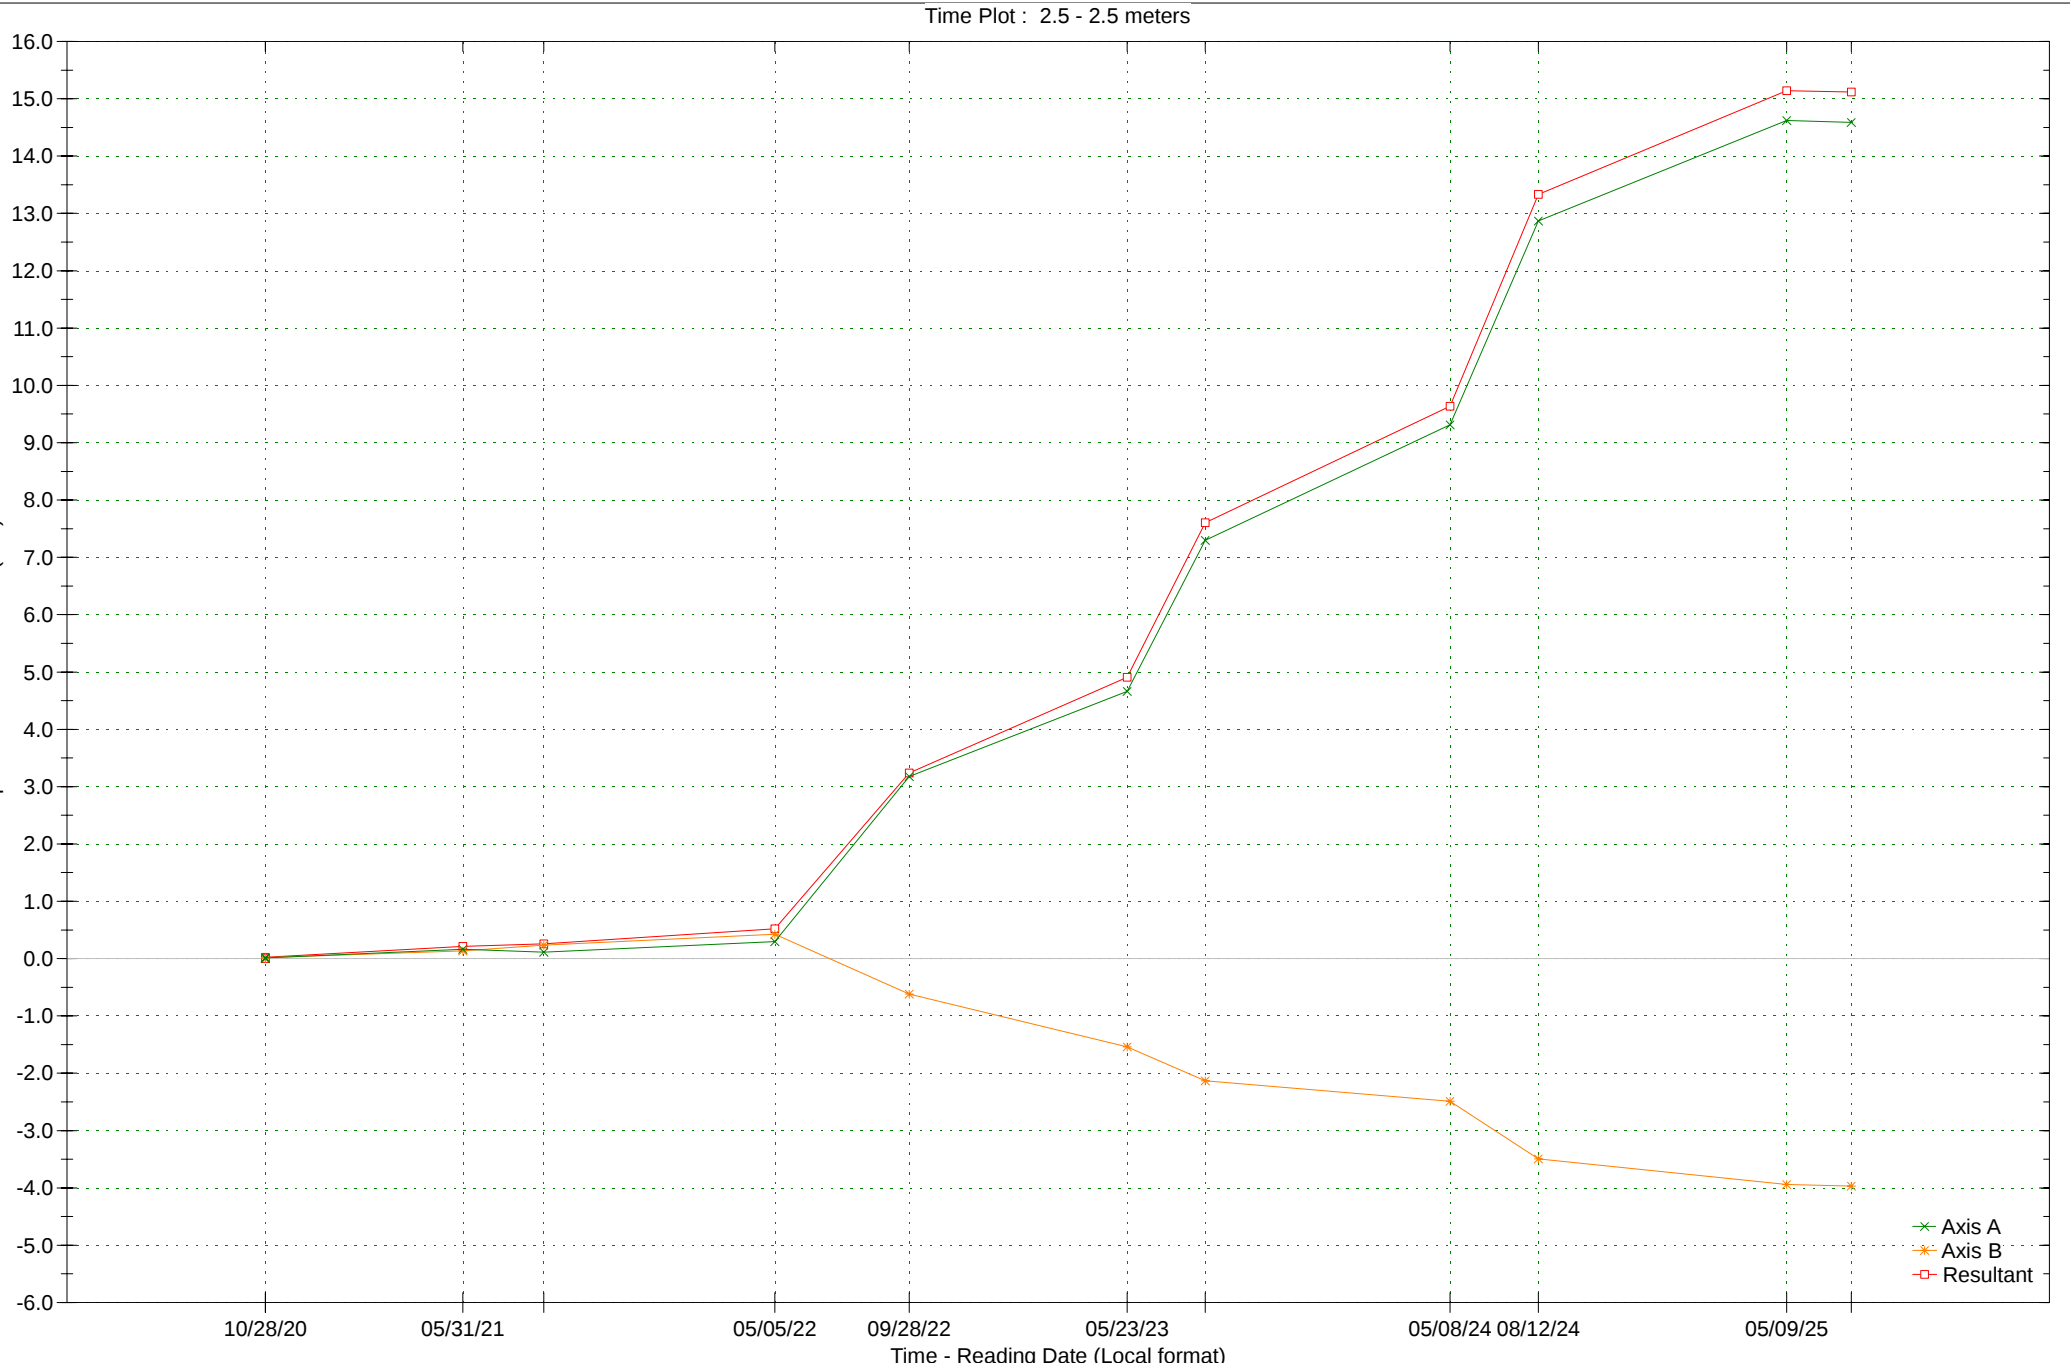
Borehole : 20-109  
Project : Nutana Slope  
Location :  
Northing : 5775622  
Easting : 385977  
Collar :

- Inclinometer COS-13-005 indicated insignificant movement (less than 2 mm or 0.08 in) between May 9 and July 18, 2025.
- Inclinometer 20-109 has indicated approximately 27 mm of cumulative downslope movement between October 28, 2020 and July 18, 2025, with insignificant movement (less than 2.0 mm or 0.04 in) between May 9 and July 18, 2025. The zone of movement is approximately 2.5 m below the top of casing. The rate of slope movement has increased from approximately 1 mm/yr between October 28, 2020 and May 5, 2022, to approximately 5 mm/yr between May 5, 2022 and May 9, 2025.

Slope inclinometer 20-109 indicates a zone of movement a depth of approximately 2.5 m below the top of casing with a rate of movement approximately 5 mm/yr between May 5, 2022 and July 18, 2025, an increase from 1 mm/yr for the period between October 2020 and May 2022. Inclinerometer 20-111 plots continue to show drifts in upslope direction, with approximately 4.5 mm (0.18 in) of cumulative movement between October 28, 2020 and July 18, 2025.

WSP recommends that the intended final monitoring trip be completed for the Nutana site for the fall of 2025.

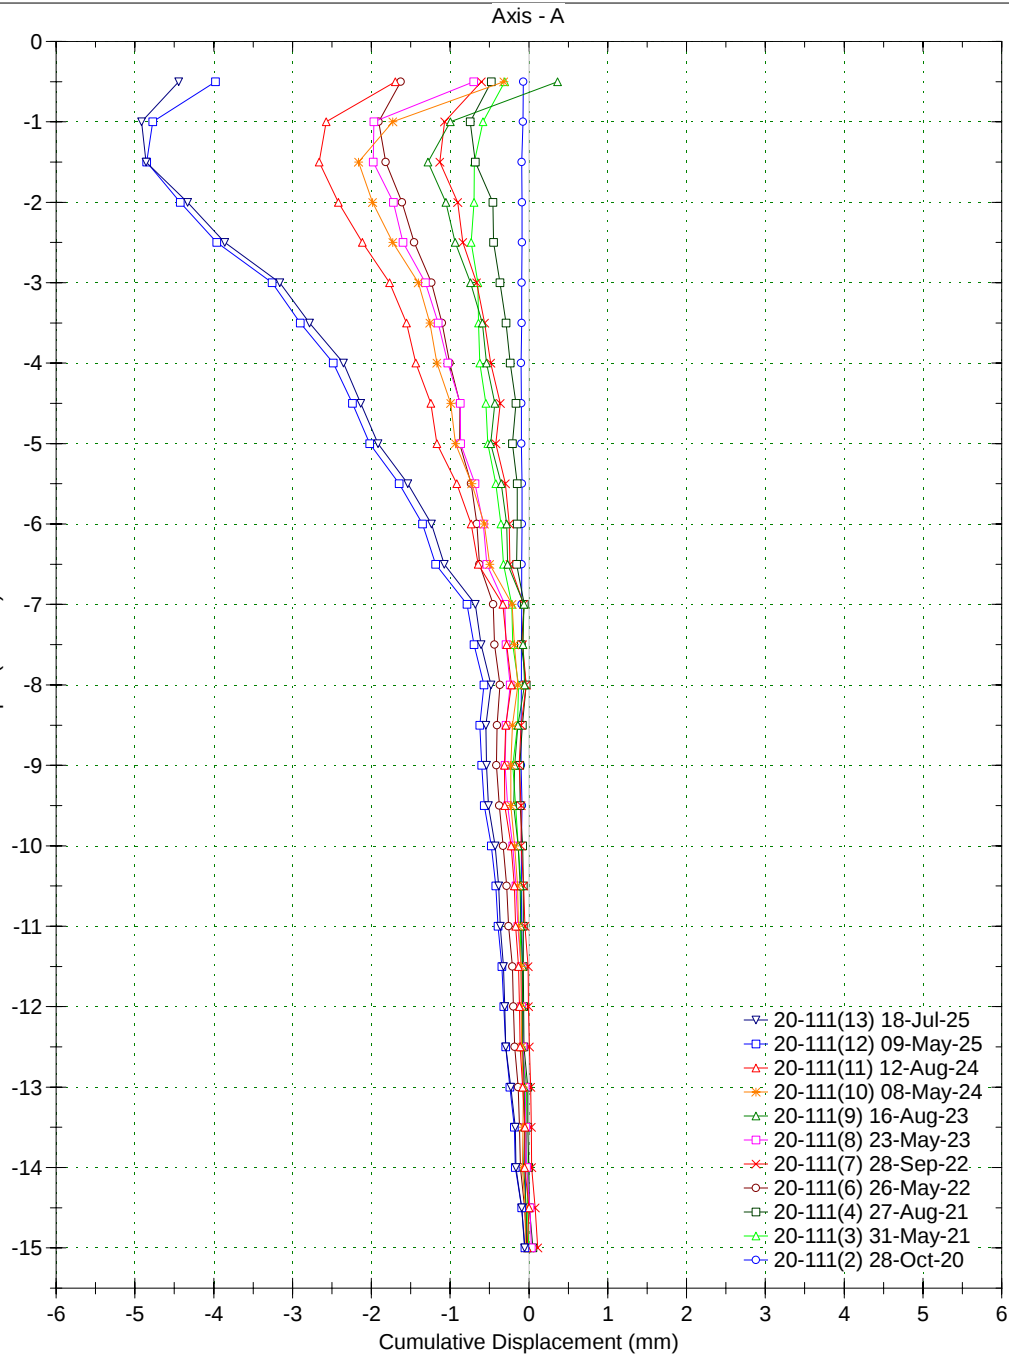
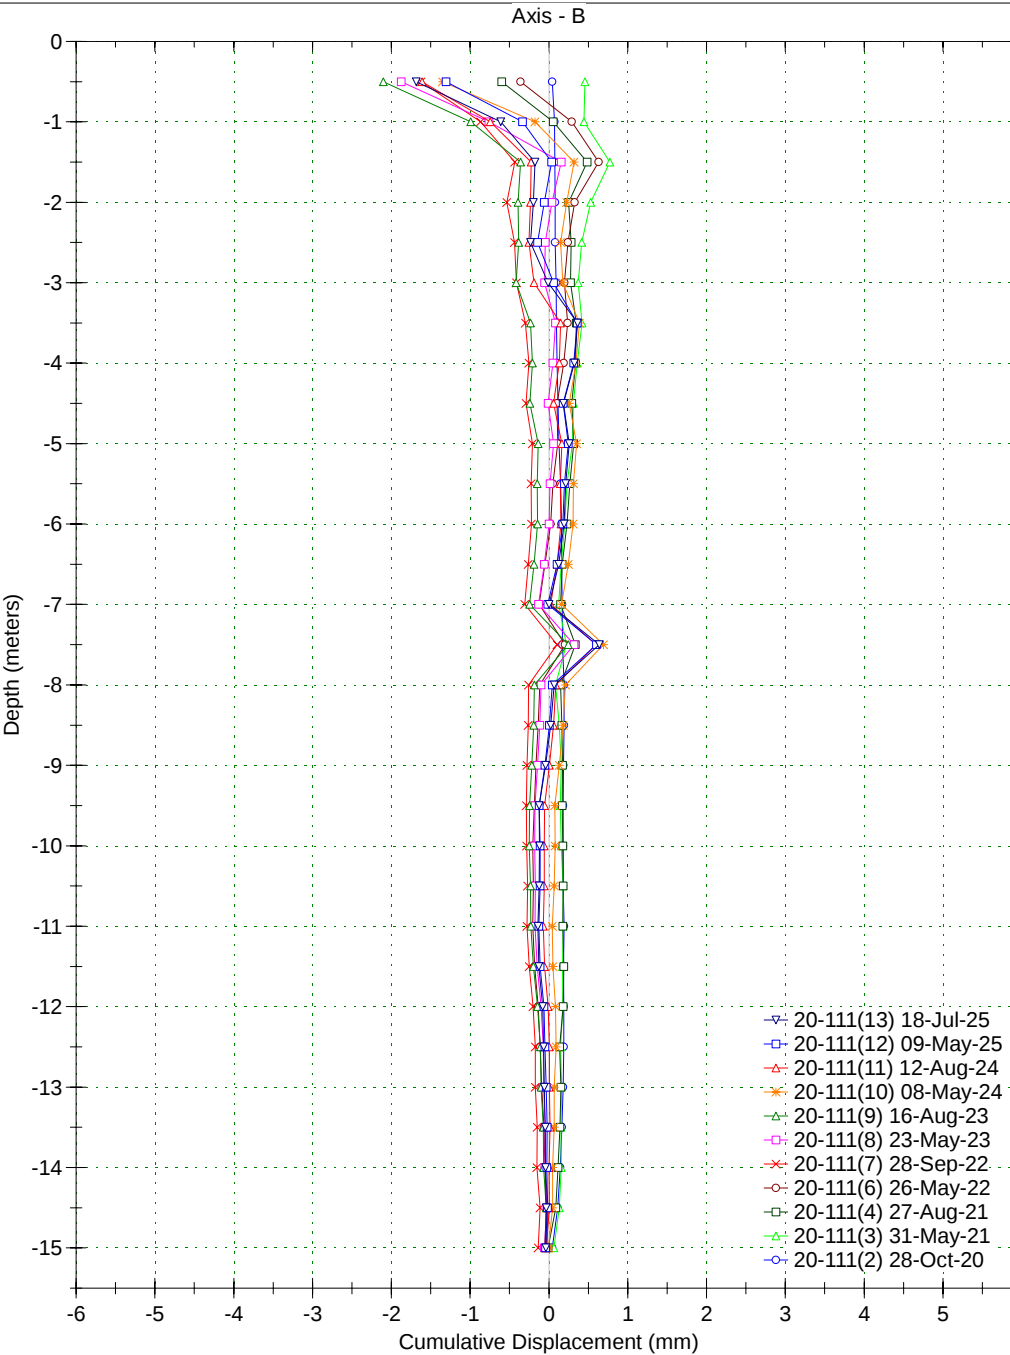
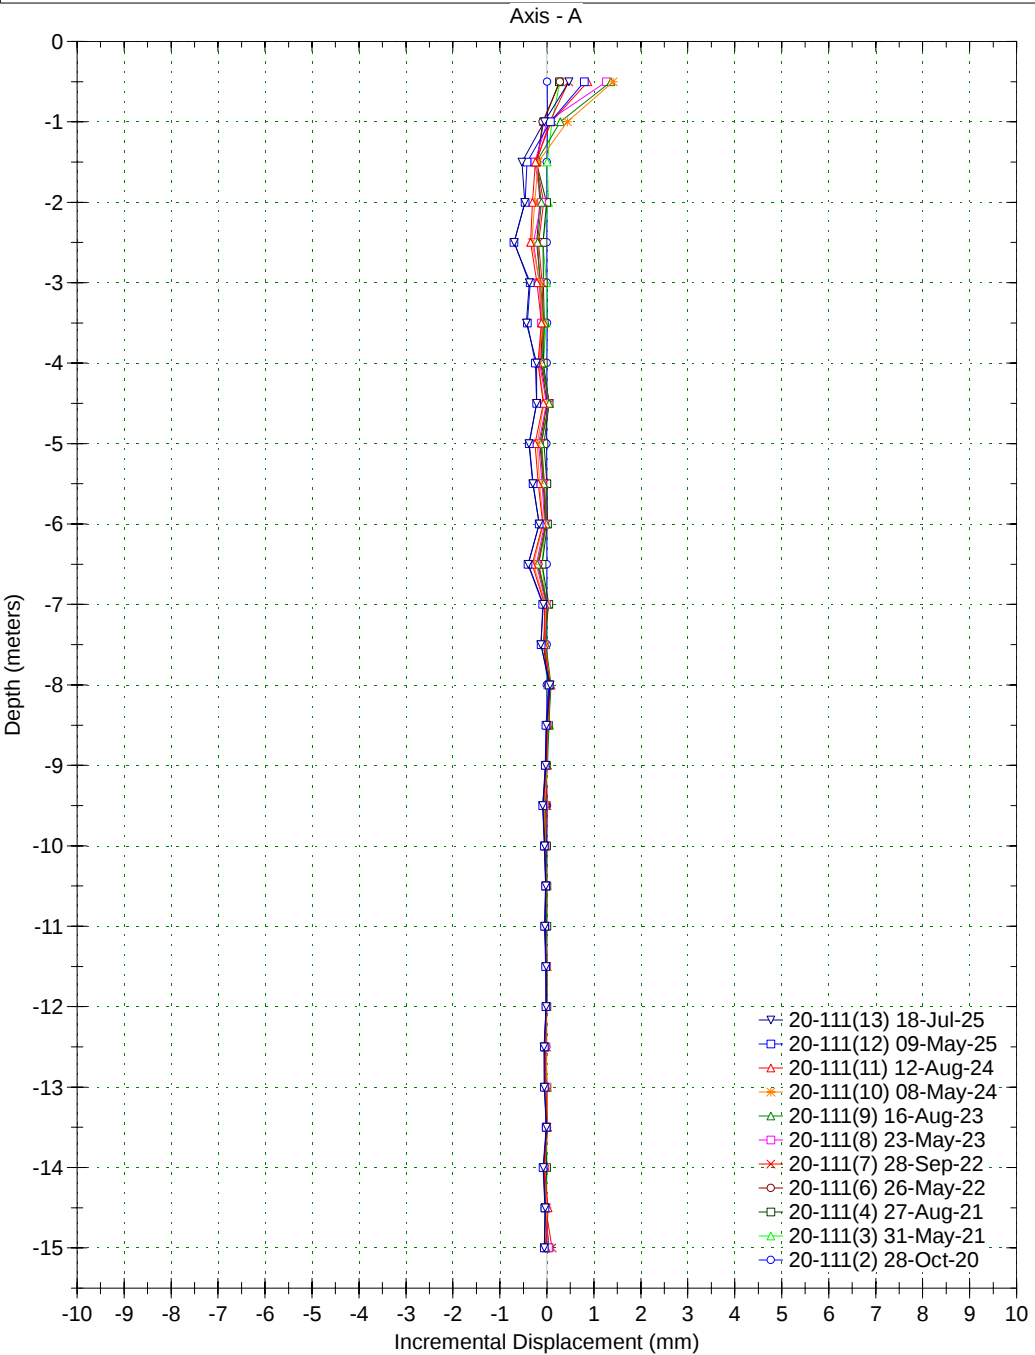
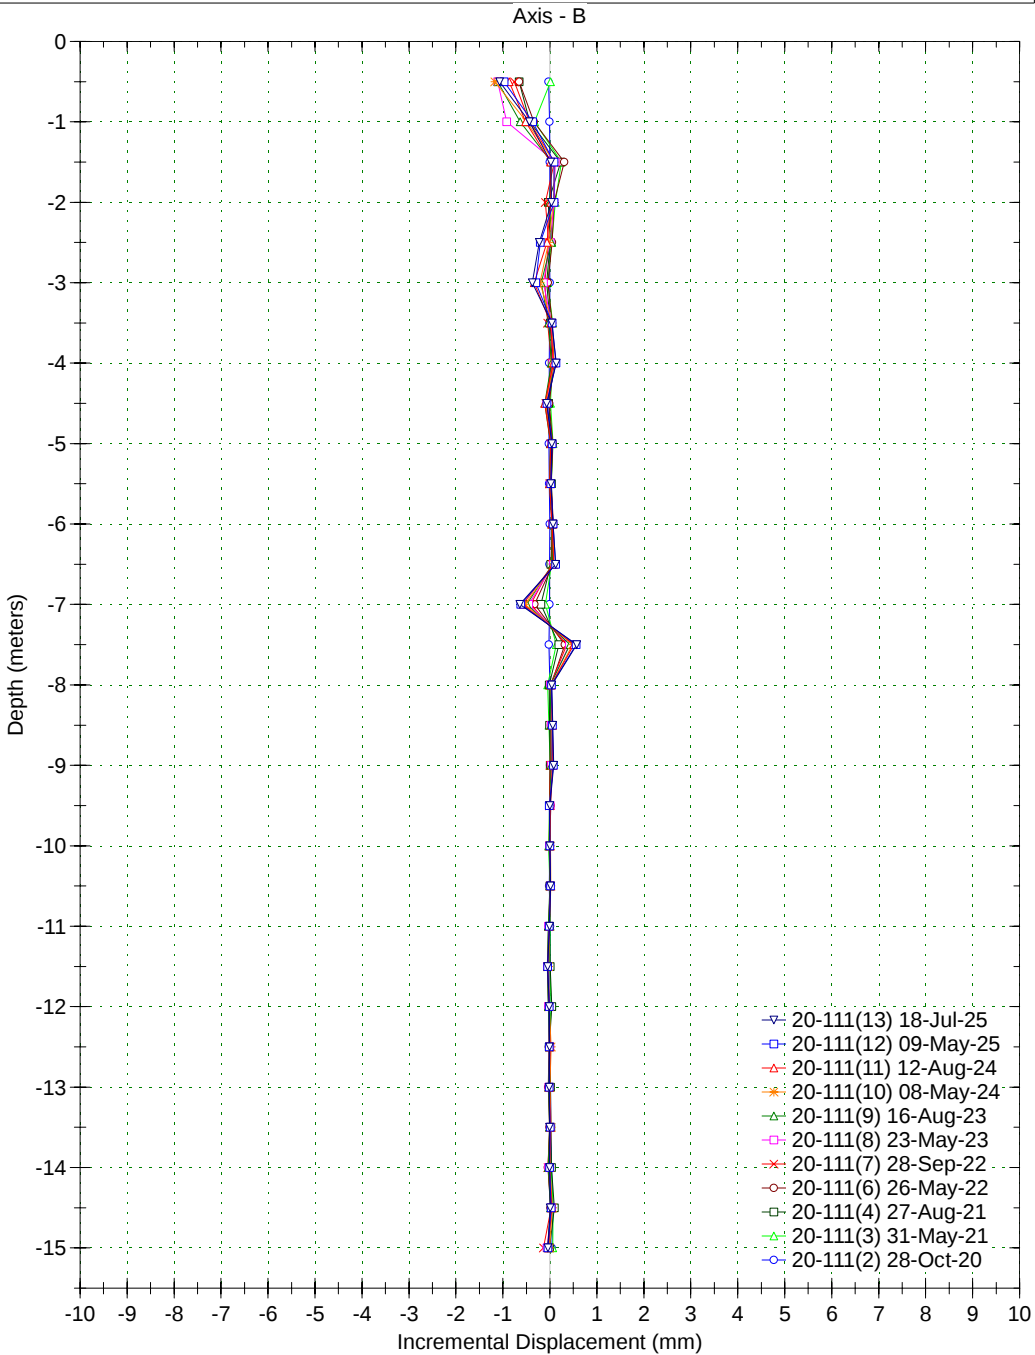
Borehole : 20-111  
Project : Nutana Slope  
Location :  
Northing : 5775568  
Easting : 385953  
Collar :

- Inclinometer 20-111 plots continue to show drifts in upslope direction, with approximately 4.5 mm (0.18 in) of cumulative movement between October 28, 2020 and Jul 18, 2025.

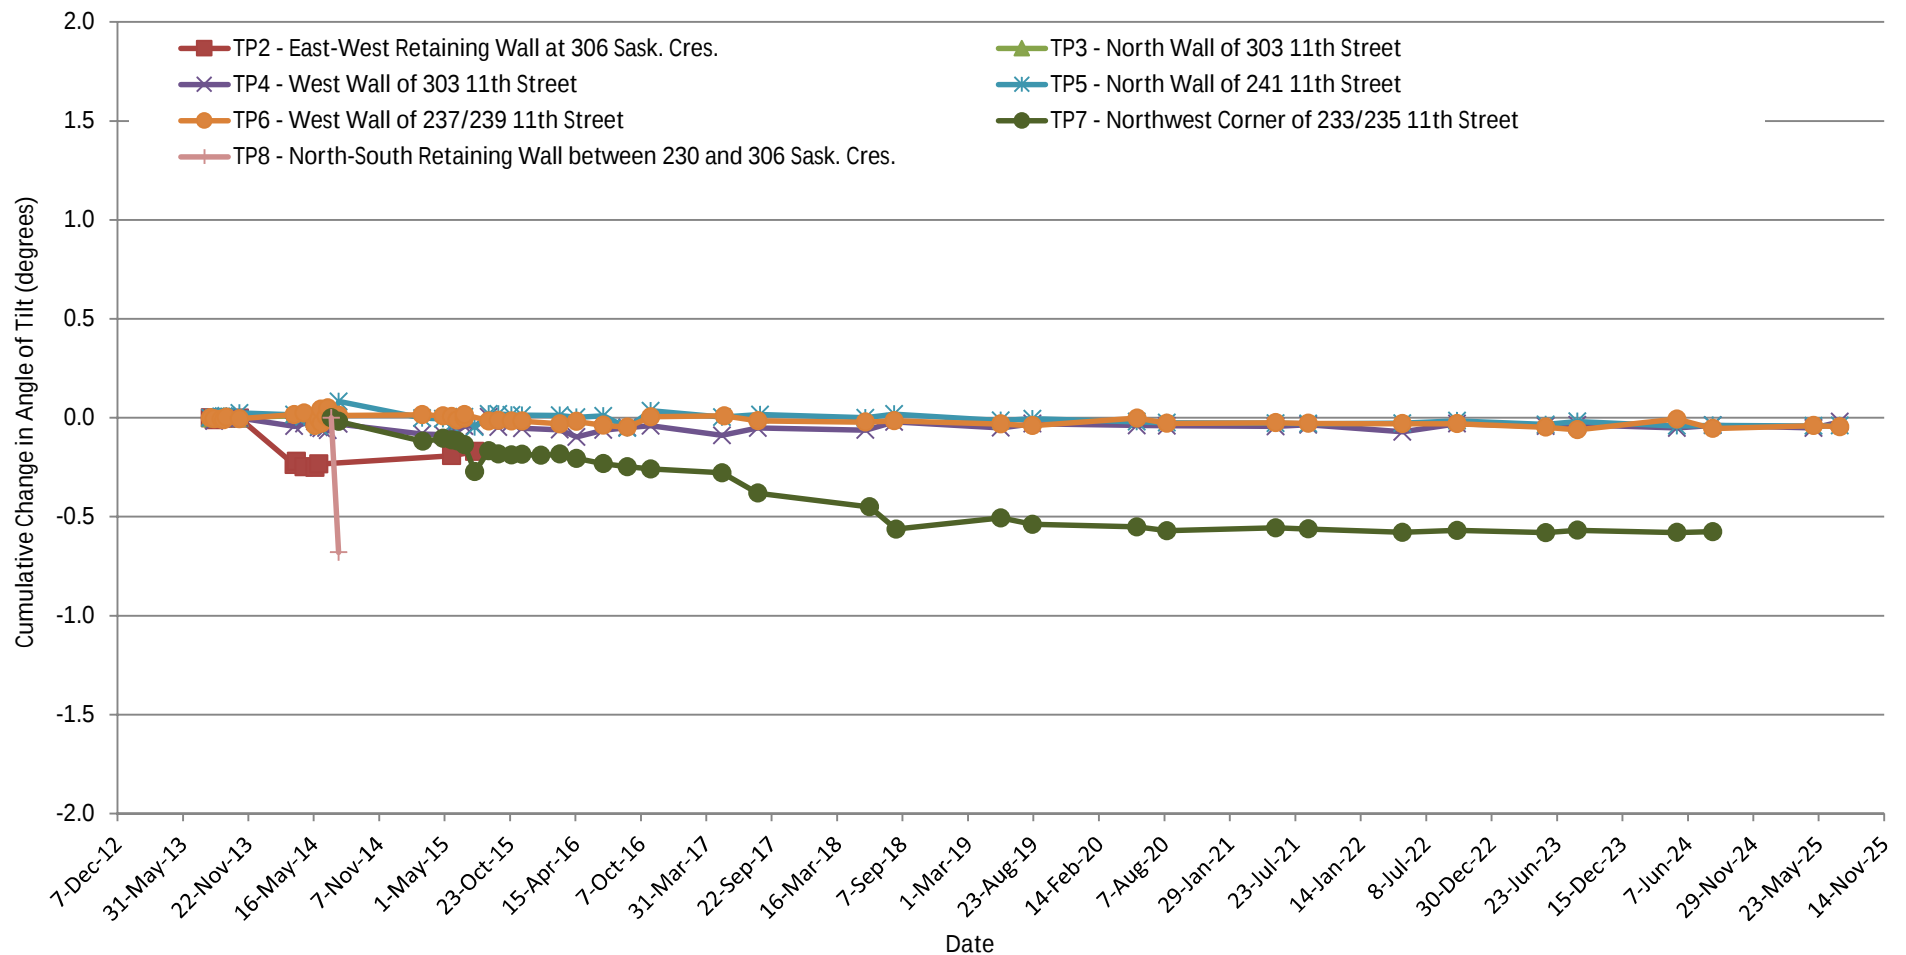
| | CADD | | | FIGURE: B1 | |

- Tilt plates TP4, TP5, and TP6 indicate insignificant changes in angle of tilt (less than 0.05 degrees) between August 23, 2013 and July 18, 2025.
- Tilt plate TP7 could not be accessed at the time of instrumentation monitoring and will be read during a future visit.

- 1) Positive changes in tilt indicate tilting toward the monitoring structure.
- 2) TP1, located on the retaining wall between 230 and 306 Sask. Cres., is not monitored for health and safety reasons; monitoring results for this tilt plate show a change in angle of tilt of approximately 9 degrees between August 2013 and June 2014.
- 3) TP3 and TP8 are destroyed, and TP2 is buried.

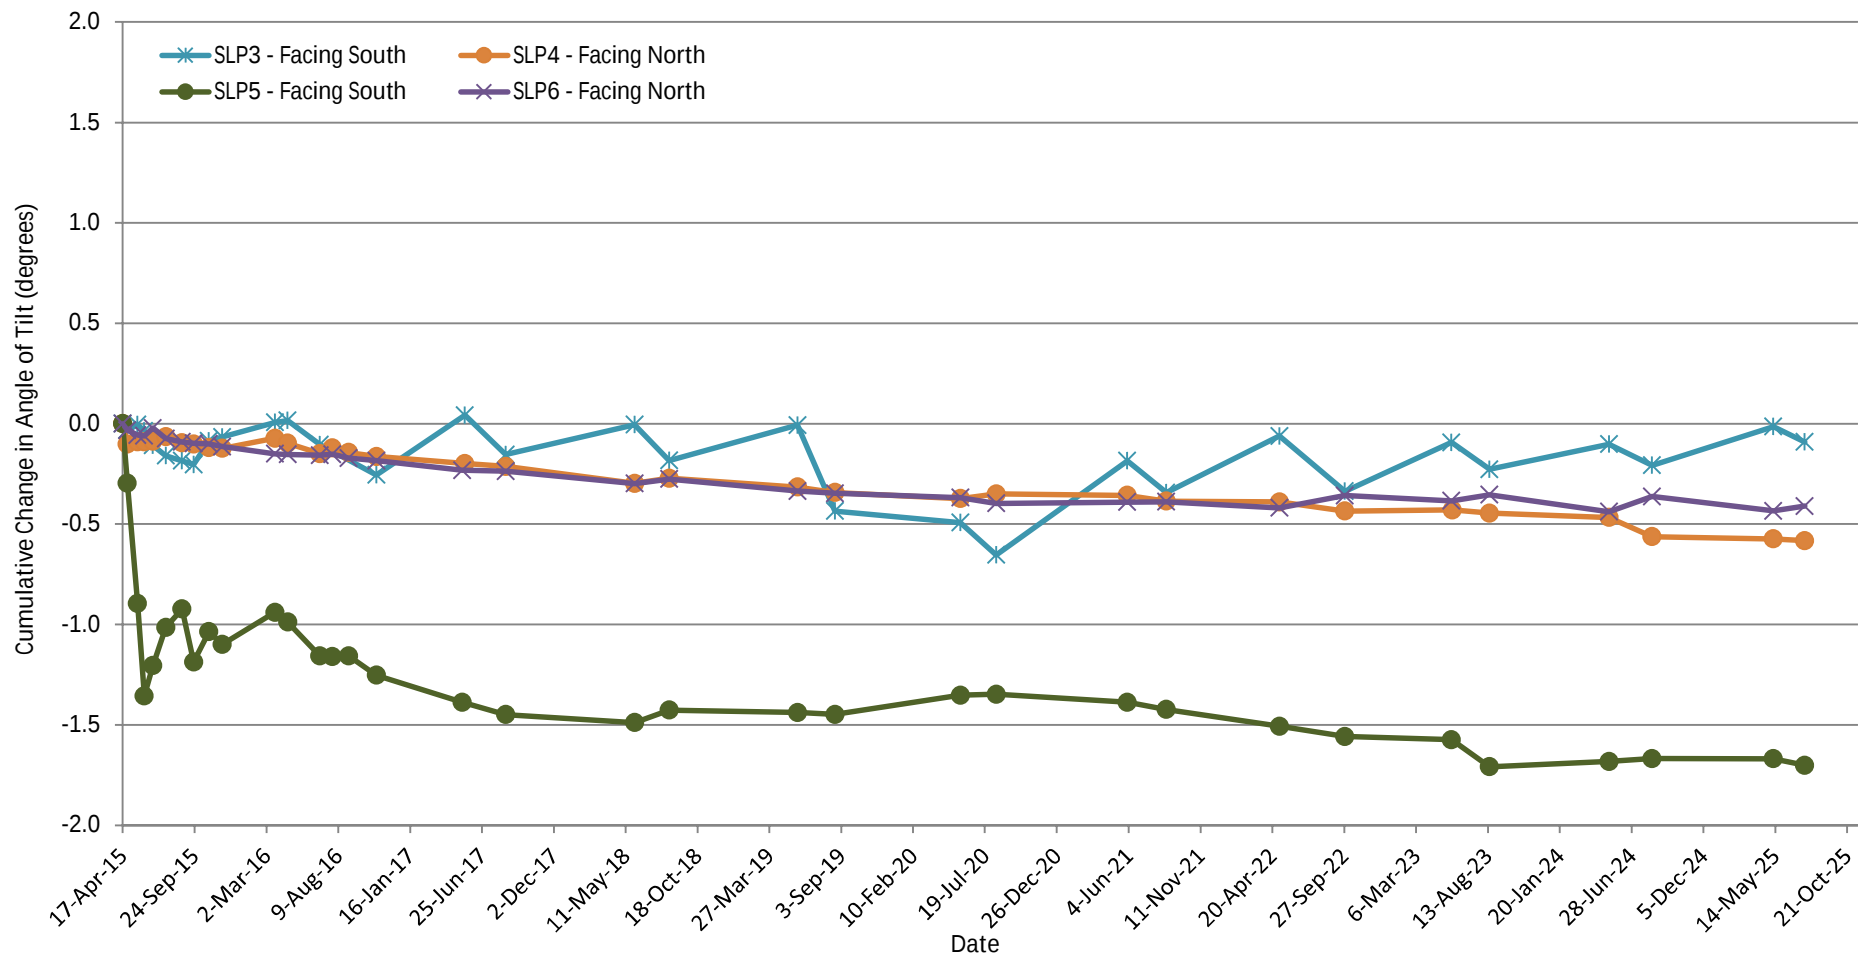
| CHECK | | FIGURE: B2 | |

- Tilt Plate SLP3 indicated a change in angle of tilt of approximately 0.08 degrees, towards the south, between May 9 and July 18, 2025. However, past readings for SLP3 have been erratic and appear to be affected by seasonal changes.

- Tilt Plate SLP4 indicated an insignificant change in angle of tilt (less than 0.05 degrees) between May 9 and July 18, 2025. The cumulative change in angle of tilt from May 2019 to July 2025 is approximately 0.30 degrees towards the north.

- Tilt plate SLP5 indicated an insignificant change in angle of tilt (less than 0.05 degrees) between May 9 and July 18, 2025.
- Tilt plate SLP6 indicated an insignificant change in angle of tilt (less than 0.05 degrees) between May 9 and July 18, 2025.
