## TECHNICAL MEMORANDUM

**Reference No.** CA0029692.2934-TM-03-Rev0

### NUTANA SLOPE STABILITY UPDATE – MAY 2025

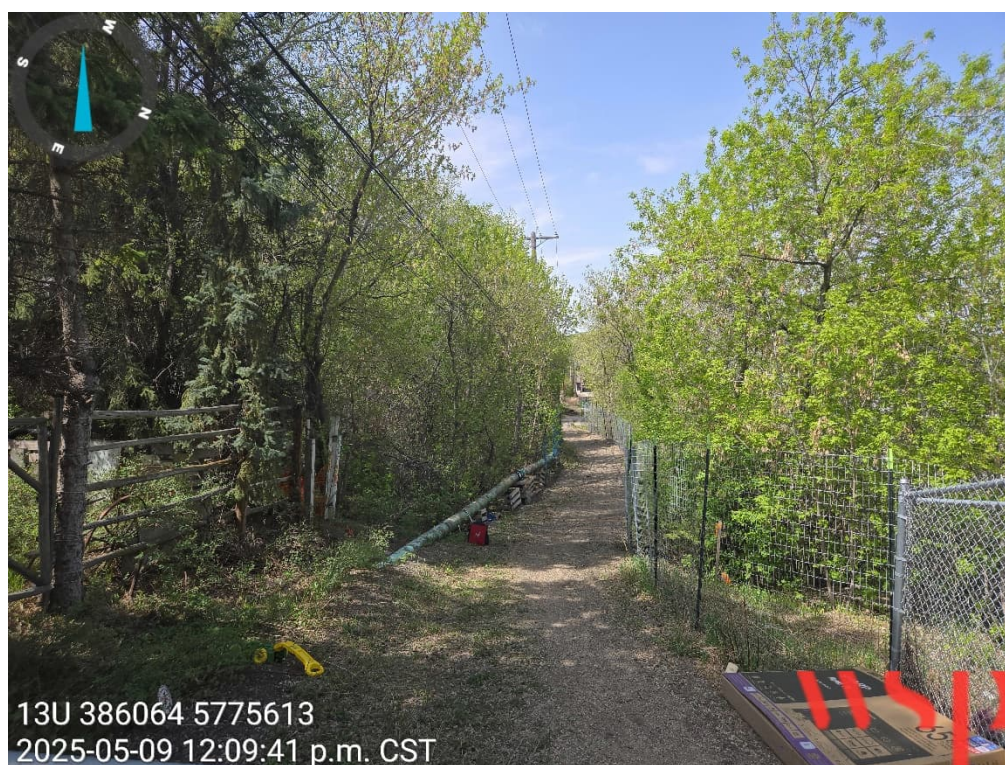
**Photograph 1: Looking west down the back alley at the East Failure (May 9, 2025)**

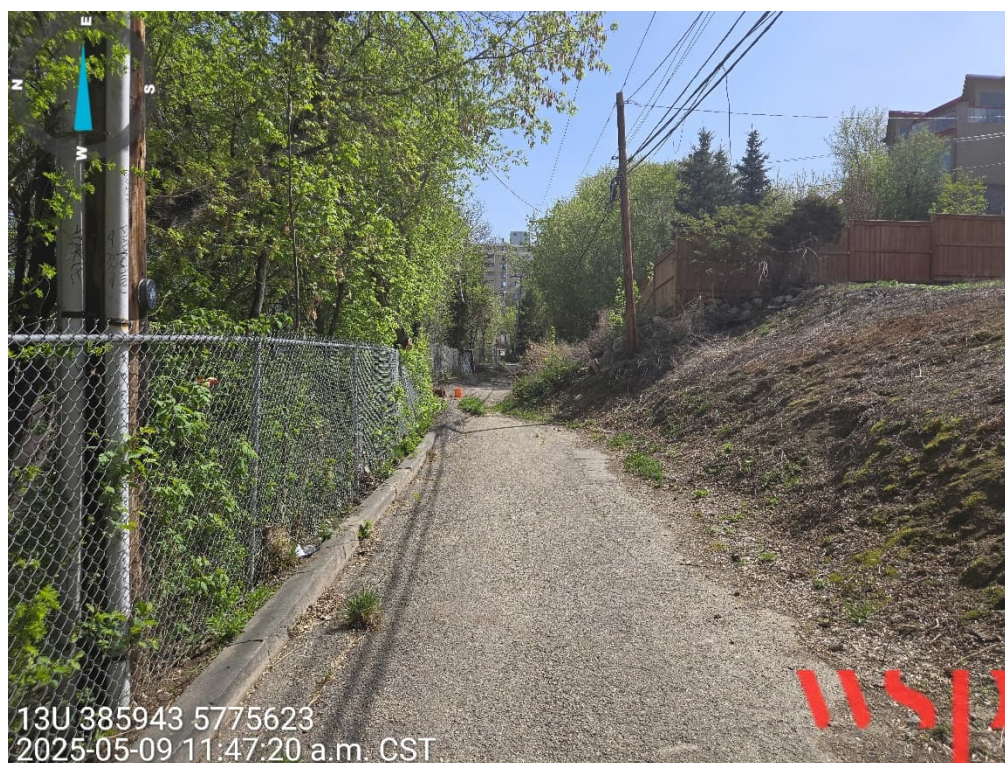
**Photograph 2: Looking east down the back alley at the West Failure (May 9, 2025)**

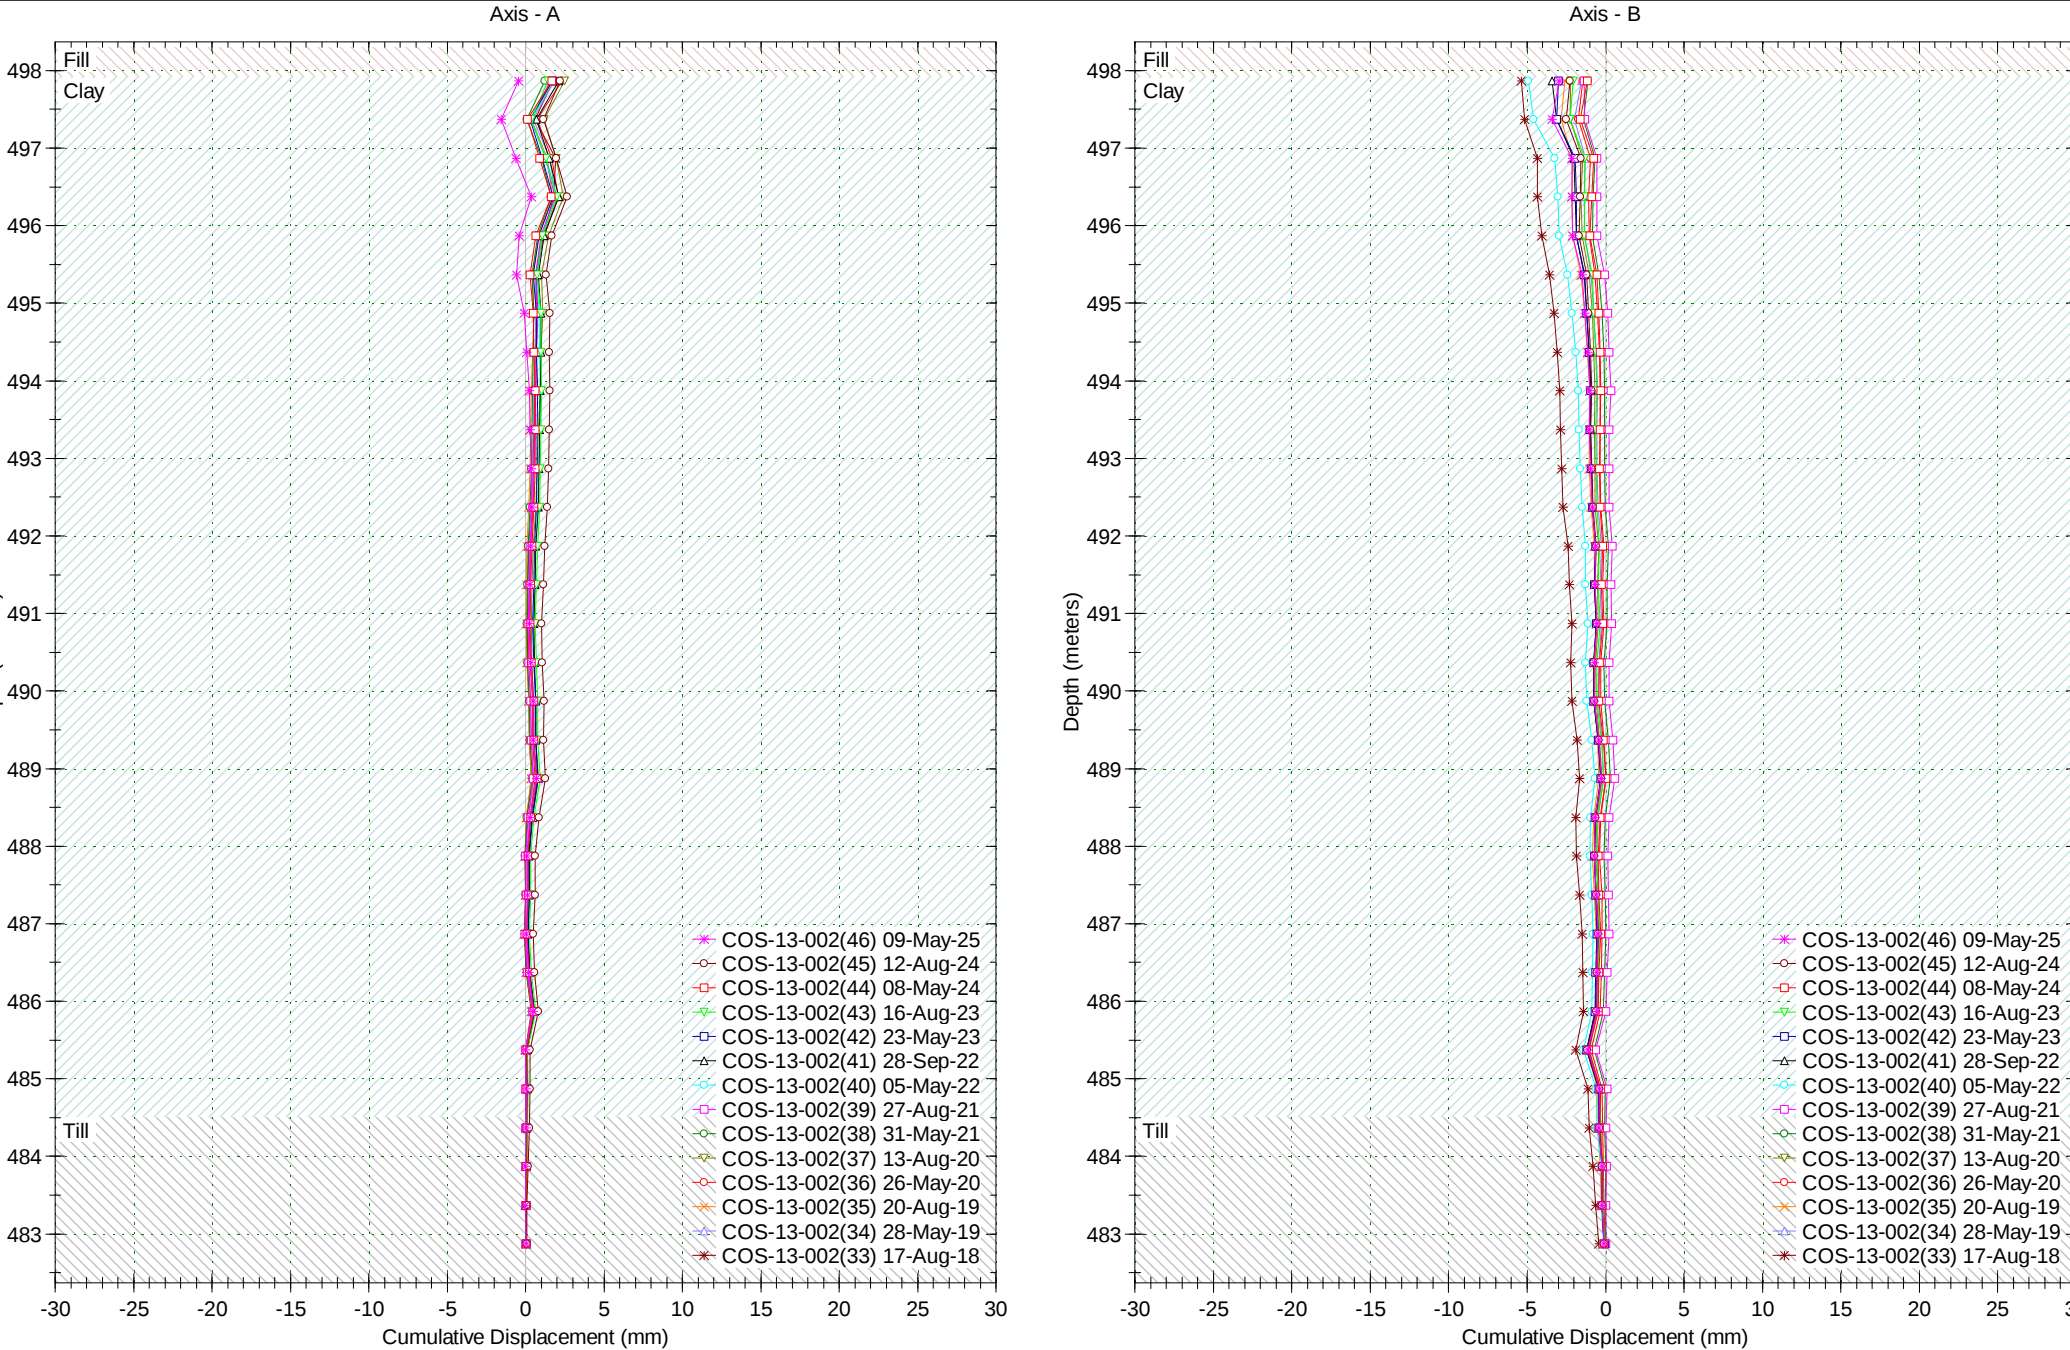
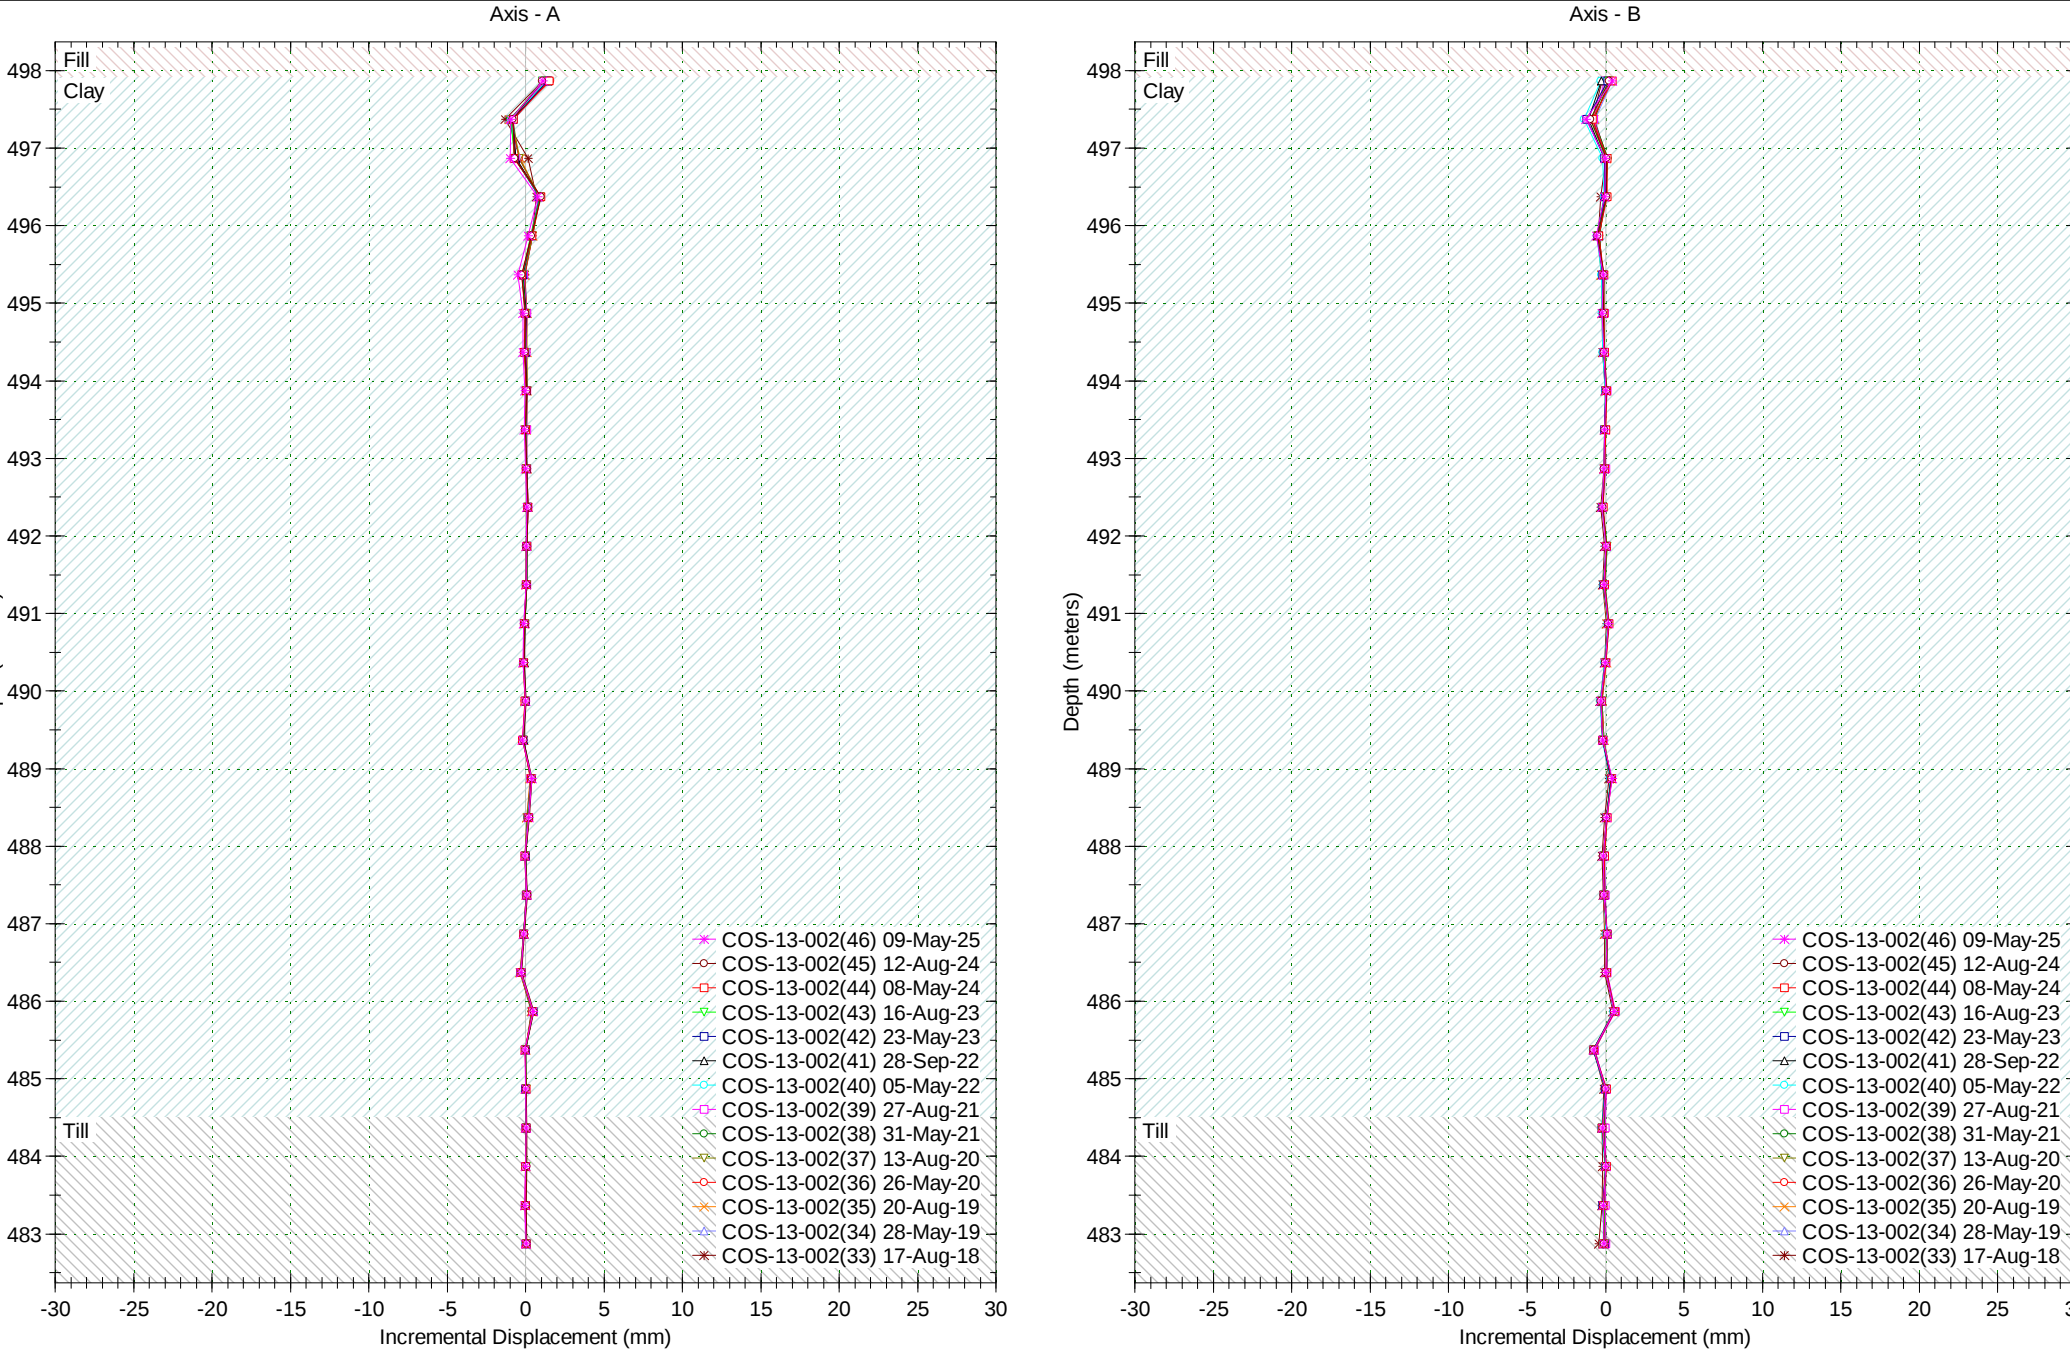
Borehole : COS-13-002  
Project : Nutana Slope  
Location : 307 11th St. E. (Front)  
Northing : 5775567.41  
Easting : 386043.54  
Collar : -0.113

- Inclinometer COS-13-002 plots continue to show a slight drift, with insignificant cumulative movement, less than 2.5 mm (or 0.10 in between July 30, 2013 and May 9, 2025).

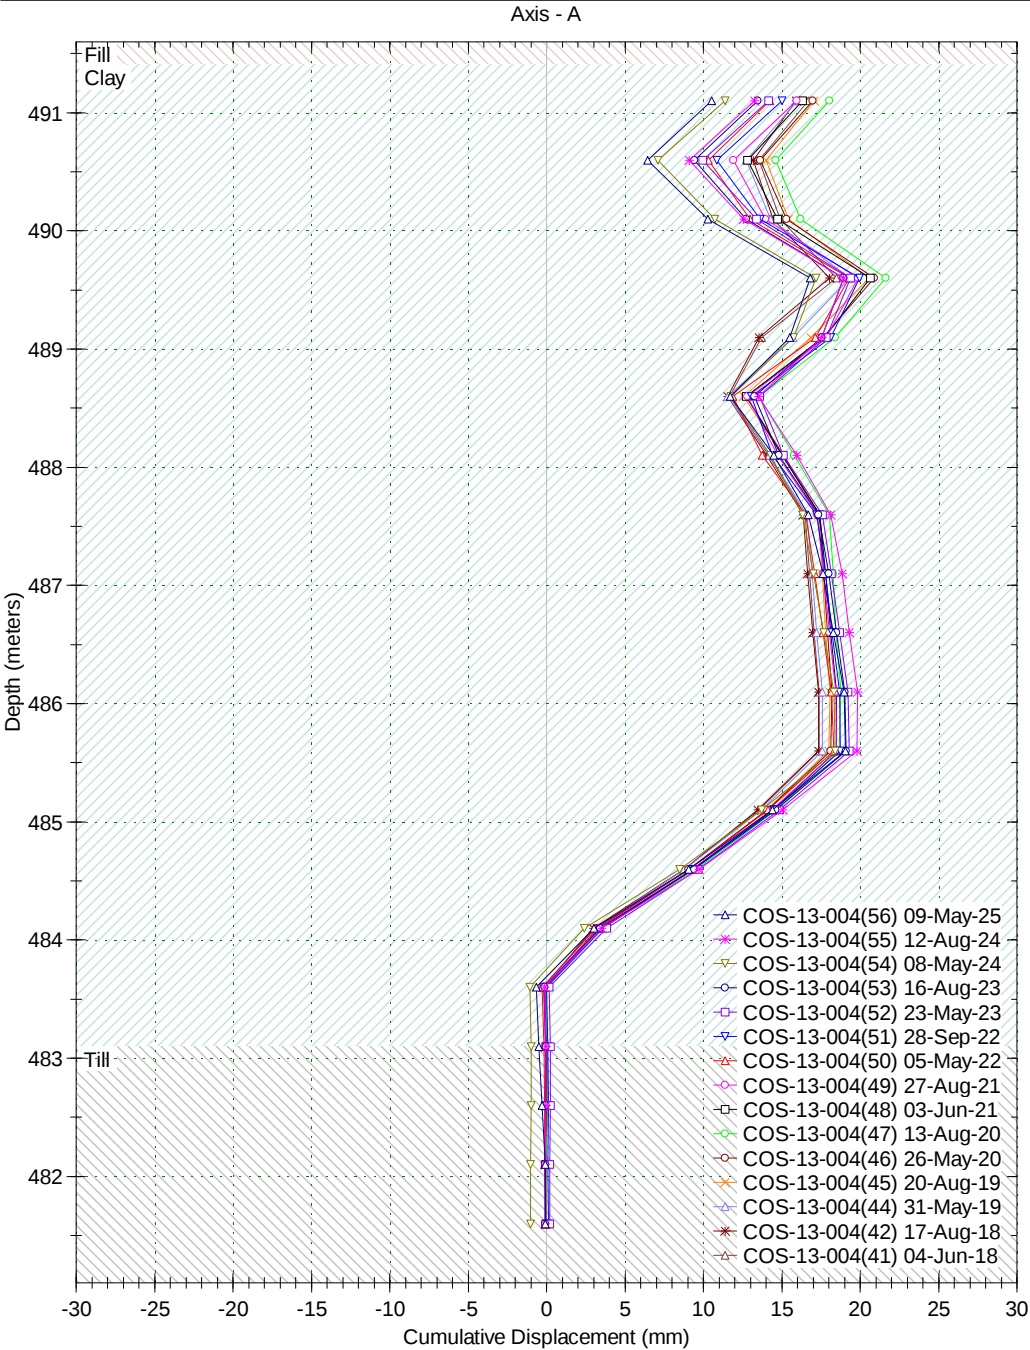
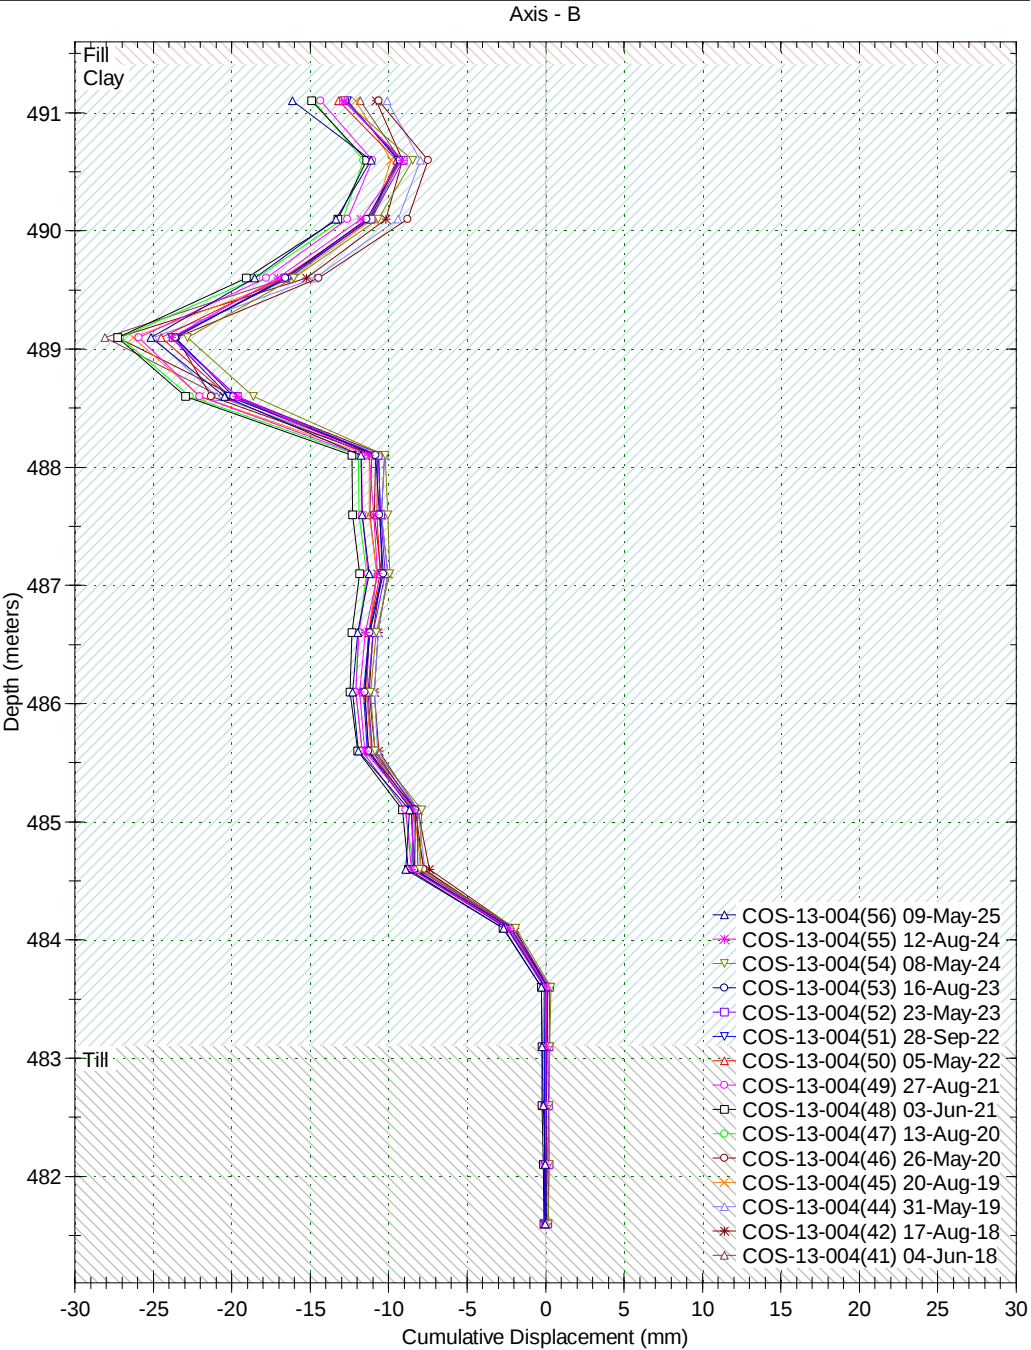
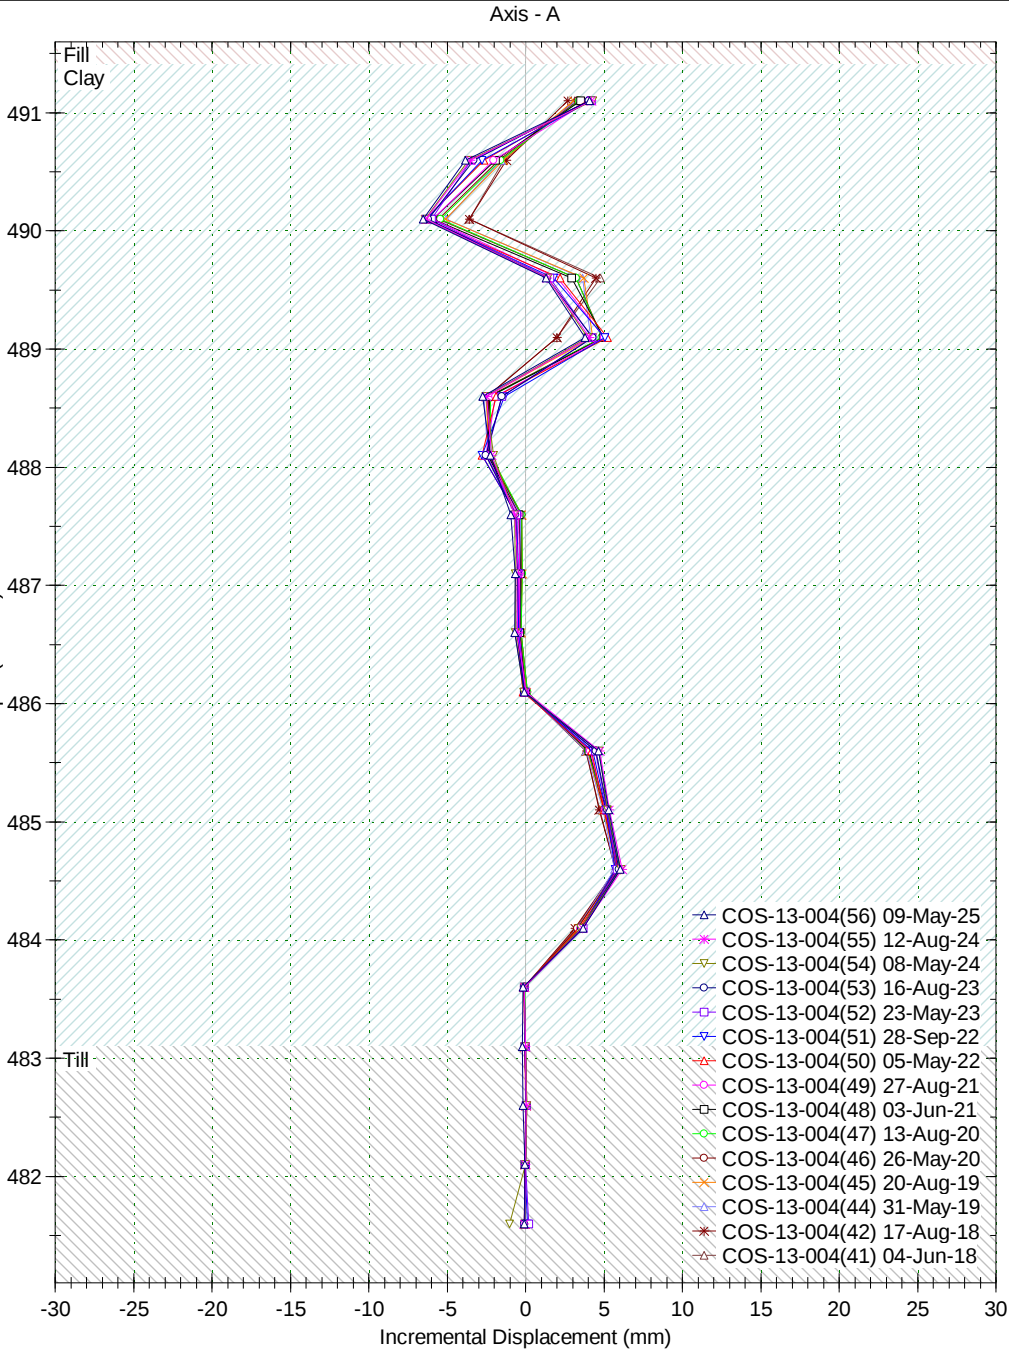
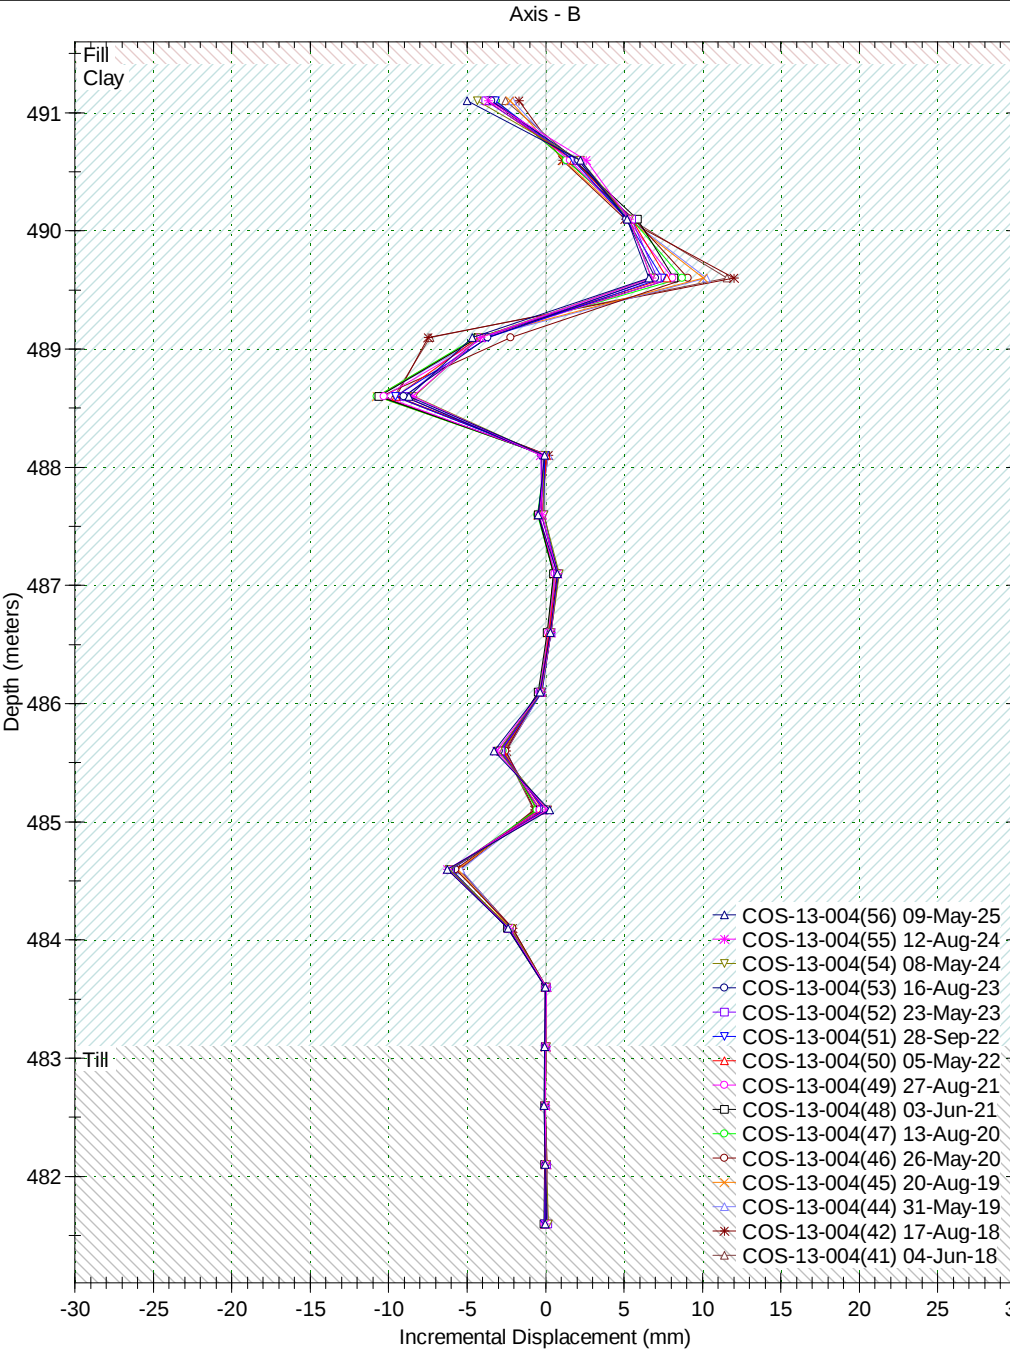
Borehole : COS-13-004  
Project : Nutana Slope  
Location : 307 11th. St. E. (back)  
Northing : 5775604.97  
Easting : 386050.63  
Collar : -0.677

- Inclinometer COS-13-004 has in recent years indicated drift both in the direction parallel to and along the direction of the laneway (perpendicular to the downslope direction). The inclinometer plots indicate approximately 3.9 mm (or 0.15 in) of movement in the upslope direction between August 12, 2024 and May 9, 2025.

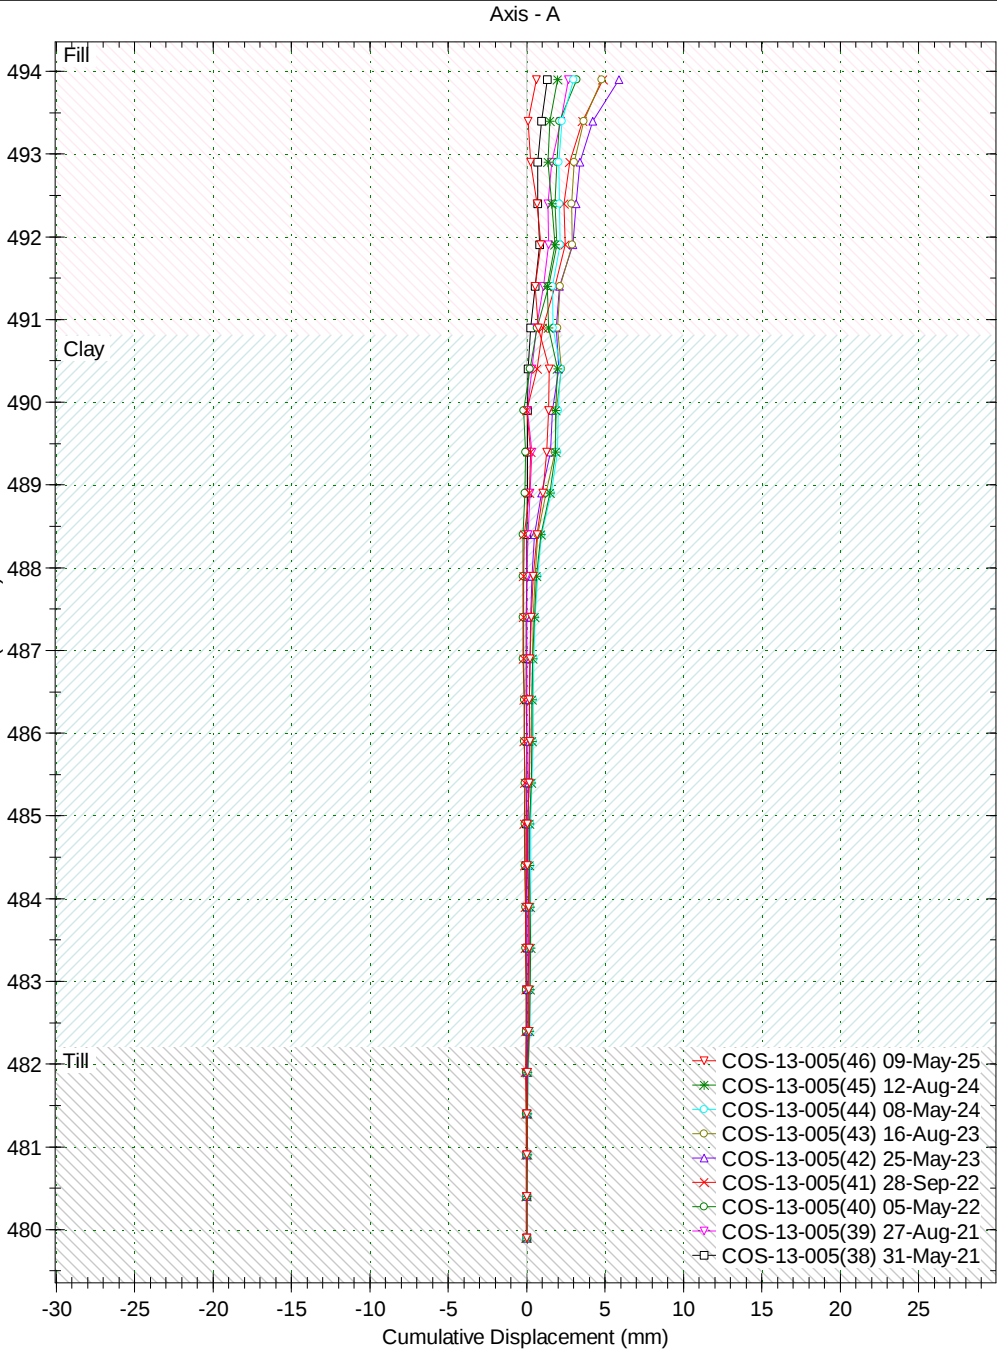
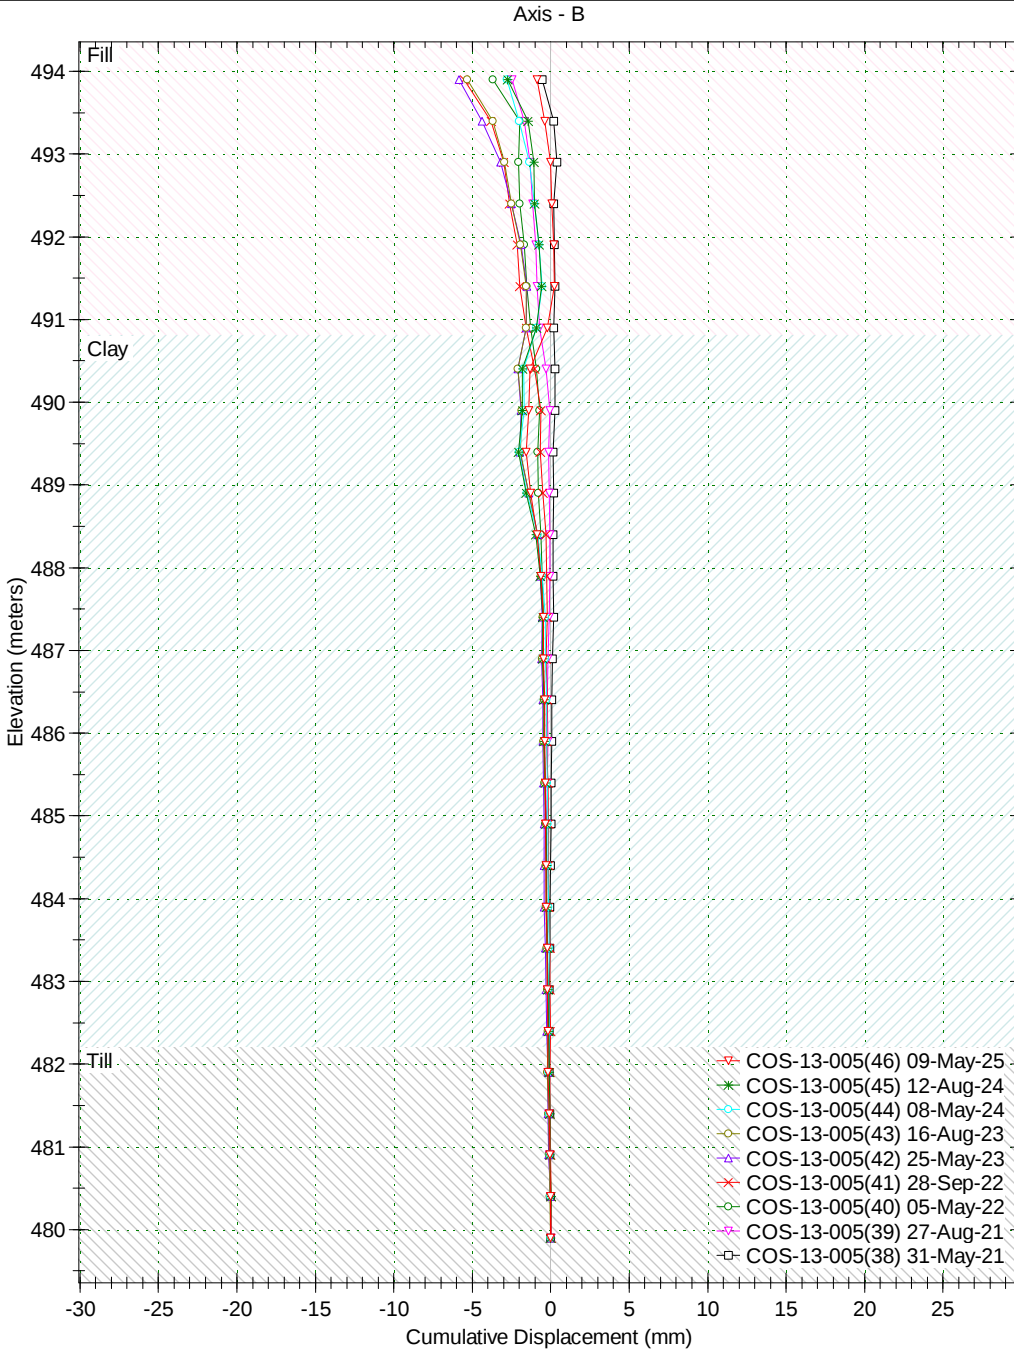
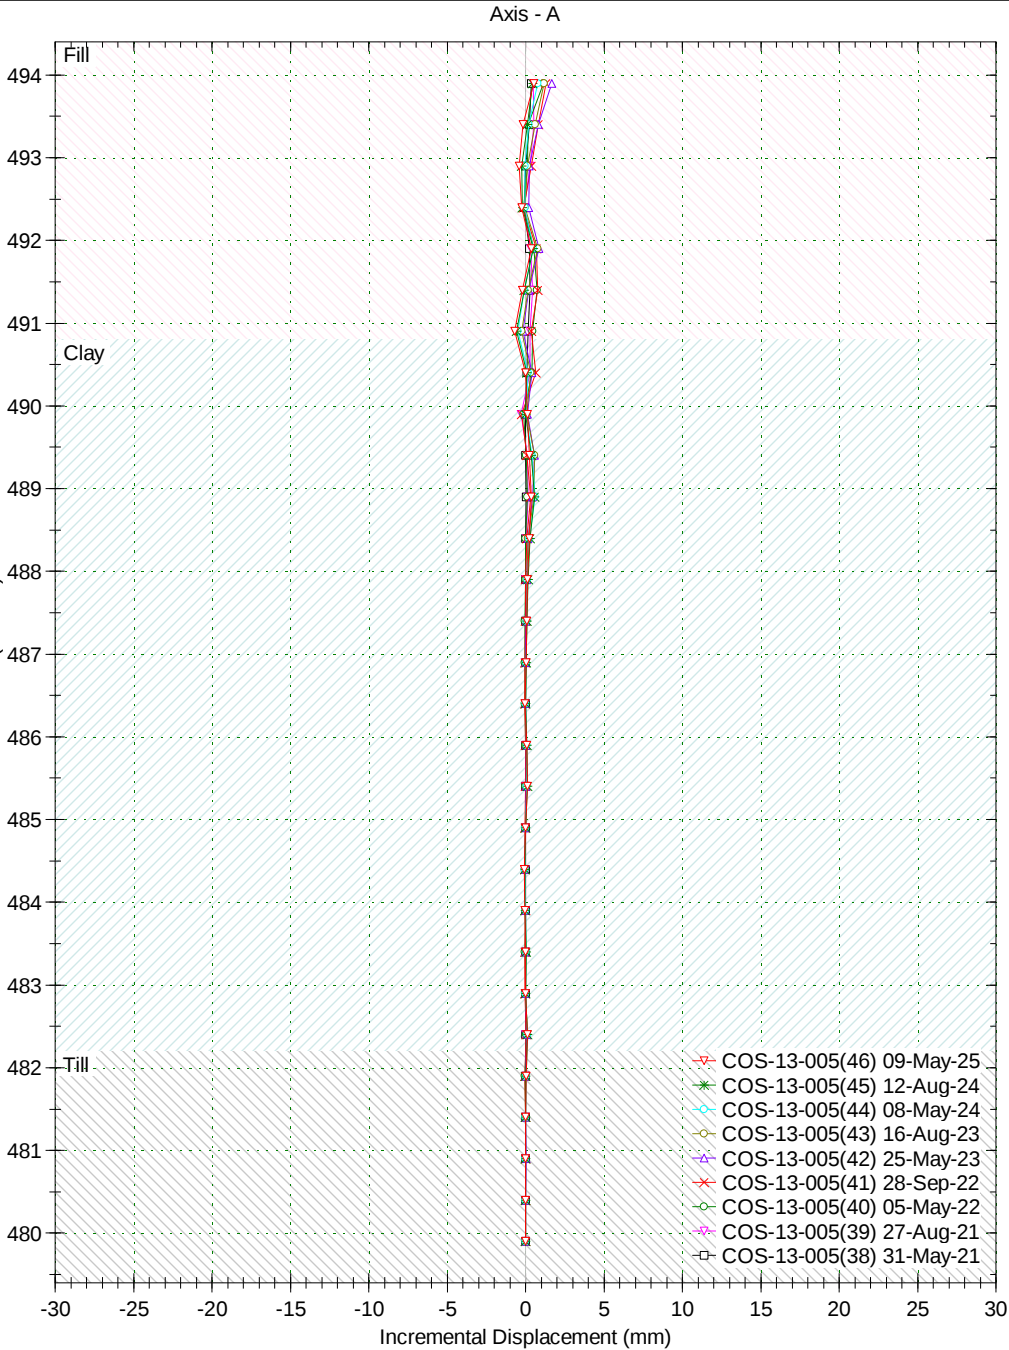
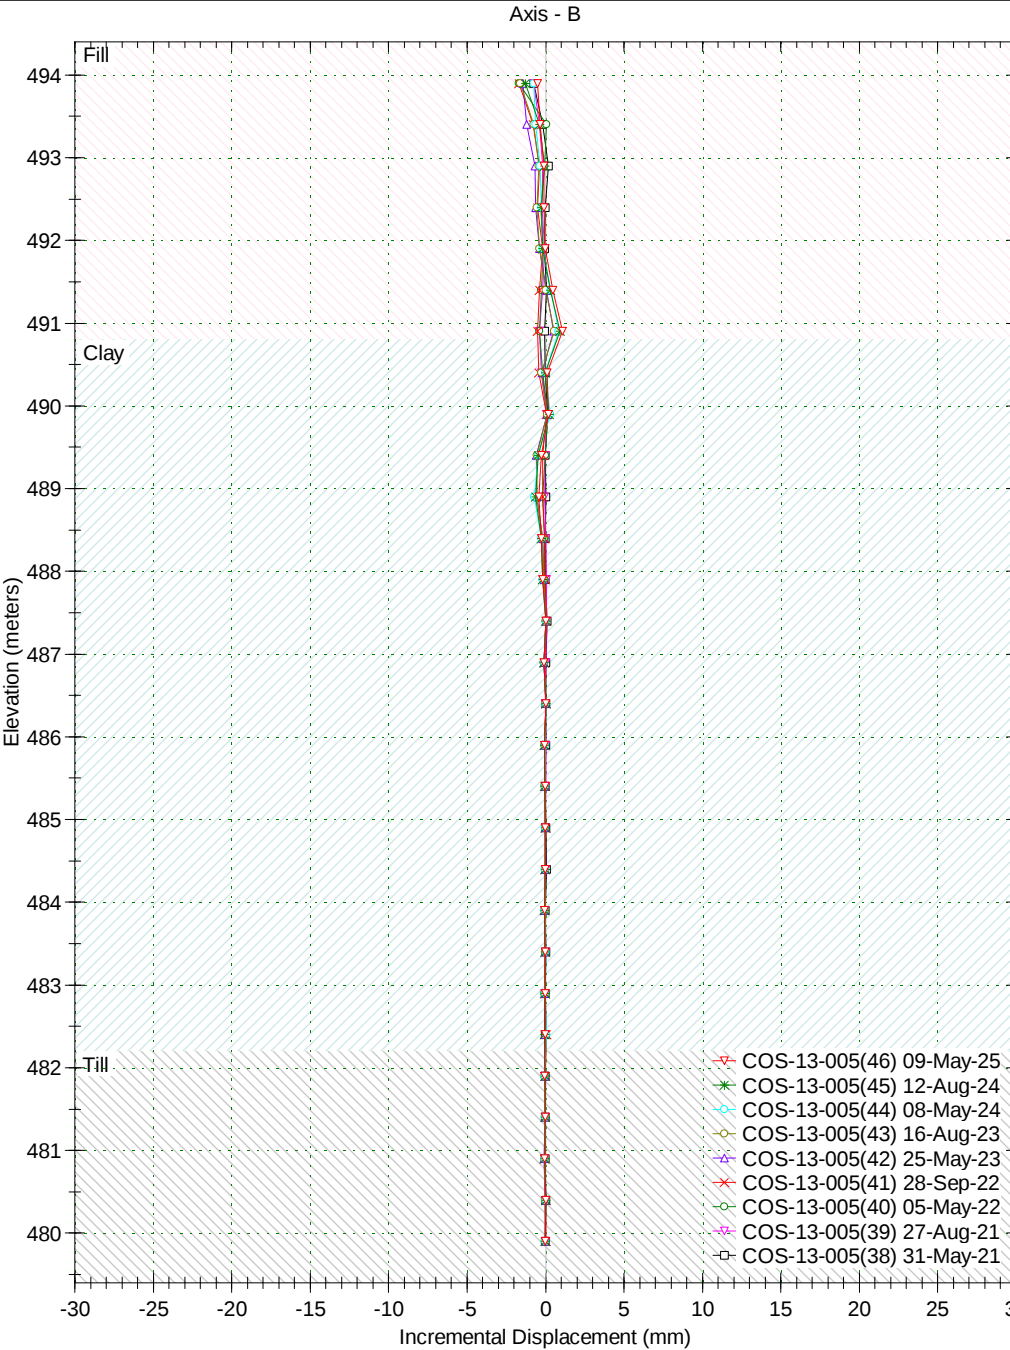
Borehole : COS-13-005 (Aug 13 2020 Baseline)  
Project : Nutana Slope  
Location : 316 Sask. Cres. E.  
Northing : 5775631.299  
Easting : 386078.8467  
Collar : -0.1

- Inclinometer COS-13-005 indicated insignificant movement (less than 2 mm or 0.08 in) between August 13, 2020 and May 9, 2025.
- Inclinometer 20-109 has indicated approximately 27 mm of cumulative downslope movement between October 28, 2020 and May 9, 2025, including 3.0 mm (0.12 in) of movement between August 12, 2024 and May 9, 2025. The zone of movement is approximately 2.5 m below the top of casing. The rate of slope movement has increased from approximately 1 mm/yr between October 28, 2020 and May 5, 2022, to approximately 5 mm/yr between May 5, 2022 and May 9, 2025.
