## TECHNICAL MEMORANDUM

**Reference No.** CA0029692.2934-TM-03-Rev0

### NUTANA SLOPE STABILITY UPDATE – MAY 2025

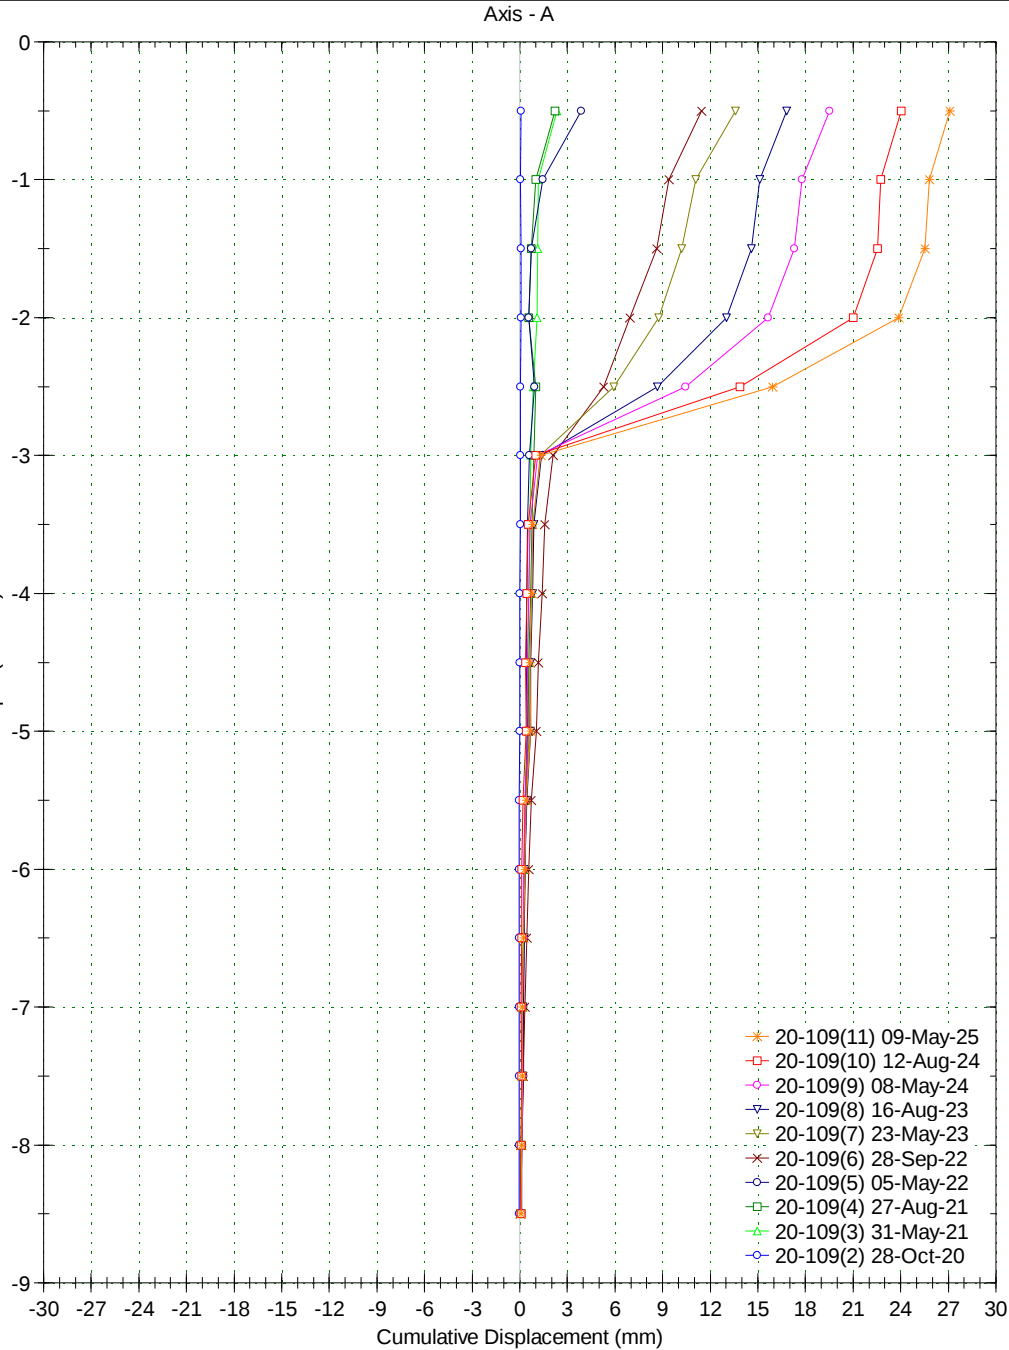
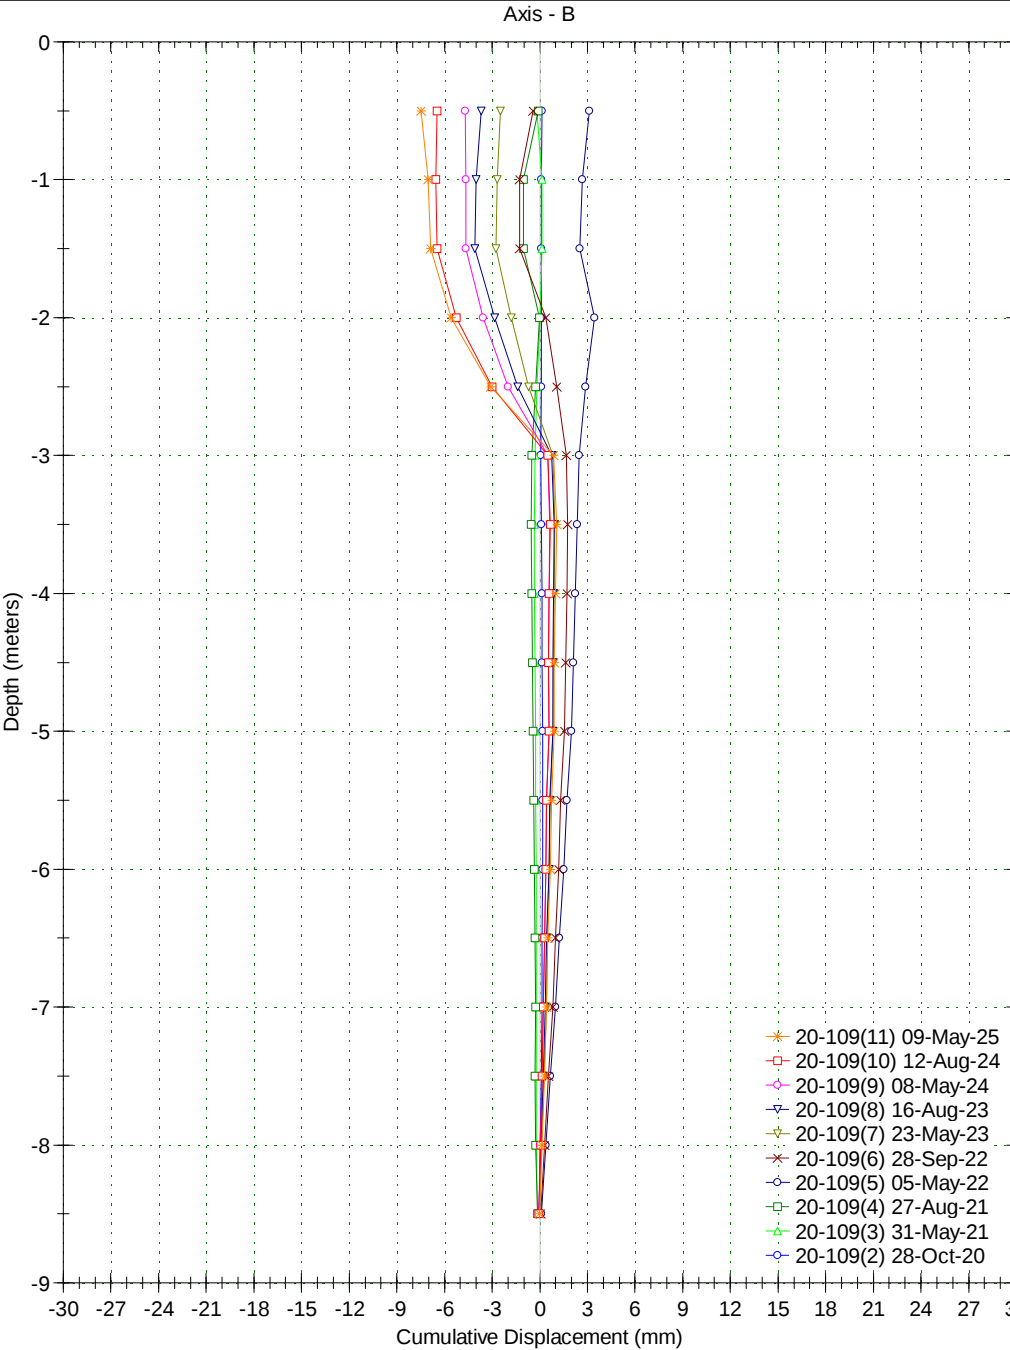
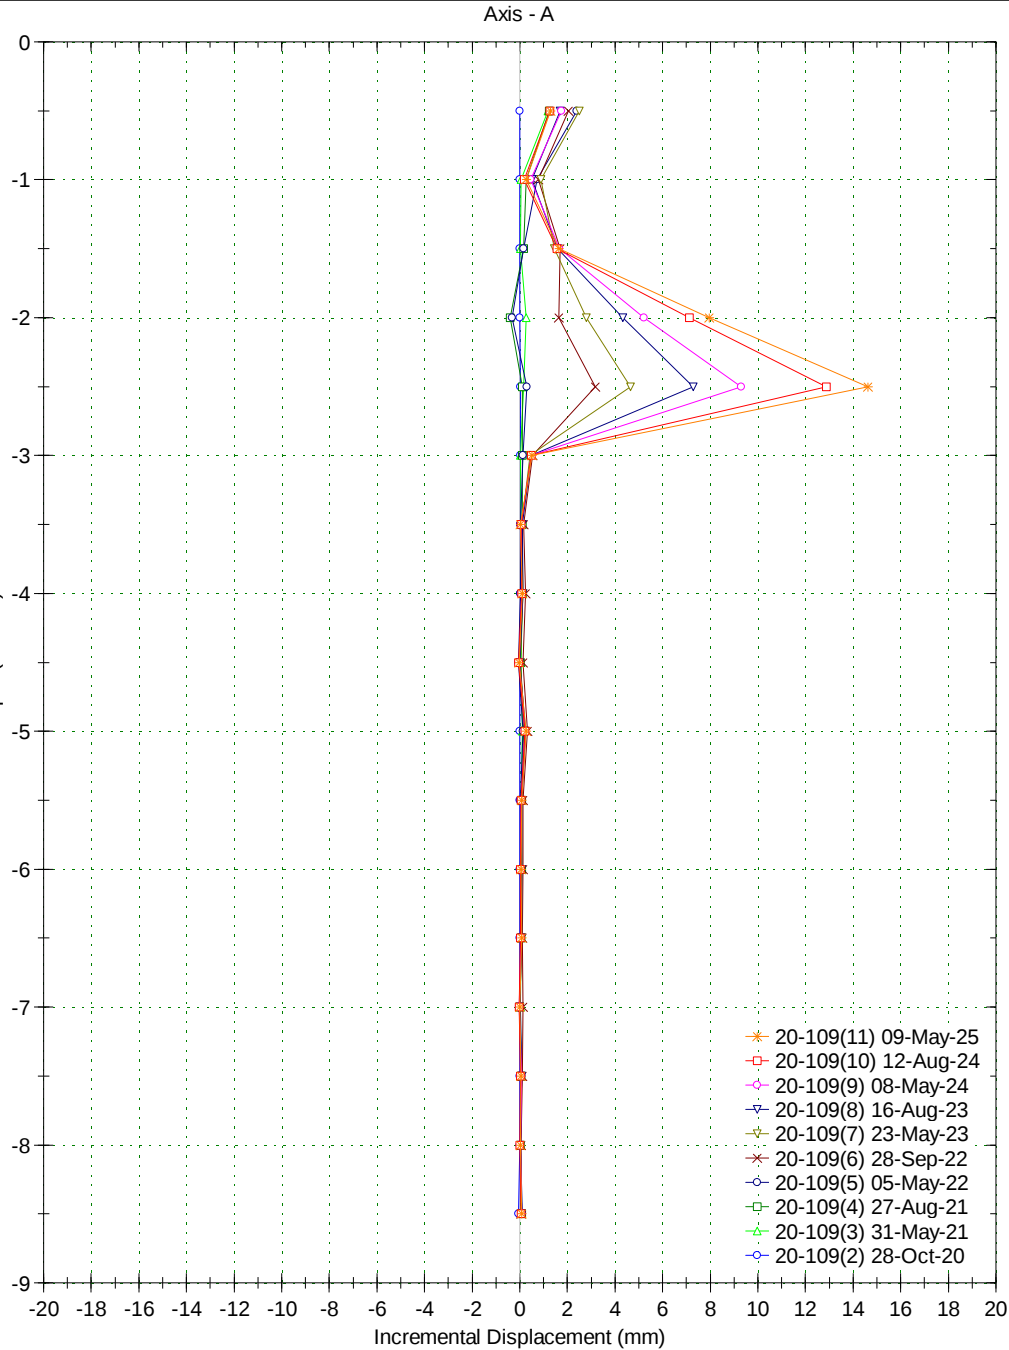
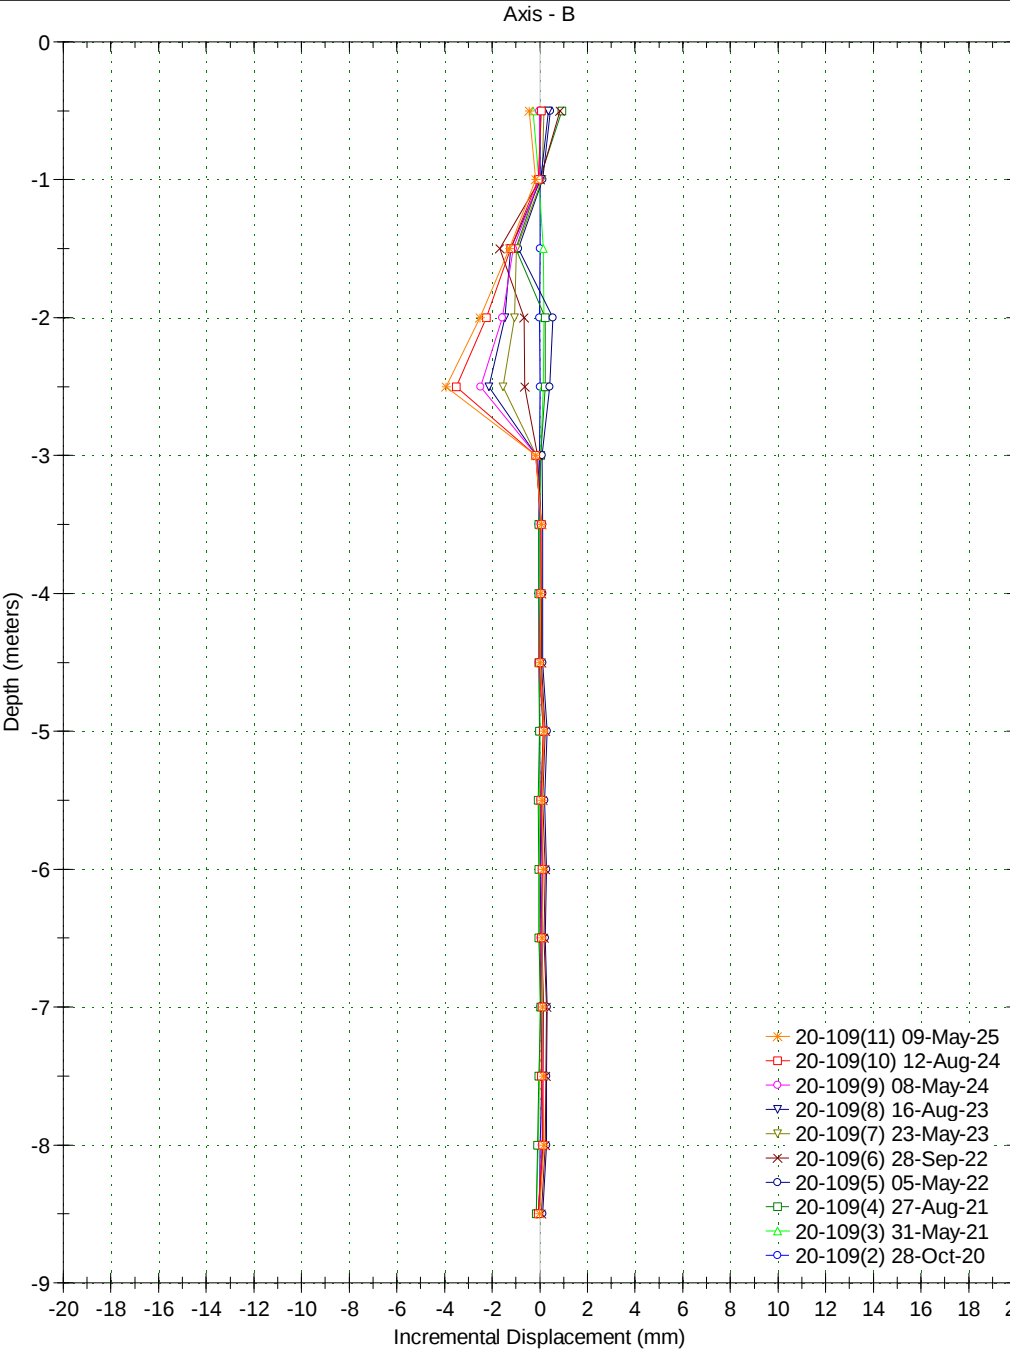
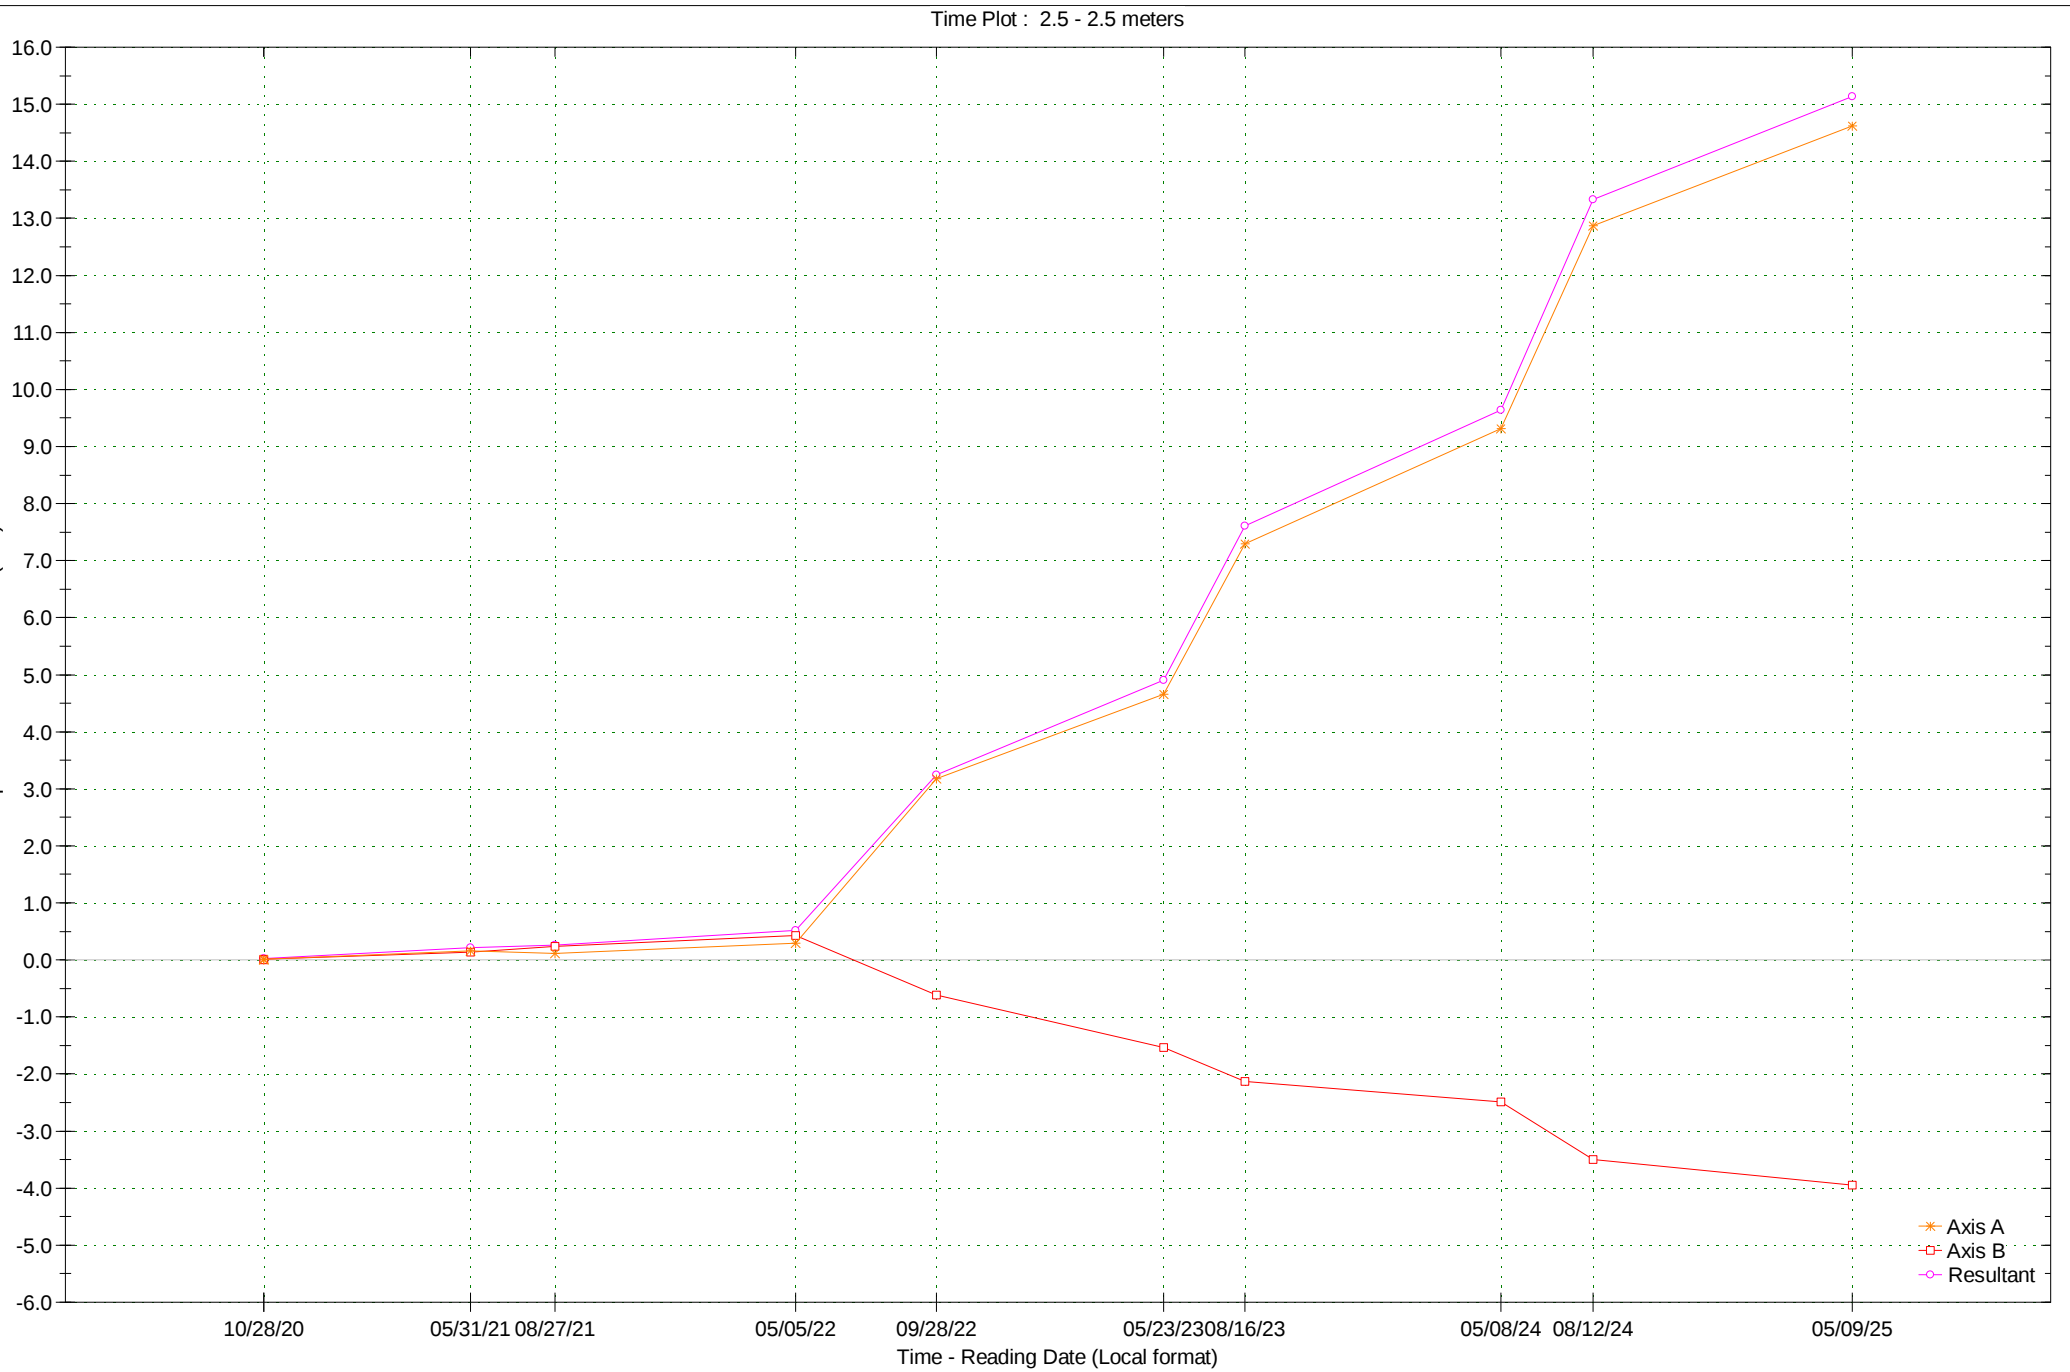
Borehole : 20-109  
Project : Nutana Slope  
Location :  
Northing : 5775622  
Easting : 385977  
Collar :

Slope inclinometer 20-109 indicates a zone of movement a depth of approximately 2.5 m below the top of casing with a rate of movement approximately 5 mm/yr between May 5, 2022 and May 9, 2025, an increase from 1 mm/yr for the period between October 2020 and May 2022. Inclinator 20-111 plots continue to show drifts in upslope direction, with approximately 4.5 mm (0.18 in) of cumulative movement between October 28, 2020 and May 9, 2025.

WSP recommends that the intended additional monitoring trip be completed for the two inclinometers on the west slide (20-109 and 20-111) in the summer.

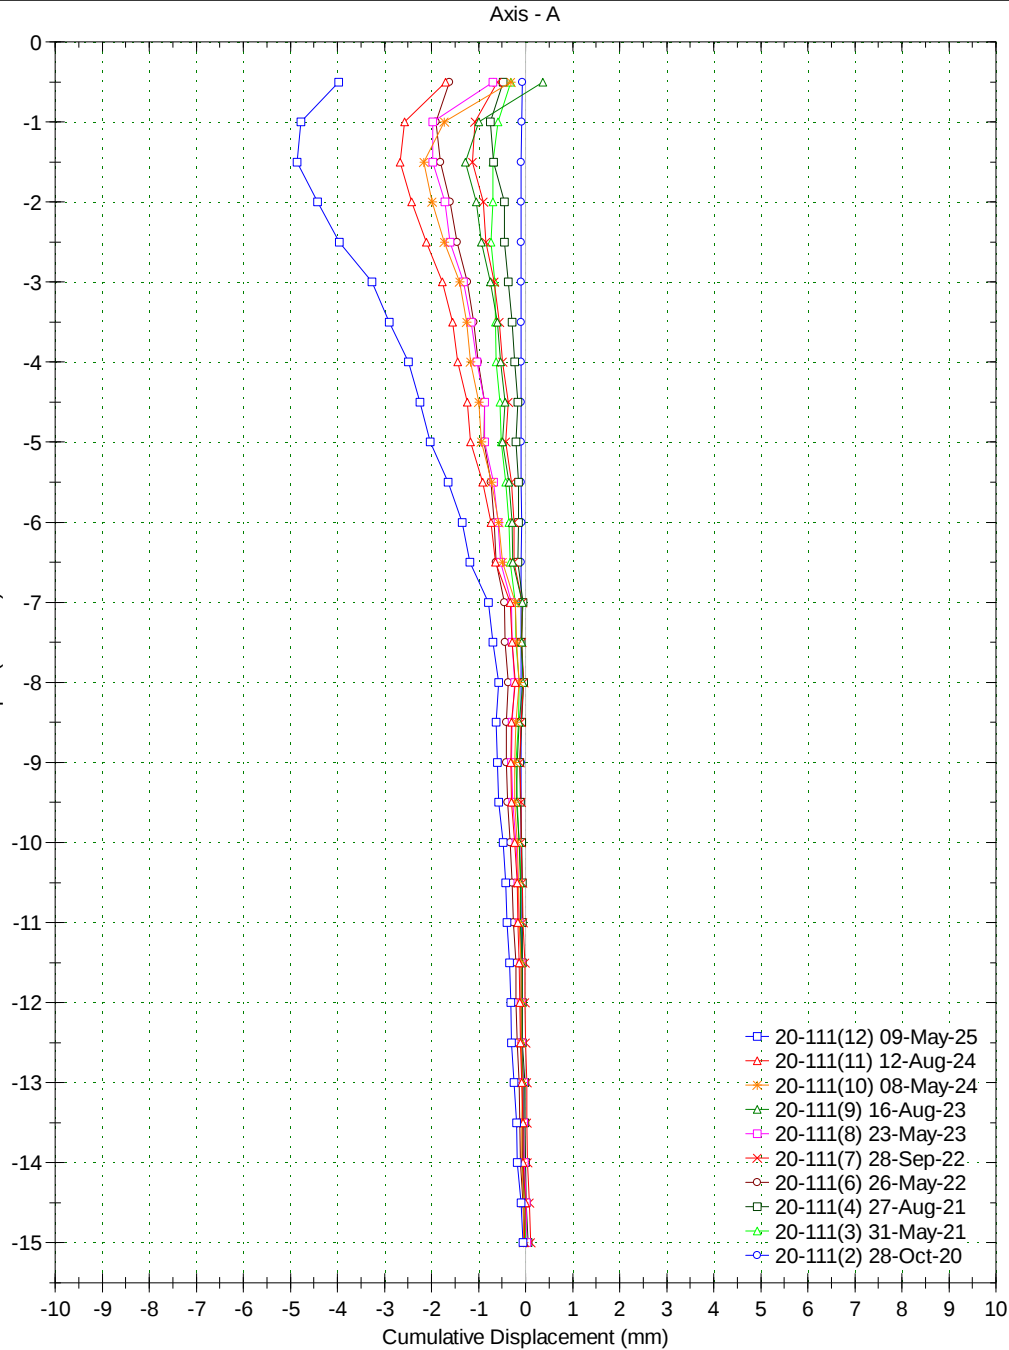
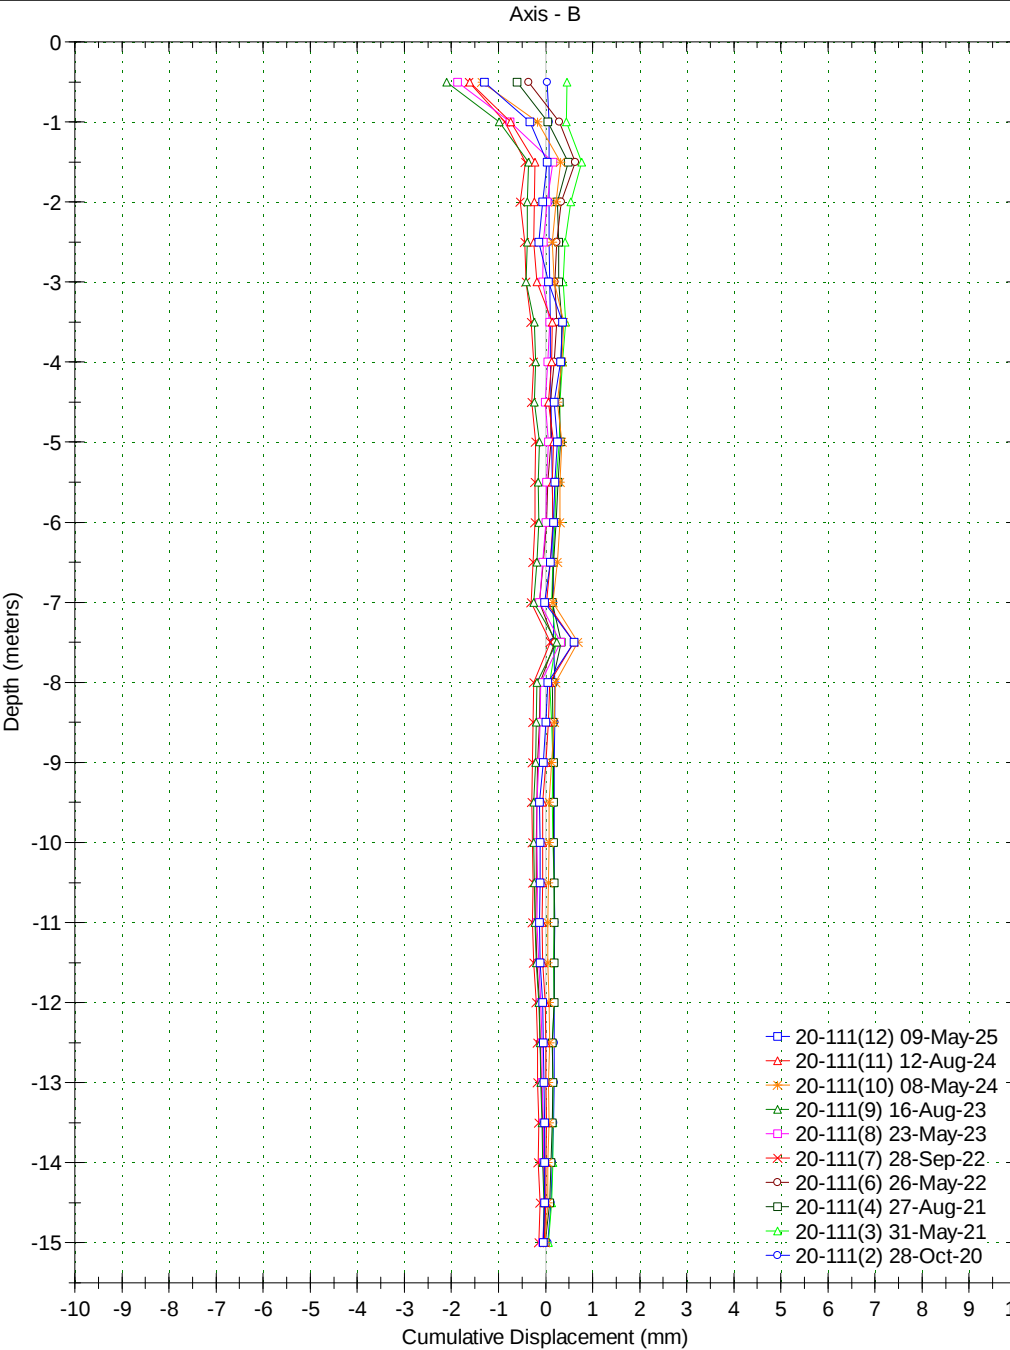
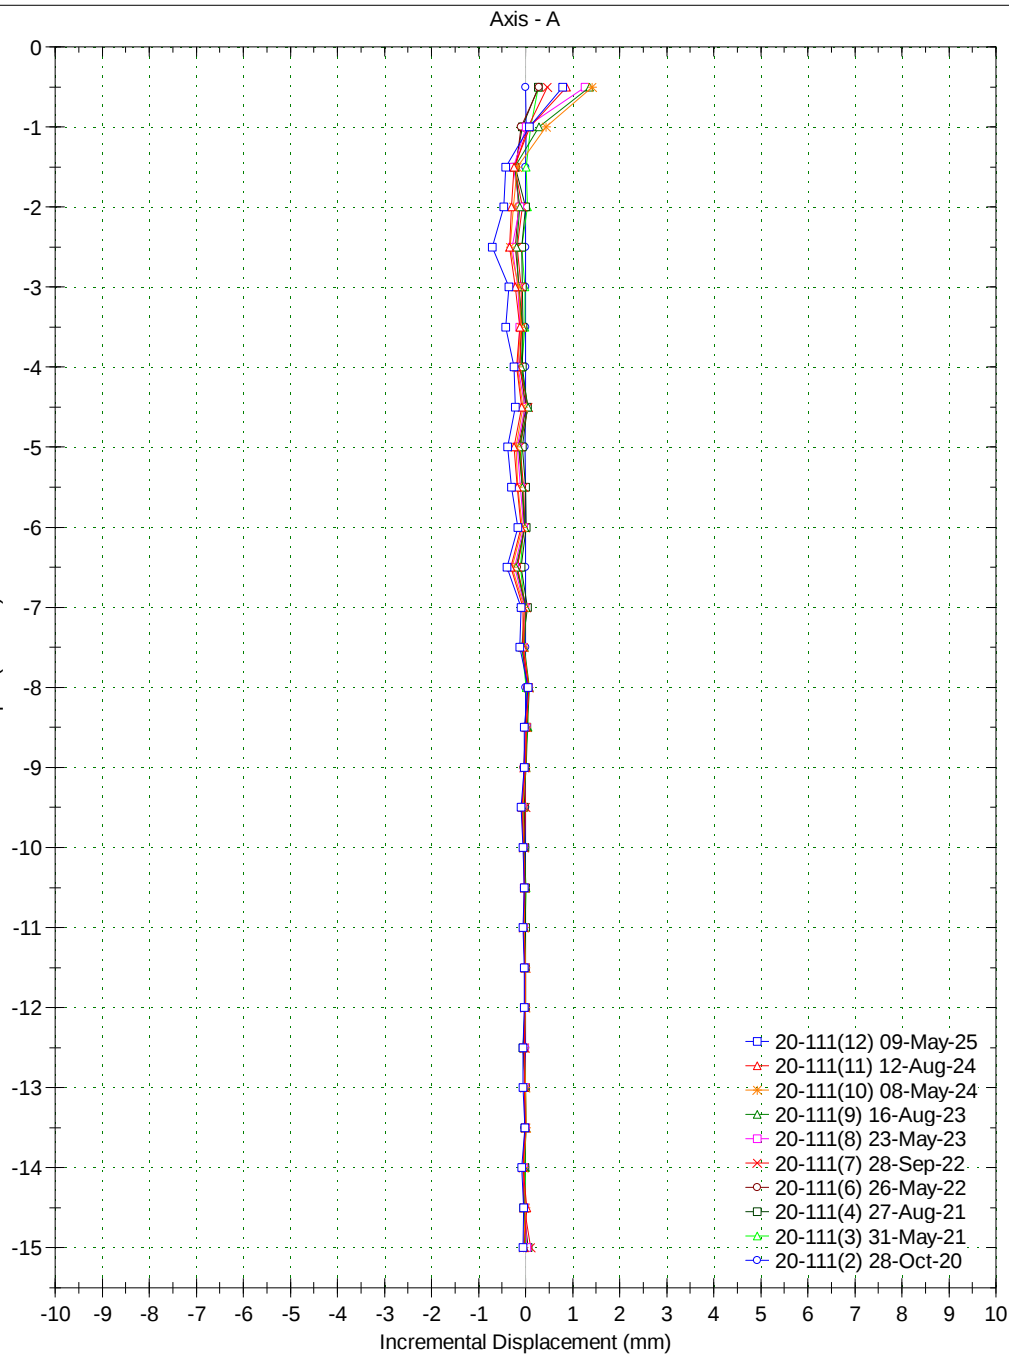
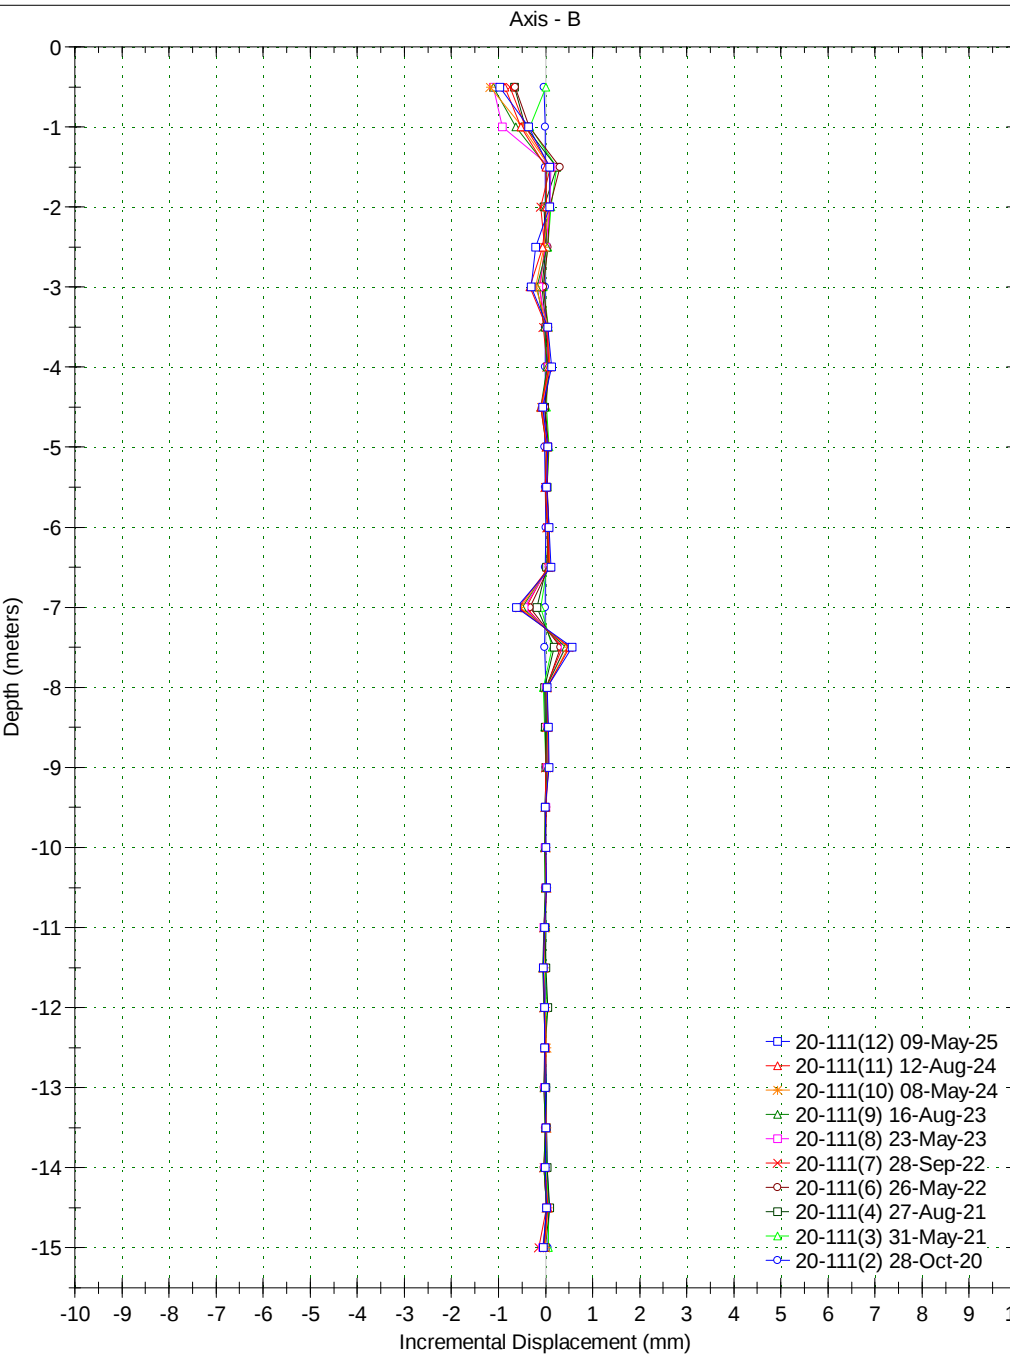
Borehole : 20-111  
Project : Nutana Slope  
Location :  
Northing : 5775568  
Easting : 385953  
Collar :

- Inclinometer 20-111 plots continue to show drifts in upslope direction, with approximately 4.5 mm (0.18 in) of cumulative movement between October 28, 2020 and May 9, 2025.

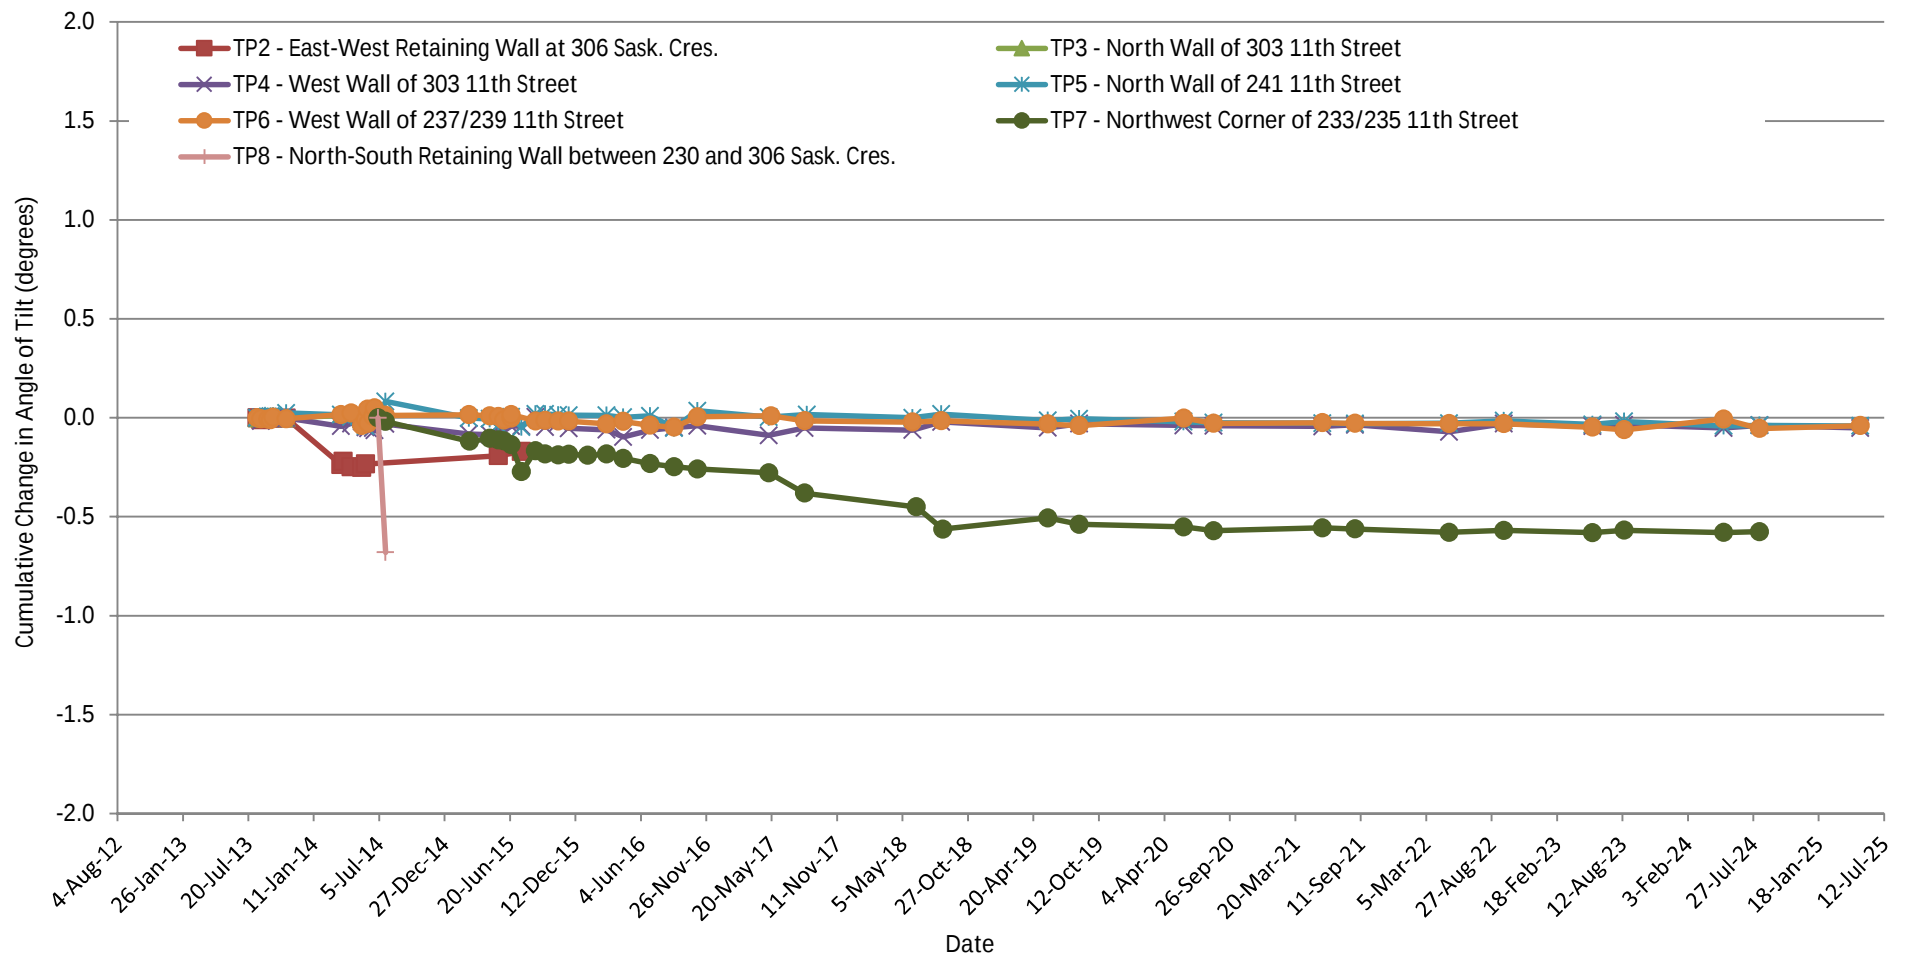
| | CHECK | | | FIGURE: B1 | |

- Tilt plates TP4, TP5, and TP6 indicate insignificant changes in angle of tilt (less than 0.05 degrees) between August 23, 2013 and May 9, 2025.
- Tilt plate TP7 could not be accessed at the time of instrumentation monitoring and will be read during a future visit.

- 1) Positive changes in tilt indicate tilting toward the monitoring structure.
- 2) TP1, located on the retaining wall between 230 and 306 Sask. Cres., is not monitored for health and safety reasons; monitoring results for this tilt plate show a change in angle of tilt of approximately 9 degrees between August 2013 and June 2014.
- 3) TP3 and TP8 are destroyed, and TP2 is buried.

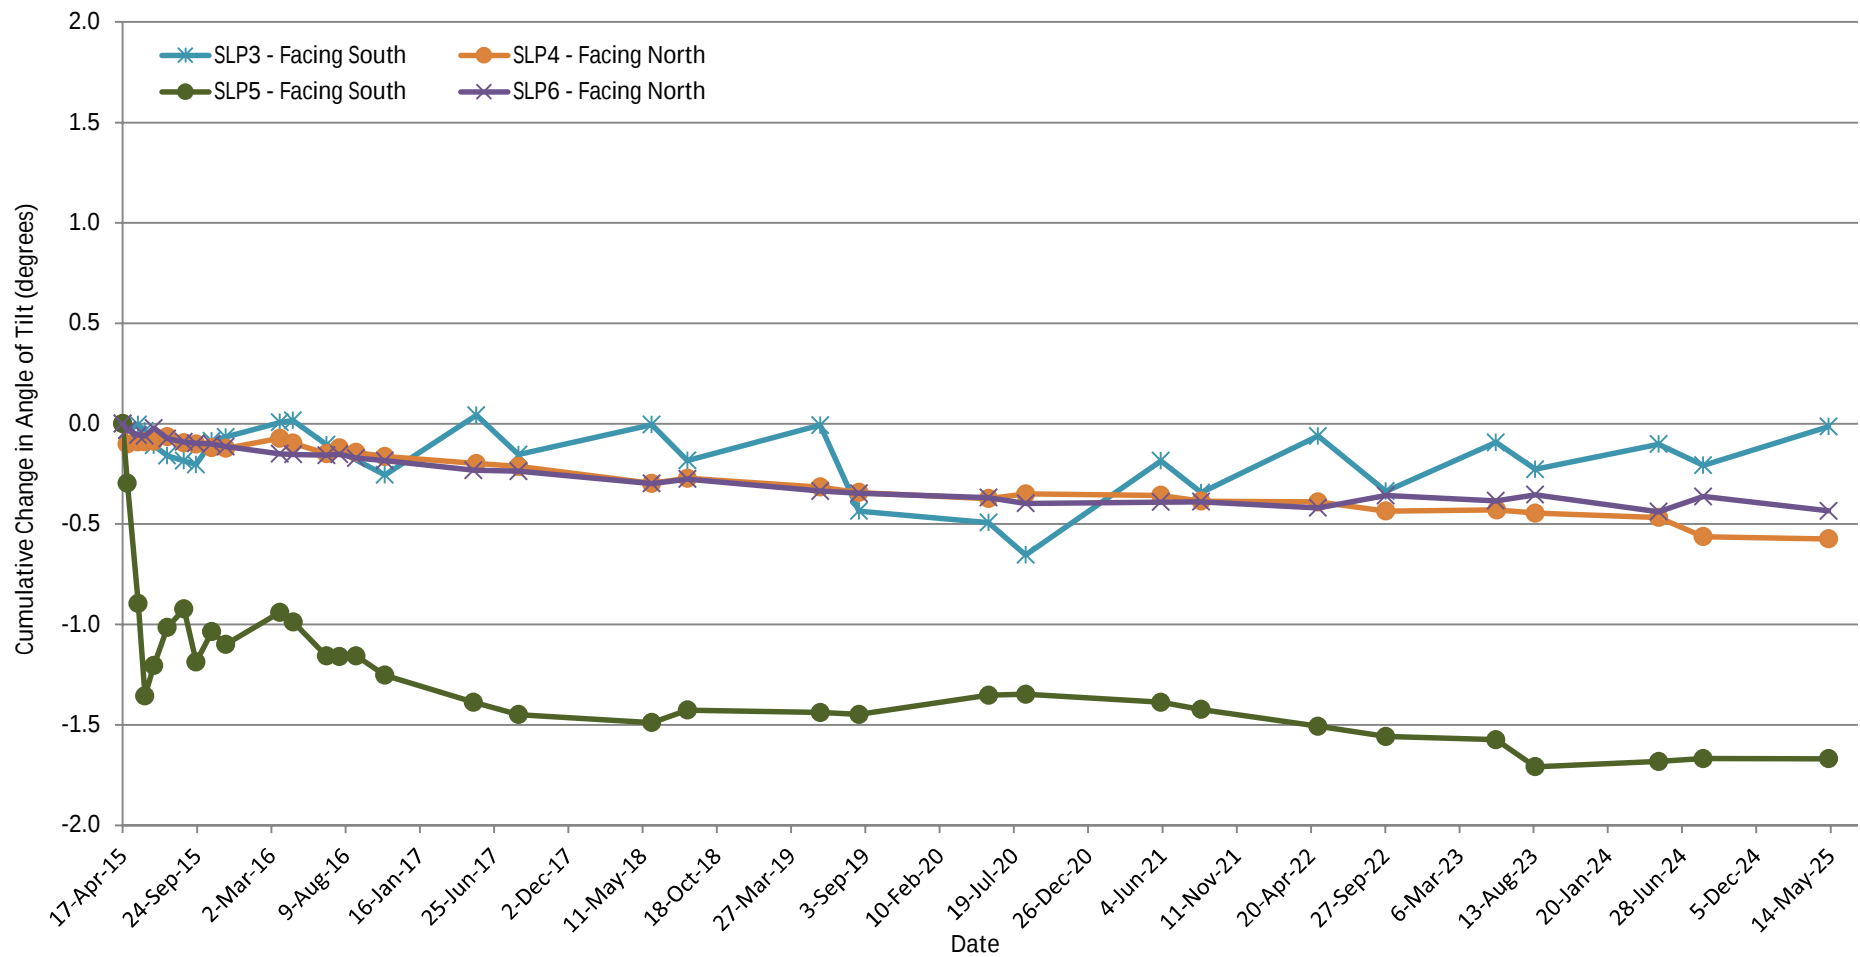
| | CHECK | | | FIGURE: B2 | |

- Tilt Plate SLP3 indicated a change in angle of tilt of approximately 0.19 degrees, towards the north, between August 12, 2024 and May 9, 2025. However, past readings for SLP3 have been erratic and appear to be affected by seasonal changes.

- Tilt Plate SLP4 indicated an insignificant change in angle of tilt (less than 0.05 degrees) between August 12, 2024 and May 9, 2025. The cumulative change in angle of tilt from May 2019 to May 2025 is approximately 0.30 degrees towards the north.

- Tilt plate SLP5 indicated an insignificant change in angle of tilt (less than 0.05 degrees) between August 12, 2024 and May 9, 2025.
- Tilt plate SLP6 indicated a change in angle of tilt of approximately 0.07 degrees, towards the north, between August 12, 2024 and May 9, 2025.
