BERSCH CONSULTING LTD.

Hazardous Building Material Assessment 88 King Street Saskatoon, Saskatchewan

November 2017

Project No: **B67HAL01G**

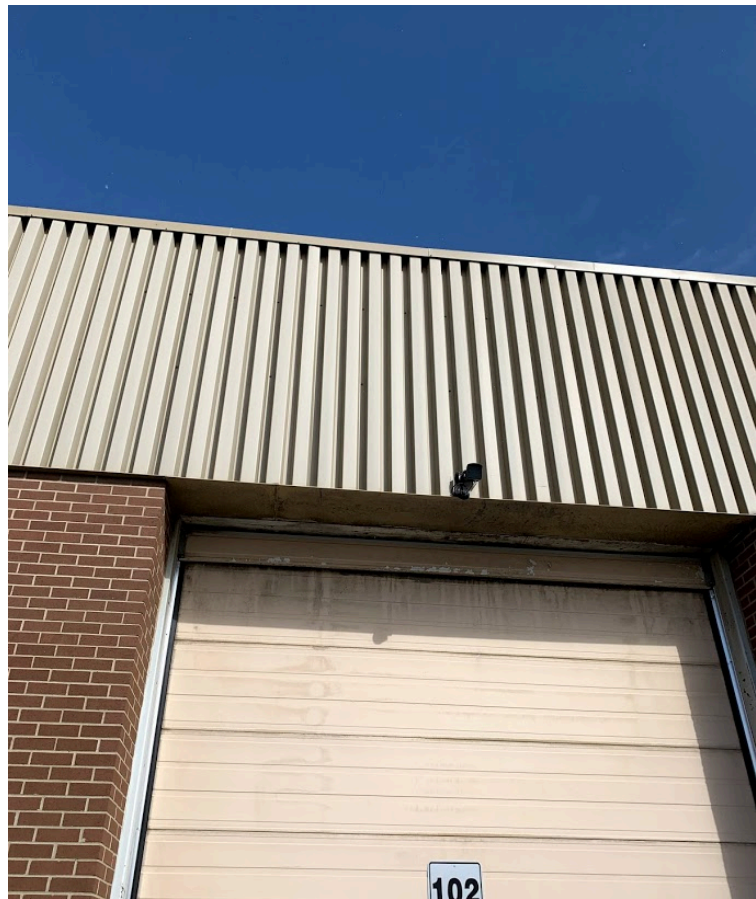
B67PRC23K – 002

South Exterior Wall above
Overhead Door.

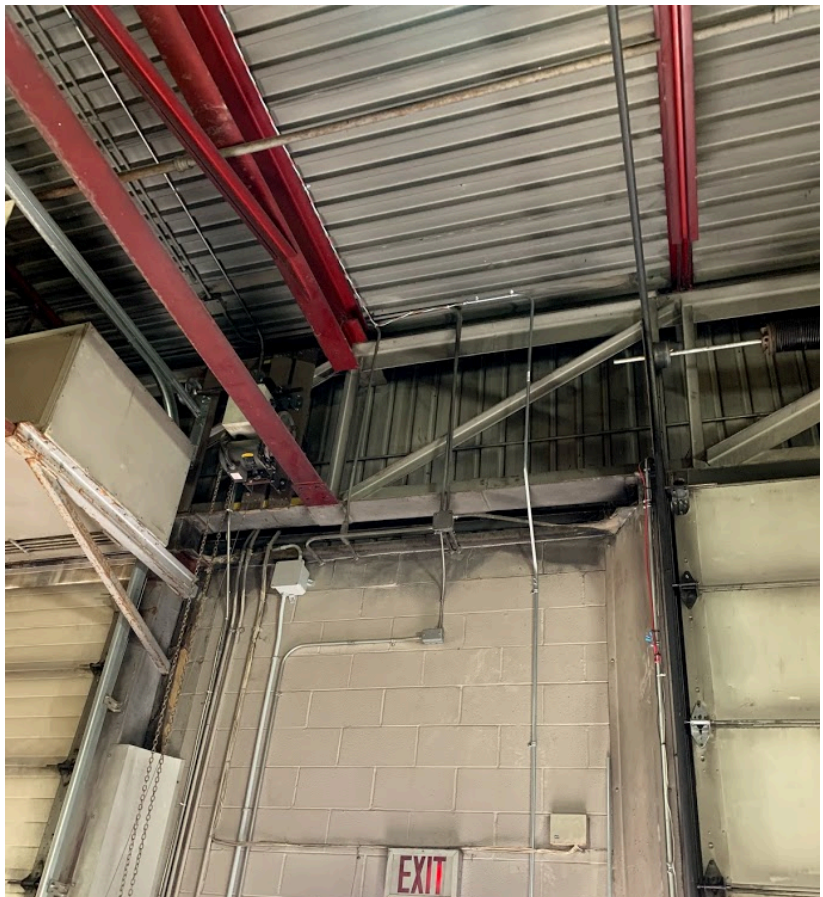
B67PRC23K - 003

Interior Wall on South Side of
Building

Metal Clad Wall above Overhead
Doors.

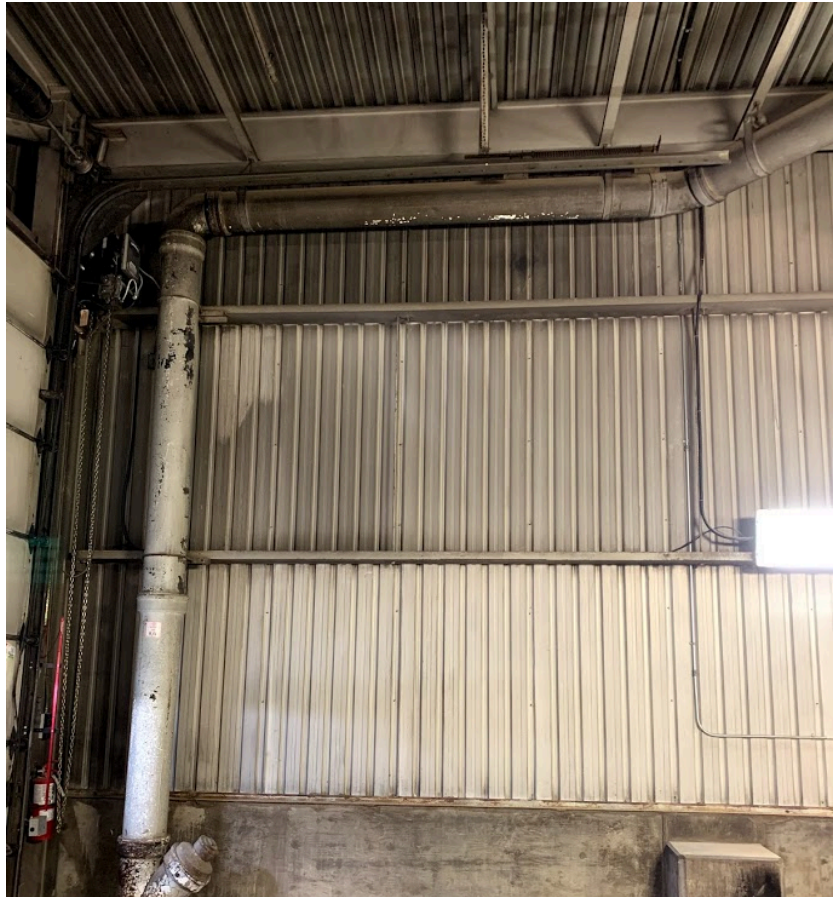
B67PRC23K – 004

Interior Wall on West Side of
Building

Fiberglass Insulation Found
Within the Wall Cavity

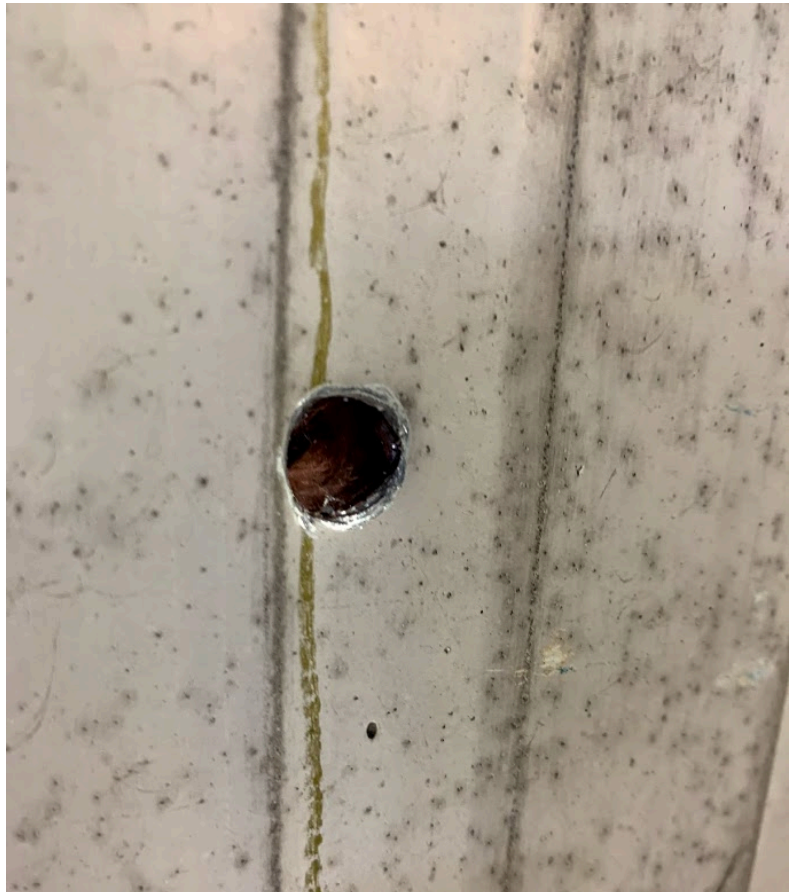
Interior Wall on the West Side of
Building

Fiberglass Insulation within Wall
Cavity of Metal Clad

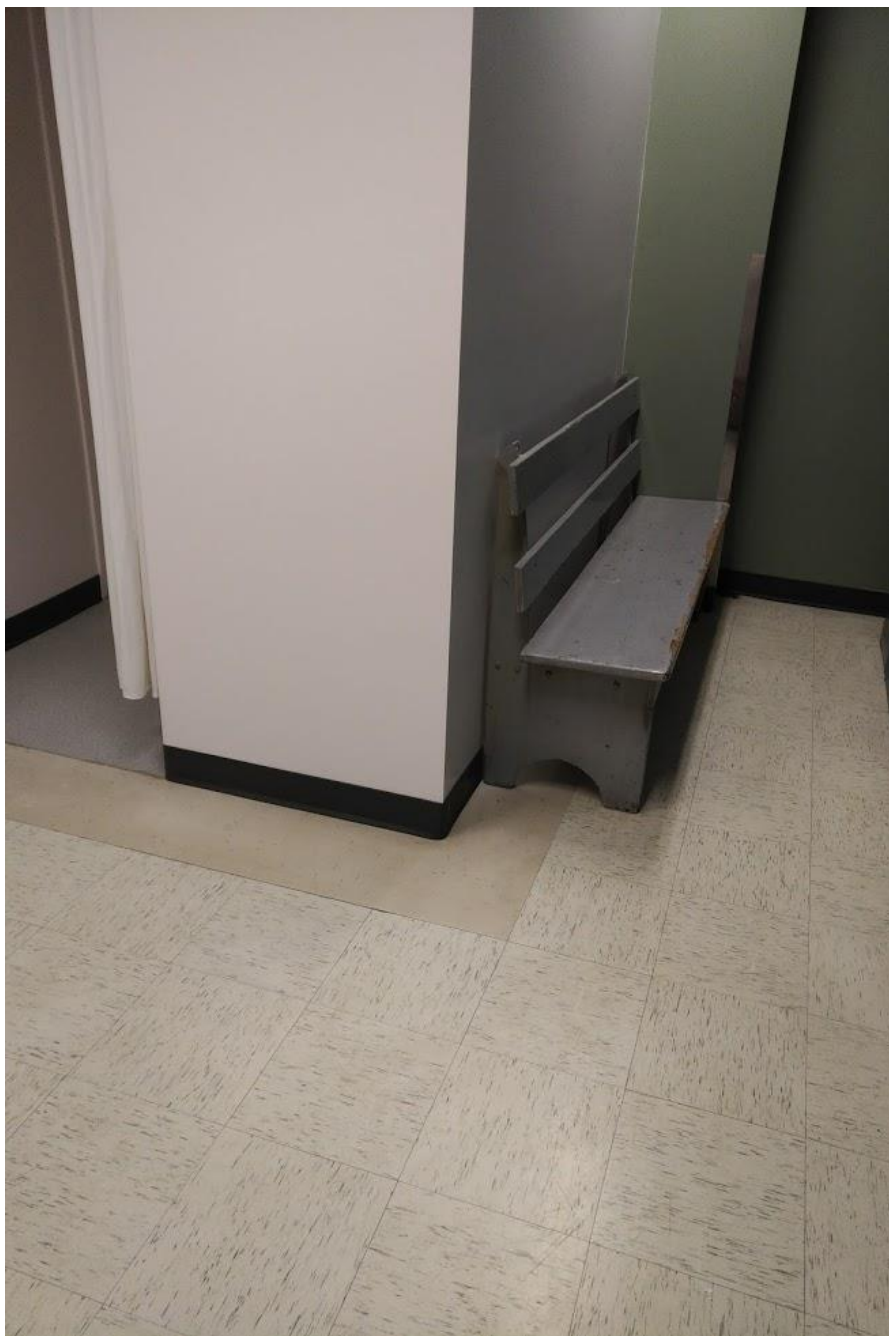
Photo 3: 210 Female Locker Room – 1' X 1' Floor Tile White w Grey Streaks. Asbestos Containing Material.

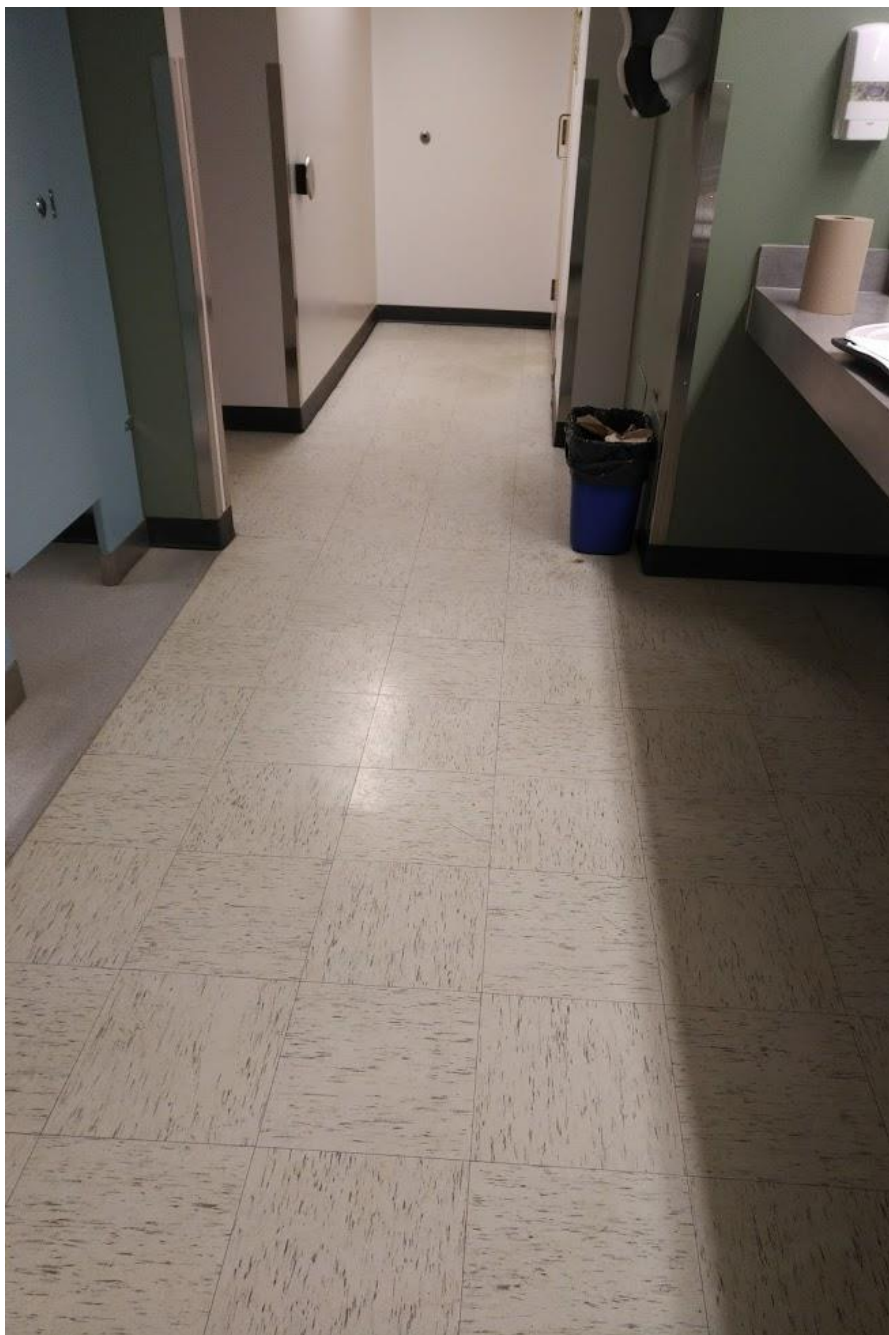
Photo 4: 209 Female Washroom – 1' X 1' Floor Tile White w Grey Streaks. Asbestos Containing Material.

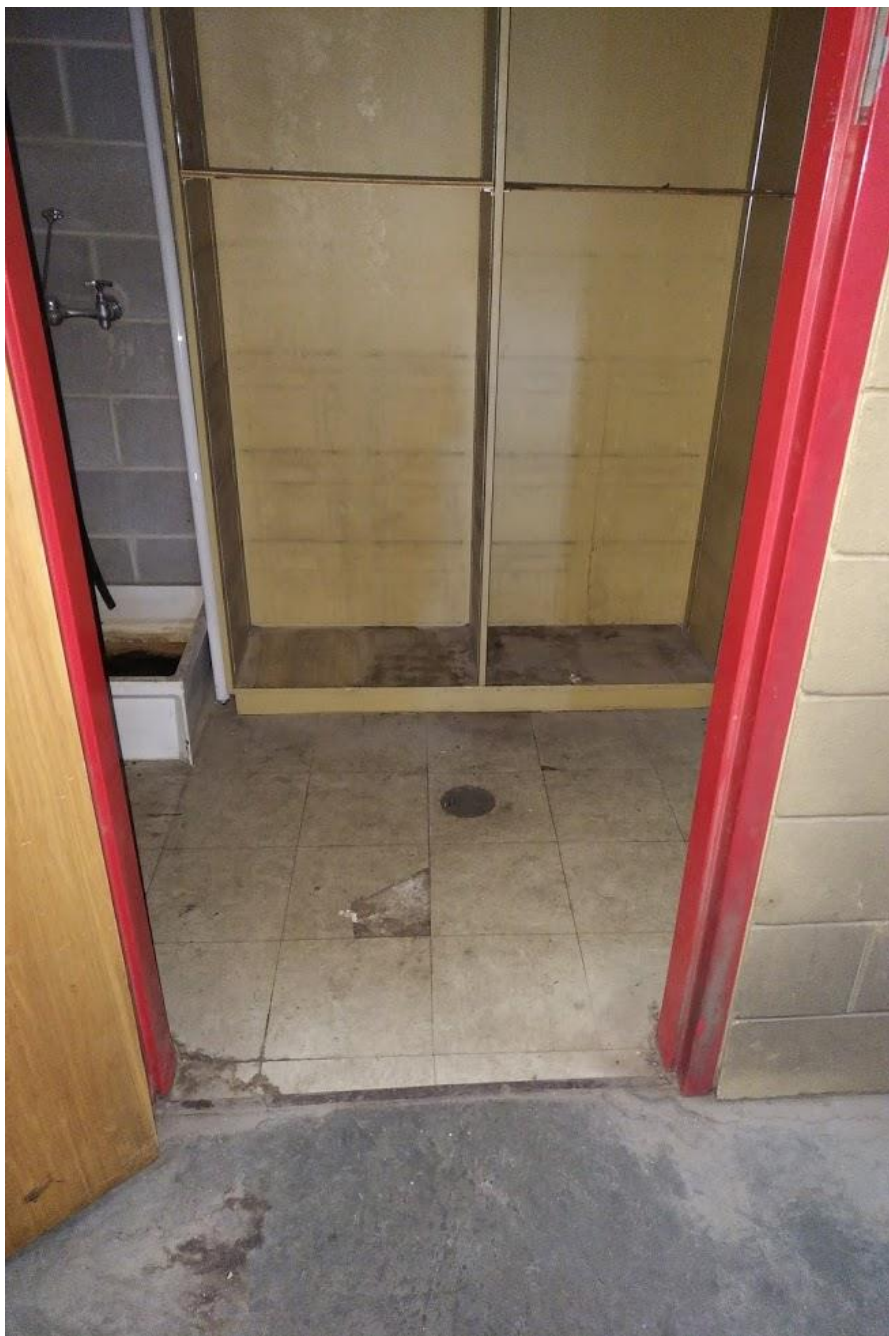
Photo 5: 122 Janitor Room – 1' X 1' Floor Tile Beige w Faint Grey Streaks. Asbestos Containing Material.

1. Removal of the floor tile as a priority 2 in the main floor Janitor Room 122 is recommended. Two broken tiles are present. The other 2 locations of floor tile are in good condition. The tar coating the fiberglass within the intake air plenum is in good condition. These materials shall be managed as part of the asbestos management plan.

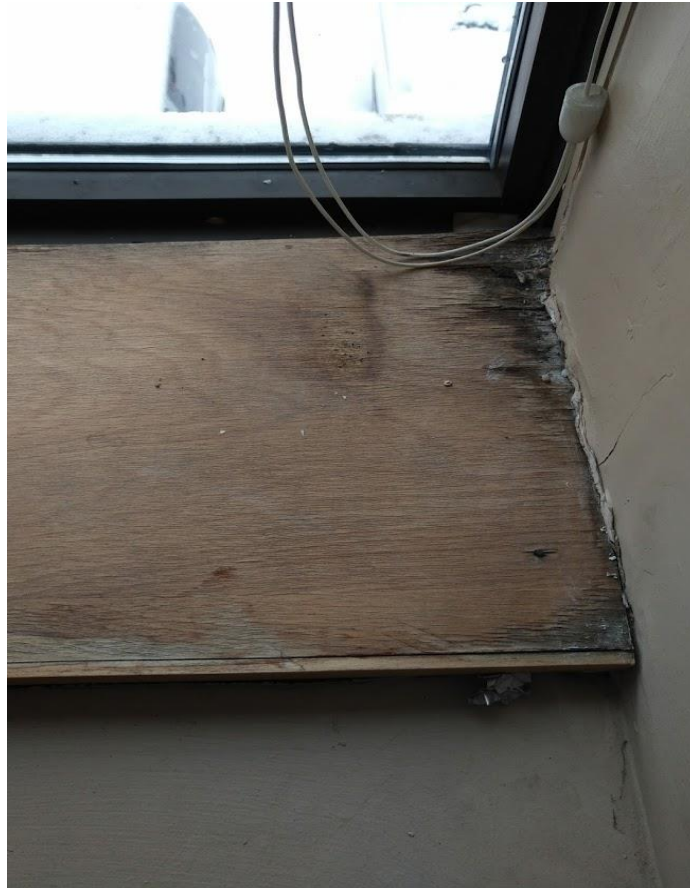
Photo 2: 218 Staff Lounge – Northeast Corner of Window Sill - Water Staining
