**A.C.T. Center
Asbestos Survey Report**

December 2014

Prepared For: City Of Saskatoon- Infrastructure Services Department
3130 Laurier Drive, Saskatoon, SK.
Attn: Brent Anderson

Prepared By: Bersch & Associates Ltd.
Project No. : B67SRL16

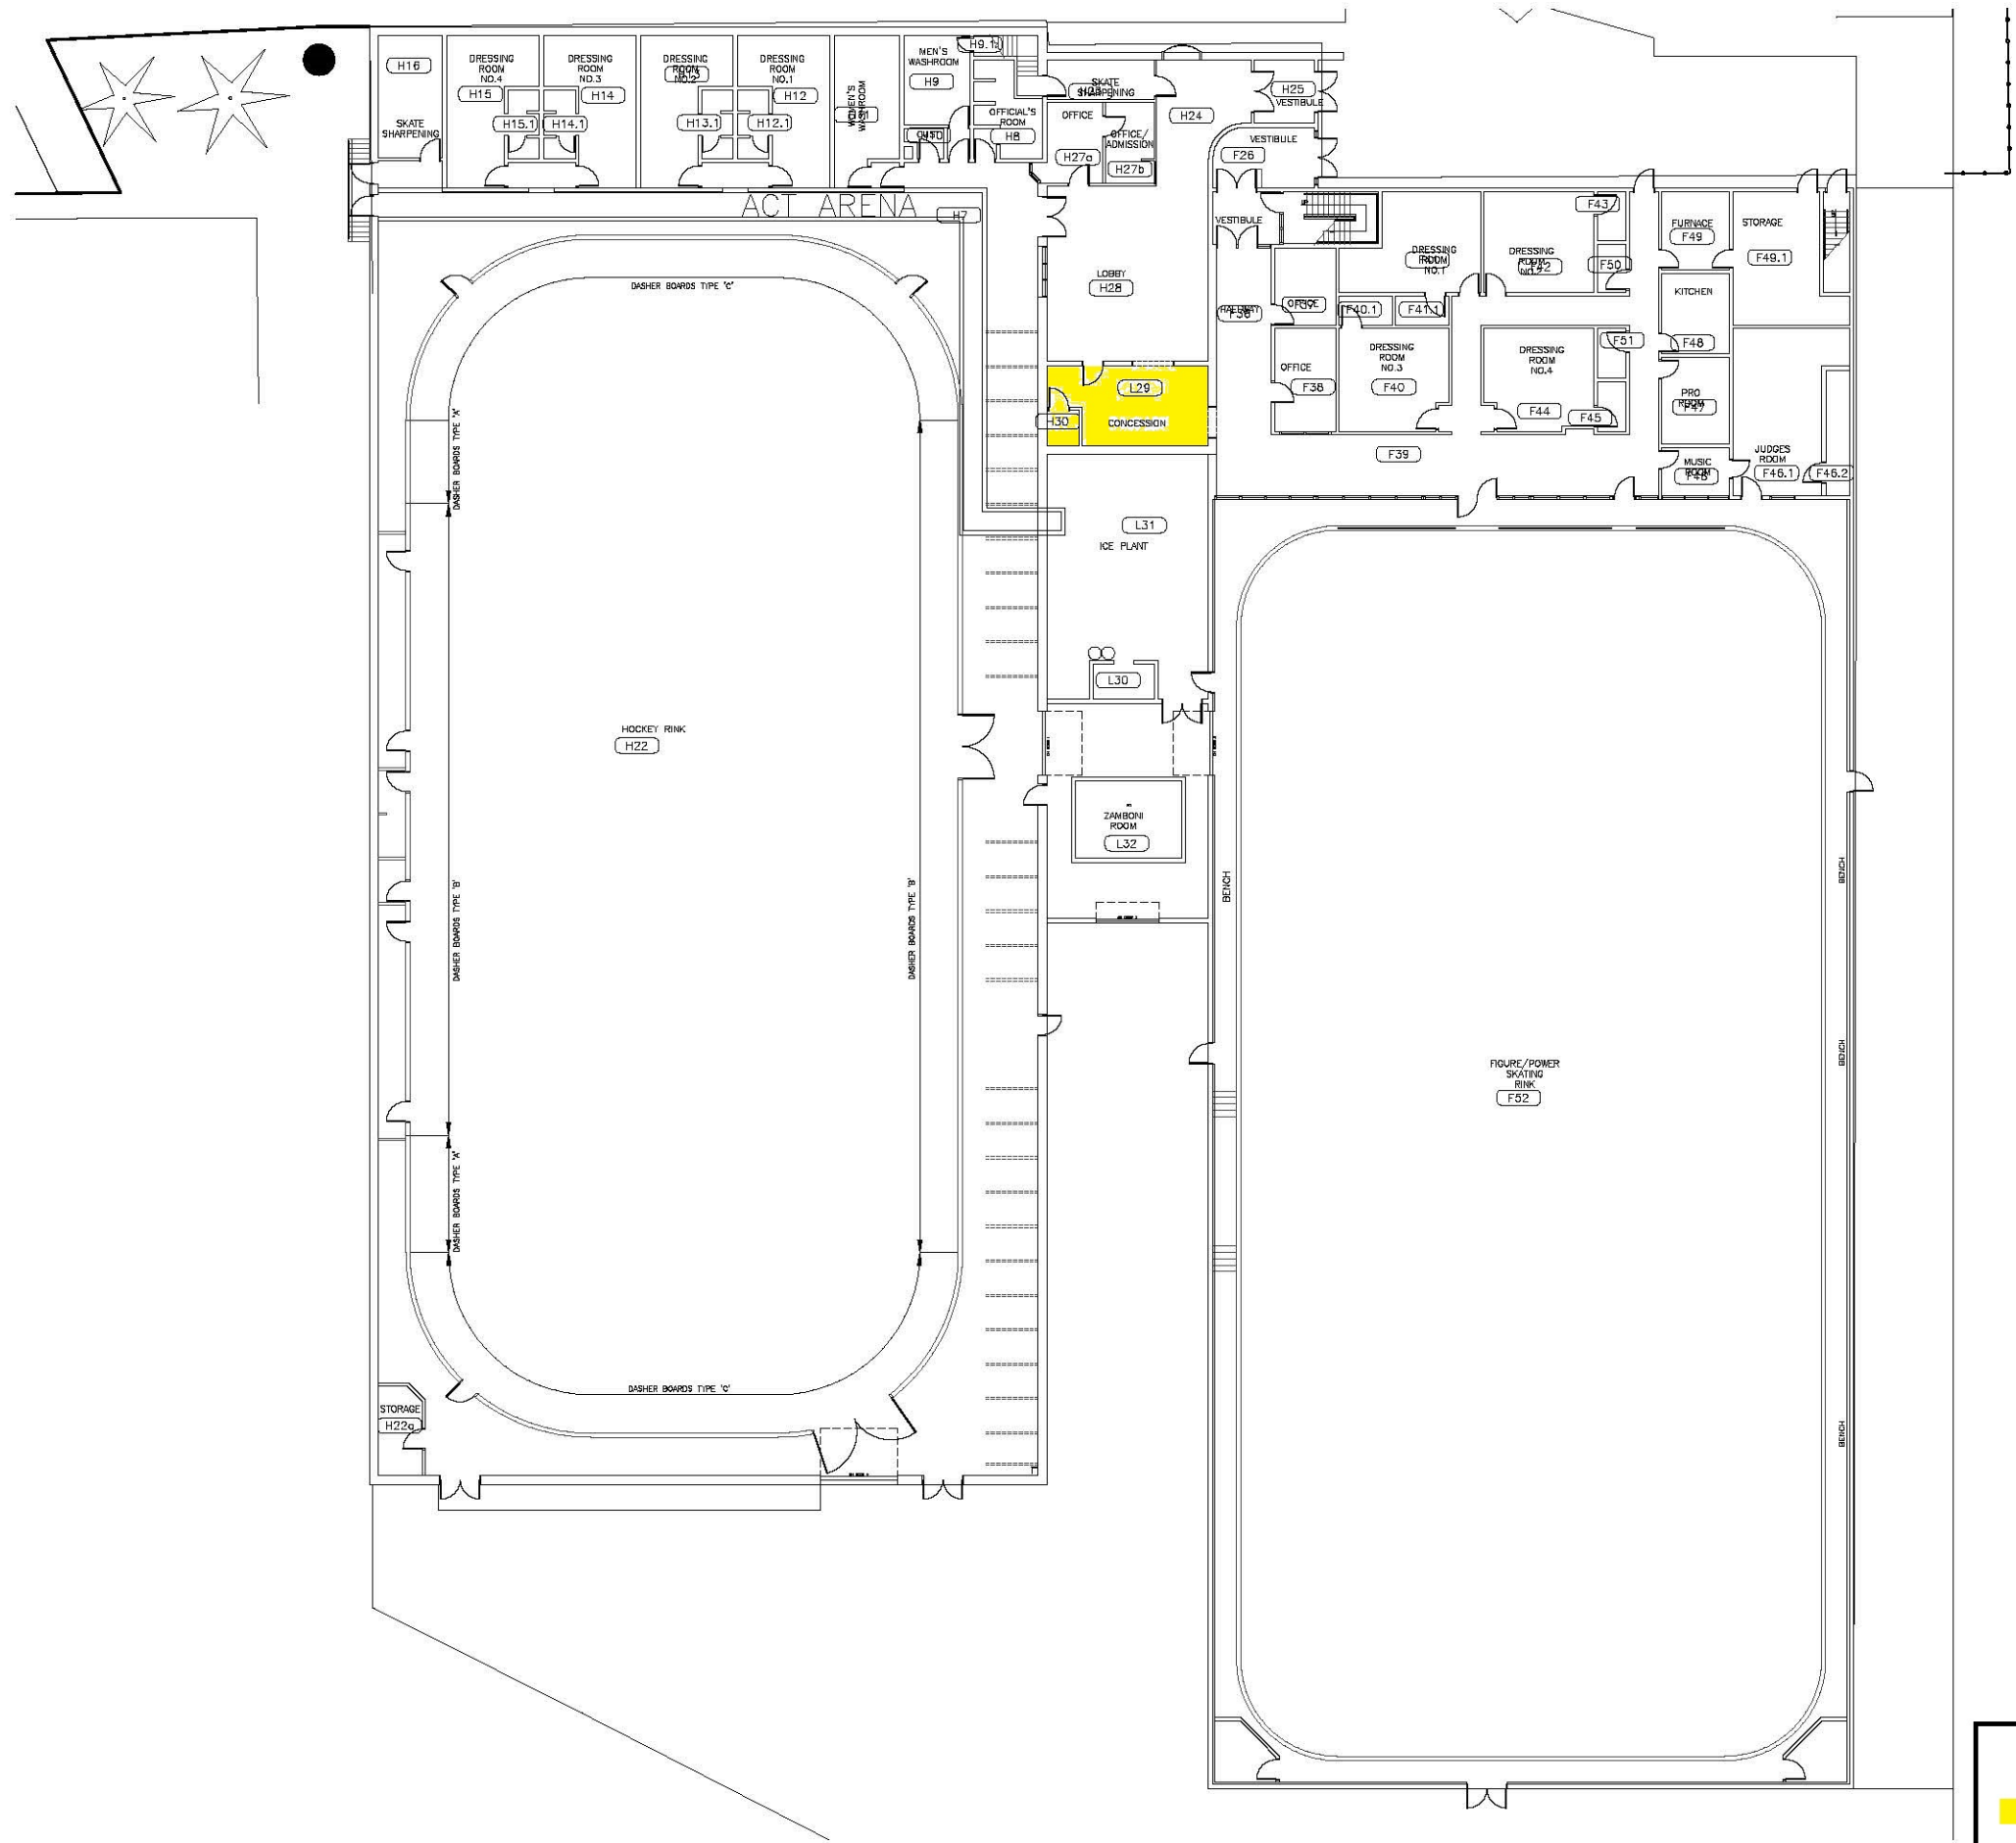
Main Floor
Base Plan

- **Vinyl Asbestos Floor Tile** is located in Rooms L29, H30, 206 and 207. The Asbestos Floor Tile is identified on the **Floor Plans** in **Appendix III** of this report.
