**Albert Community Center
Asbestos Survey Report**

January 2014

Prepared For: City Of Saskatoon- Infrastructure Services Department
1101 Avenue P North, Saskatoon, SK.
Attn: Brent Anderson

Prepared By: Bersch & Associates Ltd.
Project No. : B67SRD29

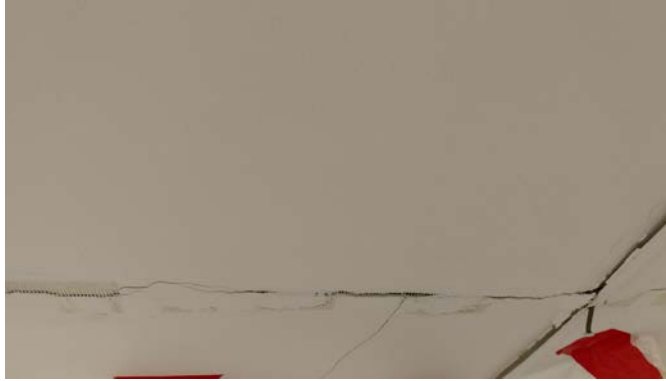
PHOTO 1 – DAY CARE MAIN CORRIDOR – PRIOR TO BULK SAMPLING

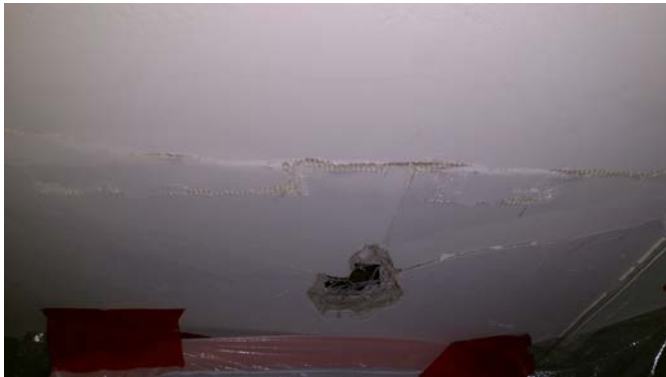
PHOTO 2 – SAMPLE AREA

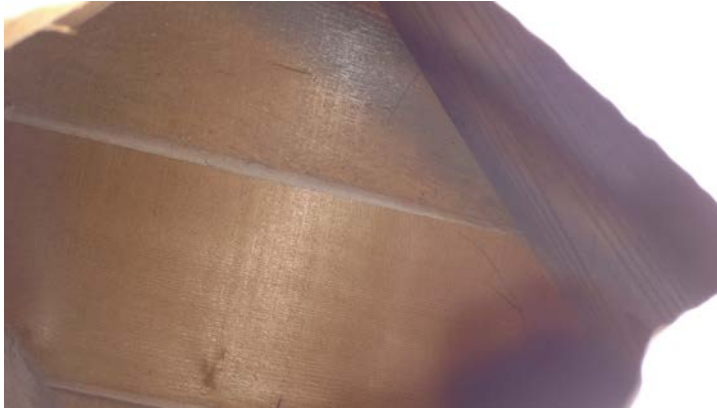
PHOTO 3 – ABOVE ENCLOSED CEILING

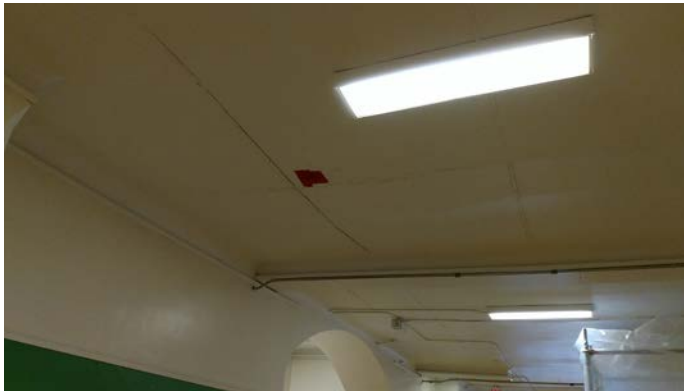
PHOTO 4 – SAMPLE AREA SEALED
