November 15, 2017

CITY OF SASKATOON

Asbestos-Containing Building Materials Assessment Report - Adelaide (Meadowlark Park) Lift Station

Report Number: 1667963

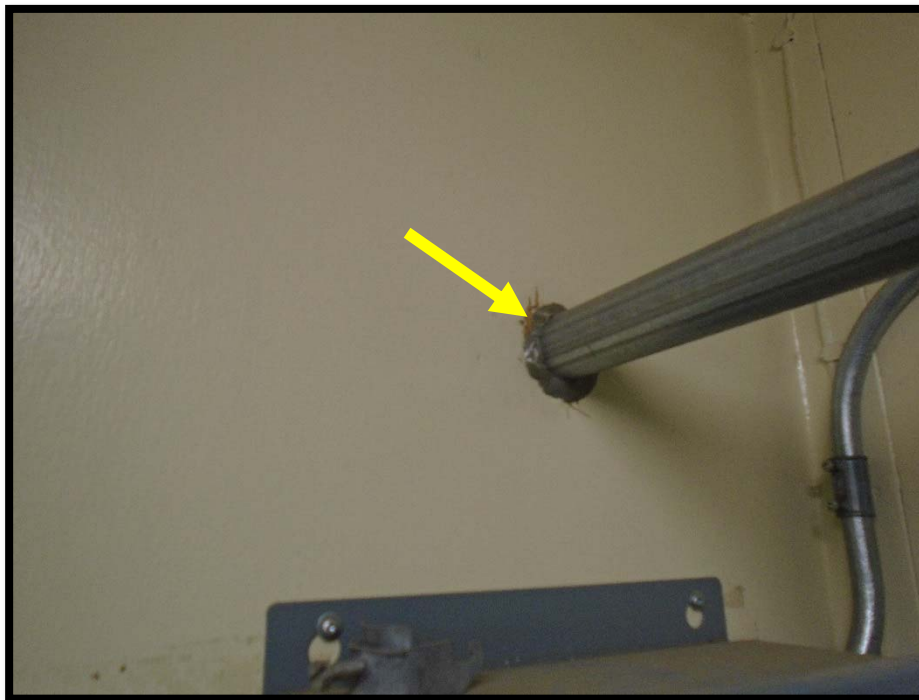
One (1) sample of grey firestop putty was collected during the assessment. The sample collected was found to contain 2.1% Chrysotile asbestos. Asbestos-containing grey firestop putty (see Photograph 1 in Appendix B) was observed in the following locations:

- Room 100 (approximately 1 ft).

Asbestos was positively identified within the grey firestop putty on Site. Asbestos was not identified in the remaining samples collected and analyzed.

Photograph 1: Asbestos-Containing Grey Firestop Putty.

If scheduled for impact, asbestos-containing grey firestop putty should be abated following low-risk abatement work procedures as outlined in the *Saskatchewan Asbestos Abatement Manual (2017)*. Alternatively, as the firestop was observed in good condition, and with a priority rating of 5 (please see the room by room spreadsheet provided in Appendix C for a description of the priority ratings), the firestop can be managed in place if not scheduled for impact.
