July 10, 2017

CITY OF SASKATOON

Asbestos-Containing Building Materials Assessment Report - Archibald Arena

Report Number: 1667963

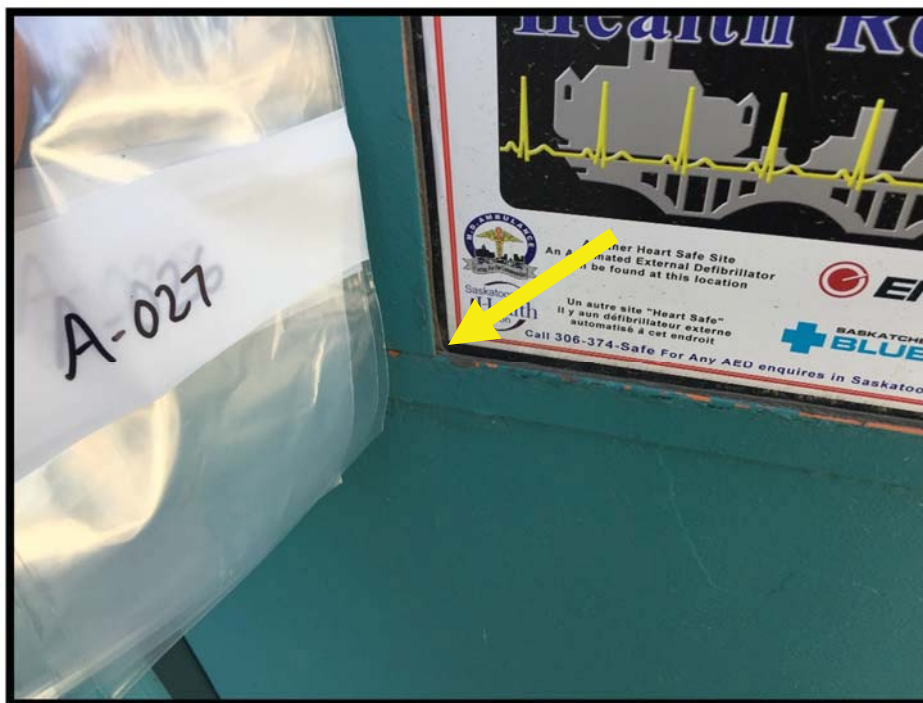
One (1) sample of black door window caulking was collected during the assessment. The sample collected was found to contain trace Chrysotile asbestos. Asbestos-containing black door window caulking (see Photograph 1 in Appendix B) was observed in the following locations:

- Exterior Doors (approximately 15 linear ft).

Please note the asbestos-containing caulking was found on the exterior of the door windows along Room 101. The caulking located on the interior of the door windows was sampled and was found to not contain asbestos.

Asbestos was positively identified within the black door window caulking along the exterior of the doors within Room 101 of the Site. Asbestos was not identified in the remaining samples collected and analyzed.

Photograph 1: Asbestos-Containing Black Door Window Caulking.

If scheduled for impact, asbestos-containing black door window caulking should be abated following low-risk abatement work procedures as outlined in the *Saskatchewan Asbestos Abatement Manual* (2017). Alternatively, as the black door window caulking was observed in good condition, and with a priority rating of 5 (please see the room by room spreadsheet provided in Appendix C for a description of the priority ratings), it can be managed in place if not scheduled for impact.
