November 15, 2017

CITY OF SASKATOON

# Asbestos-Containing Building Materials Assessment Report - Adelaide (Meadowlark Park) Lift Station

**Report Number: 1667963**

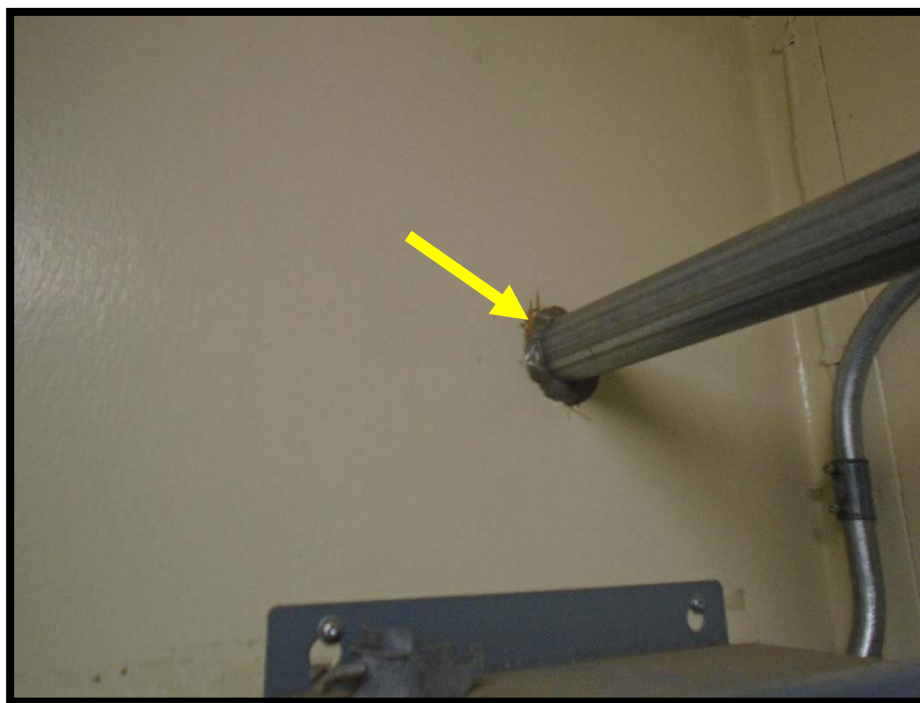
One (1) sample of grey firestop putty was collected during the assessment. The sample collected was found to contain 2.1% Chrysotile asbestos. Asbestos-containing grey firestop putty (see Photograph 1 in Appendix B) was observed in the following locations:

- Room 100 (approximately 1 ft).

**Photograph 1: Asbestos-Containing Grey Firestop Putty.**

| Included/Excluded | Floor | Room # | Area Description | Elements | Subelements | Material Description | Accessibility | Suspect? | Sampled? | Asbestos Containing Material? | Condition | Field Notes | Sample Type | Sample ID | Sample Date | Asbestos Type | ACM Product | % of asbestos | Friable | Sprayed-on | Maintenance | Inspection | Priority | Potential for Disturbance | Recommended Action | Quantity | Photograph ID | Labelling Type |
|---|---|---|---|---|---|---|---|---|---|---|---|--|---|---|---|---|---|---|---|---|---|---|---|--|---|---|---|---|
| Included | M | 100 | Open Area | Walls | Firestop | Grey Putty | High | No | Yes | Yes | Good | | Bulk | A-002 | 17-Oct-17 | Chrysotile | Firestop | 2.1 | No | No | N/A | Annually | 5 | High | Manage in place | 5 ft | Photograph 1 | |

If scheduled for impact, asbestos-containing grey firestop putty should be abated following low-risk abatement work procedures as outlined in the *Saskatchewan Asbestos Abatement Manual (2017)*. Alternatively, as the firestop was observed in good condition, and with a priority rating of 5 (please see the room by room spreadsheet provided in Appendix C for a description of the priority ratings), the firestop can be managed in place if not scheduled for impact.
