**Albert Community Center
Asbestos Survey Report**

January 2014

Prepared For: City Of Saskatoon- Infrastructure Services Department
1101 Avenue P North, Saskatoon, SK.
Attn: Brent Anderson

Prepared By: Bersch & Associates Ltd.
Project No. : B67SRD29

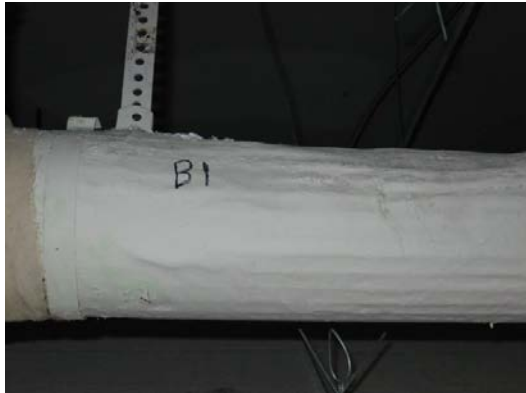
#1) Aircell Pipeline Insulation

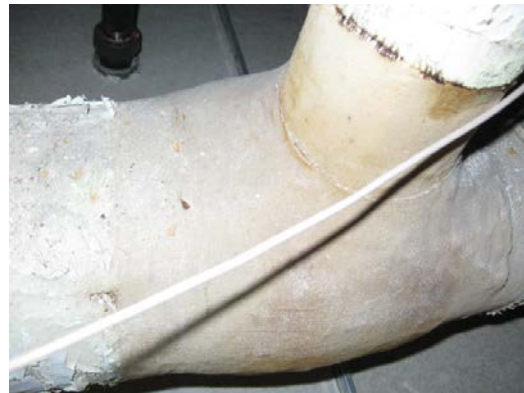
#2) Pipeline fitting

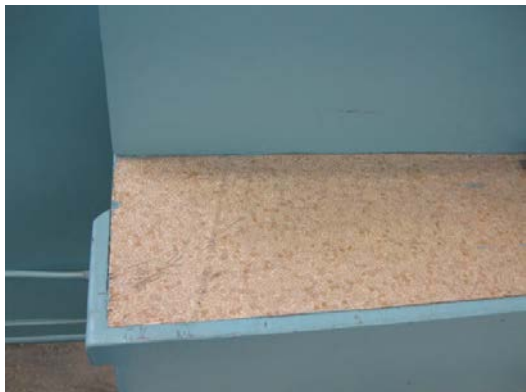
#3) Asbestos Sheet Flooring

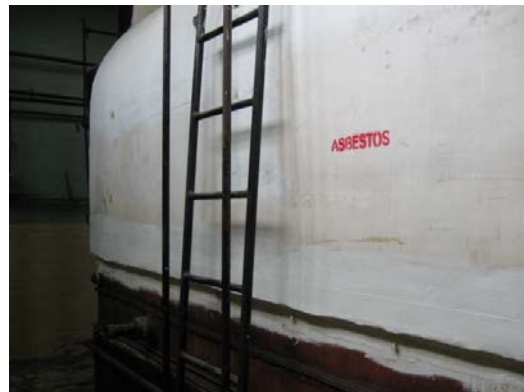
#4) Boiler Insulation

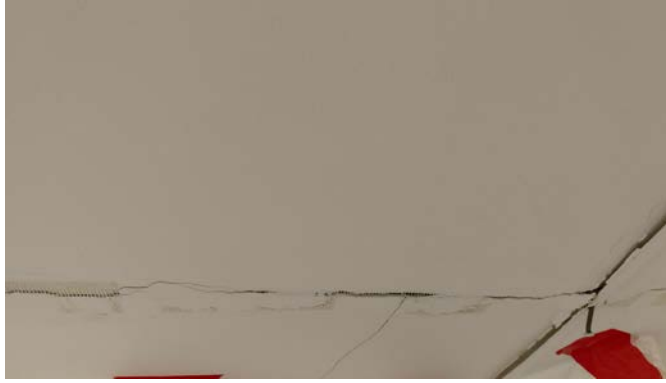
PHOTO 1 – DAY CARE MAIN CORRIDOR – PRIOR TO BULK SAMPLING

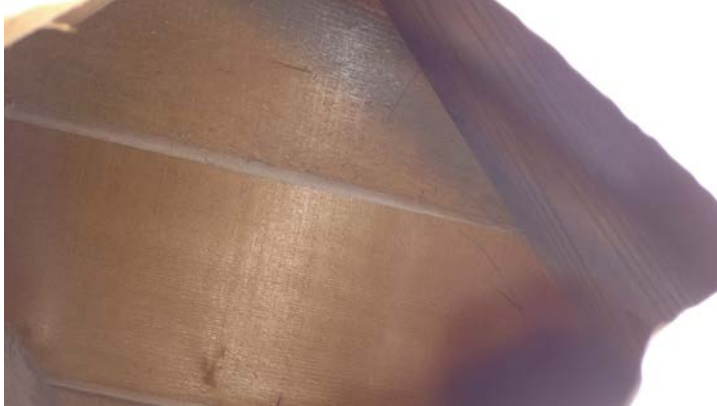
PHOTO 3 – ABOVE ENCLOSED CEILING

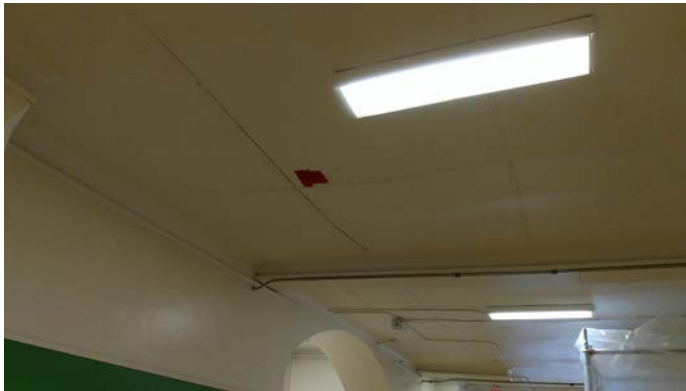
PHOTO 4 – SAMPLE AREA SEALED
