July 10, 2017

CITY OF SASKATOON

Asbestos-Containing Building Materials Assessment Report - Archibald Arena

Report Number: 1667963

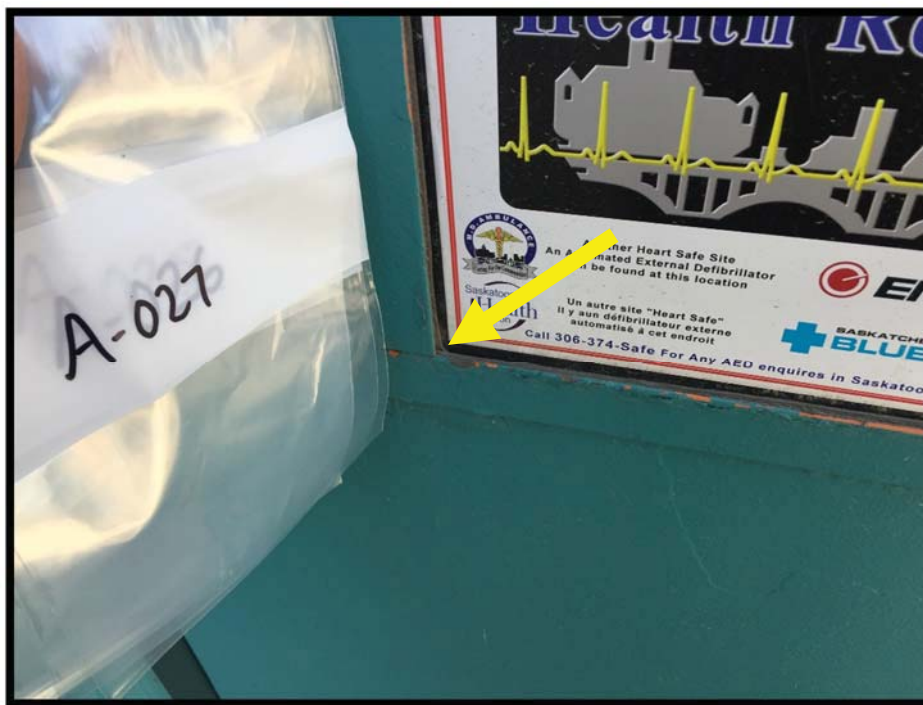
One (1) sample of black door window caulking was collected during the assessment. The sample collected was found to contain trace Chrysotile asbestos. Asbestos-containing black door window caulking (see Photograph 1 in Appendix B) was observed in the following locations:

- Exterior Doors (approximately 15 linear ft).

Please note the asbestos-containing caulking was found on the exterior of the door windows along Room 101. The caulking located on the interior of the door windows was sampled and was found to not contain asbestos.

Asbestos was positively identified within the black door window caulking along the exterior of the doors within Room 101 of the Site. Asbestos was not identified in the remaining samples collected and analyzed.

Photograph 1: Asbestos-Containing Black Door Window Caulking.

If scheduled for impact, asbestos-containing black door window caulking should be abated following low-risk abatement work procedures as outlined in the *Saskatchewan Asbestos Abatement Manual (2017)*. Alternatively, as the black door window caulking was observed in good condition, and with a priority rating of 5 (please see the room by room spreadsheet provided in Appendix C for a description of the priority ratings), it can be managed in place if not scheduled for impact.
