October 25, 2017

CITY OF SASKATOON

# Asbestos-Containing Building Materials Assessment Report - Bowerman House Garage

**Report Number: 1667963**

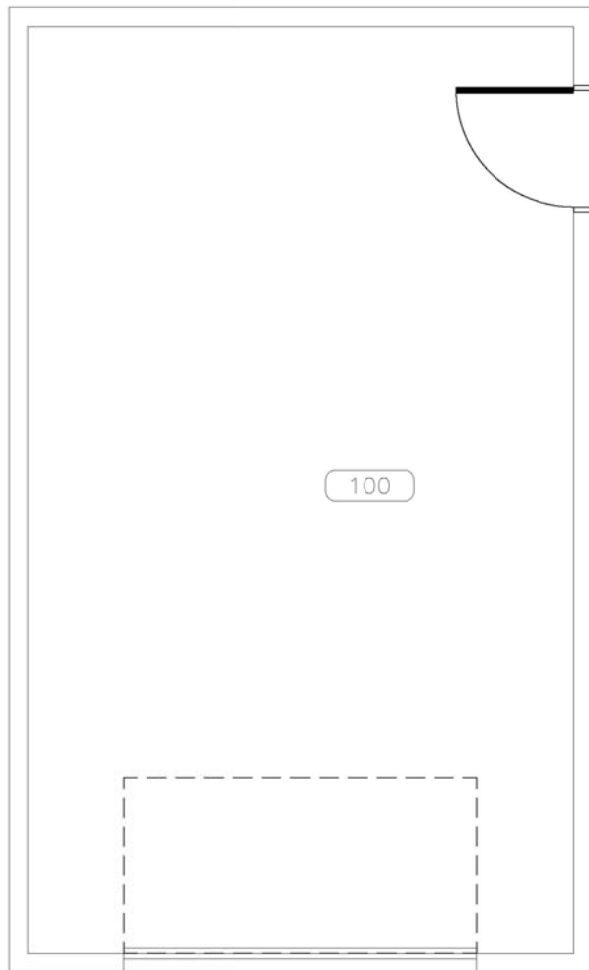
TITLE  
**GARAGE**

1. ASBESTOS IS A CARCINOGEN. DO NOT BREATHE ASBESTOS DUST.
2. ASBESTOS-CONTAINING MATERIALS WERE NOT OBSERVED WITHIN THE GARAGE AT THE TIME OF THE ASSESSMENT.
