PHASE I ASBESTOS INSPECTION REPORT

Conducted At: Building #2
1101 Avenue P North
Saskatoon, SK

got mold?TM Project Number: 2721A1

Inspection Date: June 21, 2016
Report Date: August 15, 2016

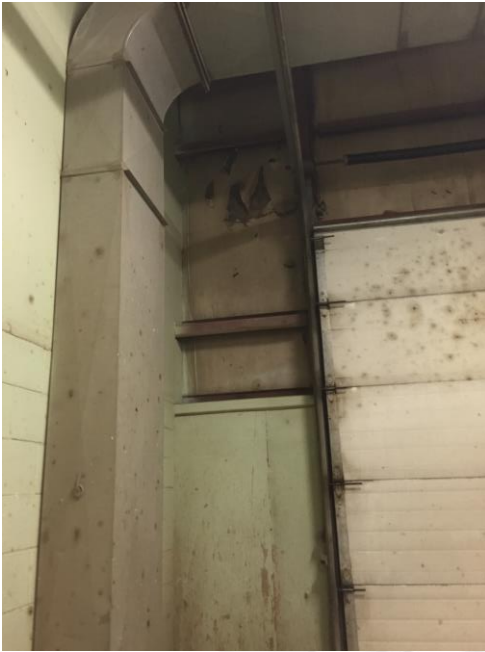
- The drywall on the concrete block wall to the left of the overhead door is beginning to crumble. This could be an indication of water infiltration.
- There's some damage to the wall insulation at the top left of the overhead door.

Damaged Wall Insulation

While no asbestos containing materials were found as a result of our inspection, we would like to bring to your attention a couple of observations that may warrant further investigation on the part of the building owner.

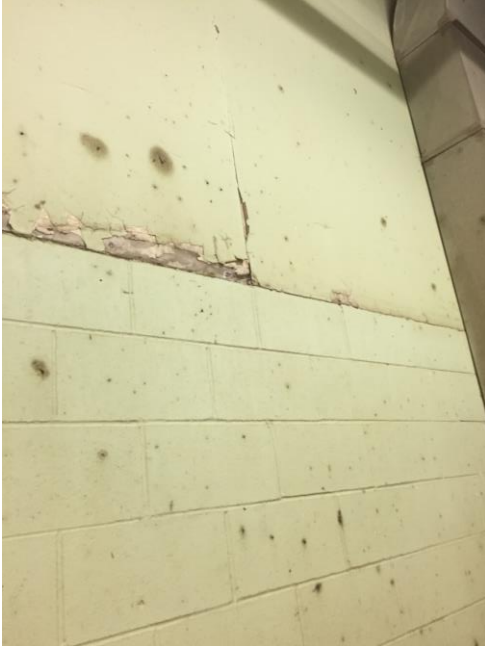
Damaged Drywall

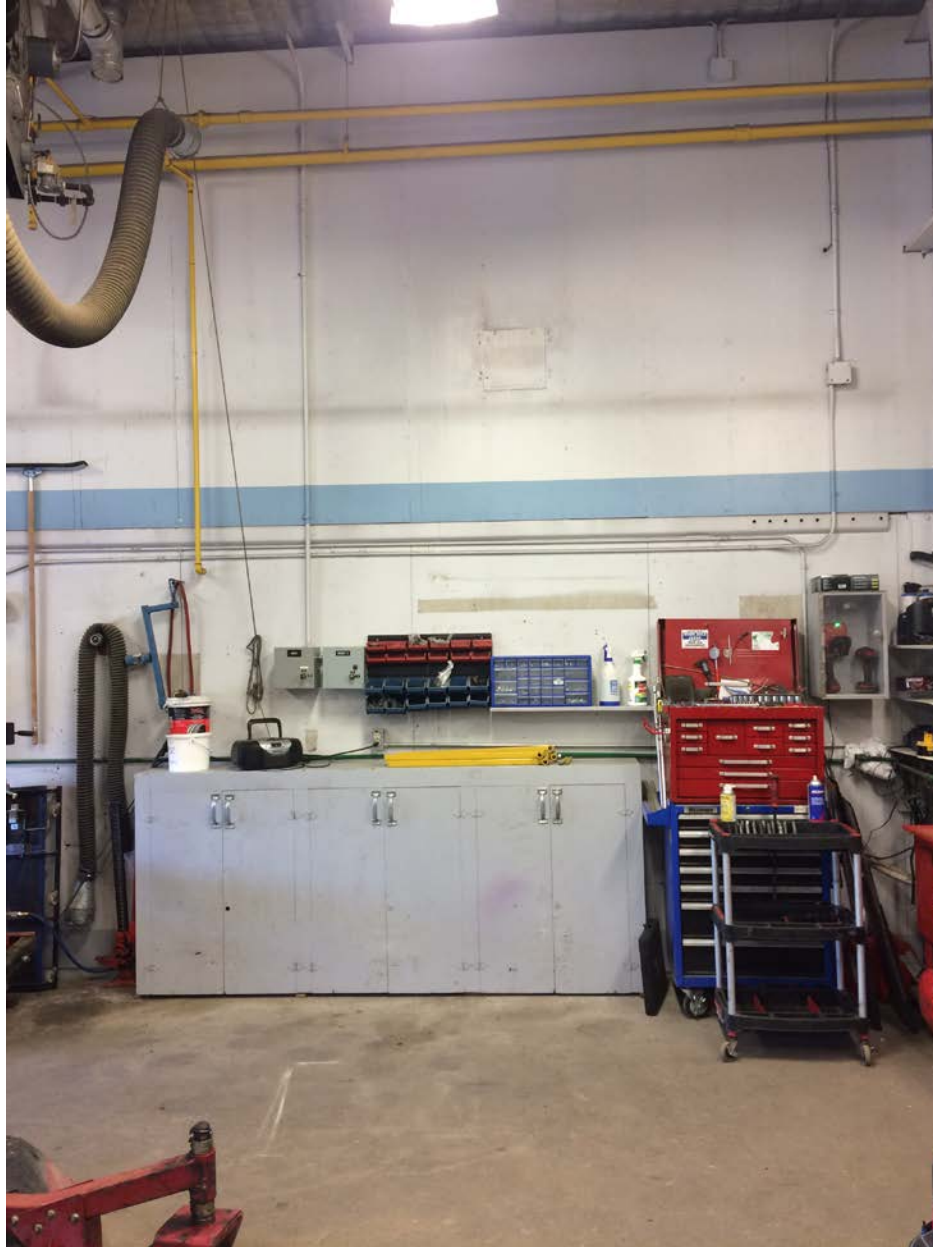
The project involves the installation of a central vacuum system on the east shop wall. The lower, approximately 8 feet of this wall is finished with transite board. One (1) sample, of the transite board was collected and analyzed for the presence/ absence of asbestos. Asbestos **was** detected within the sample. Above the transite board is a steel lintel above which the wall is finished with 1/2in plywood sheathing. A small patch of the plywood wall was removed to determine the materials located in the wall space. The interior of the wall was determined to be wood framing with a metal clad exterior. The wall is insulated with fiberglass insulation. One sample of the insulation was collected and analyzed. The insulation was found to not contain asbestos. The vacuum is to be vented into the small storage shed on the exterior of the building. The west interior wall is the same metal cladding as the exterior of the building. There are no asbestos concerns within this area.

Based on observations during the site visit and the results of bulk sampling, there is an asbestos concern regarding the transite board identified on the lower portion of the shop wall. The vacuum

Figure 1- East wall of Maintenance Shop- Lower portion finished with Transite Board.

system can be mounted and plumbed above the metal lintel on the plywood section of wall without disturbing the transite board wall covering on the lower portion. A second option is to remove and replace a panel of transite board following low-risk procedures (avoiding cutting, breaking, drilling or grinding the board) to facilitate the installation of the vacuum system.

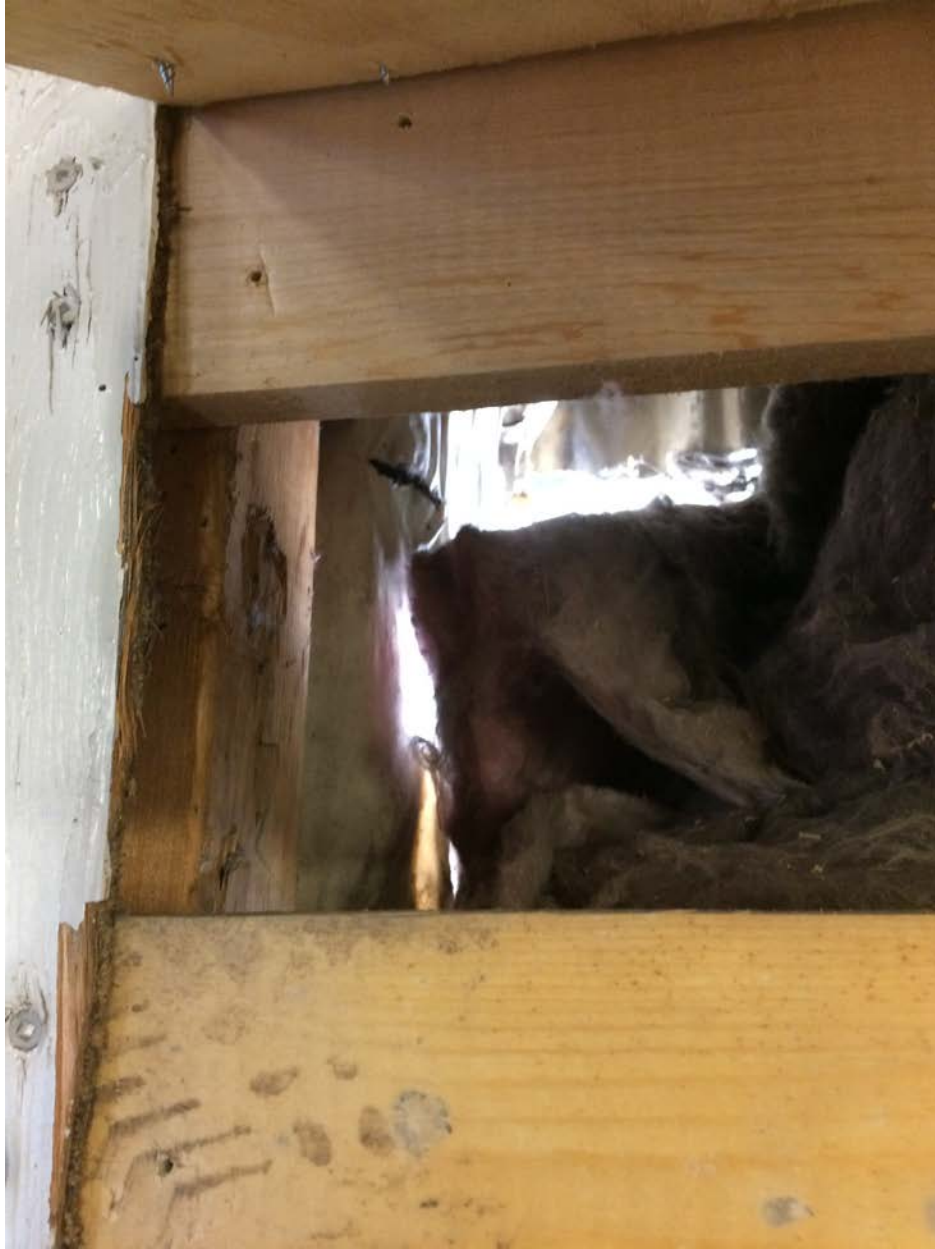
Figure 2- Wall cavity accessed from patch.

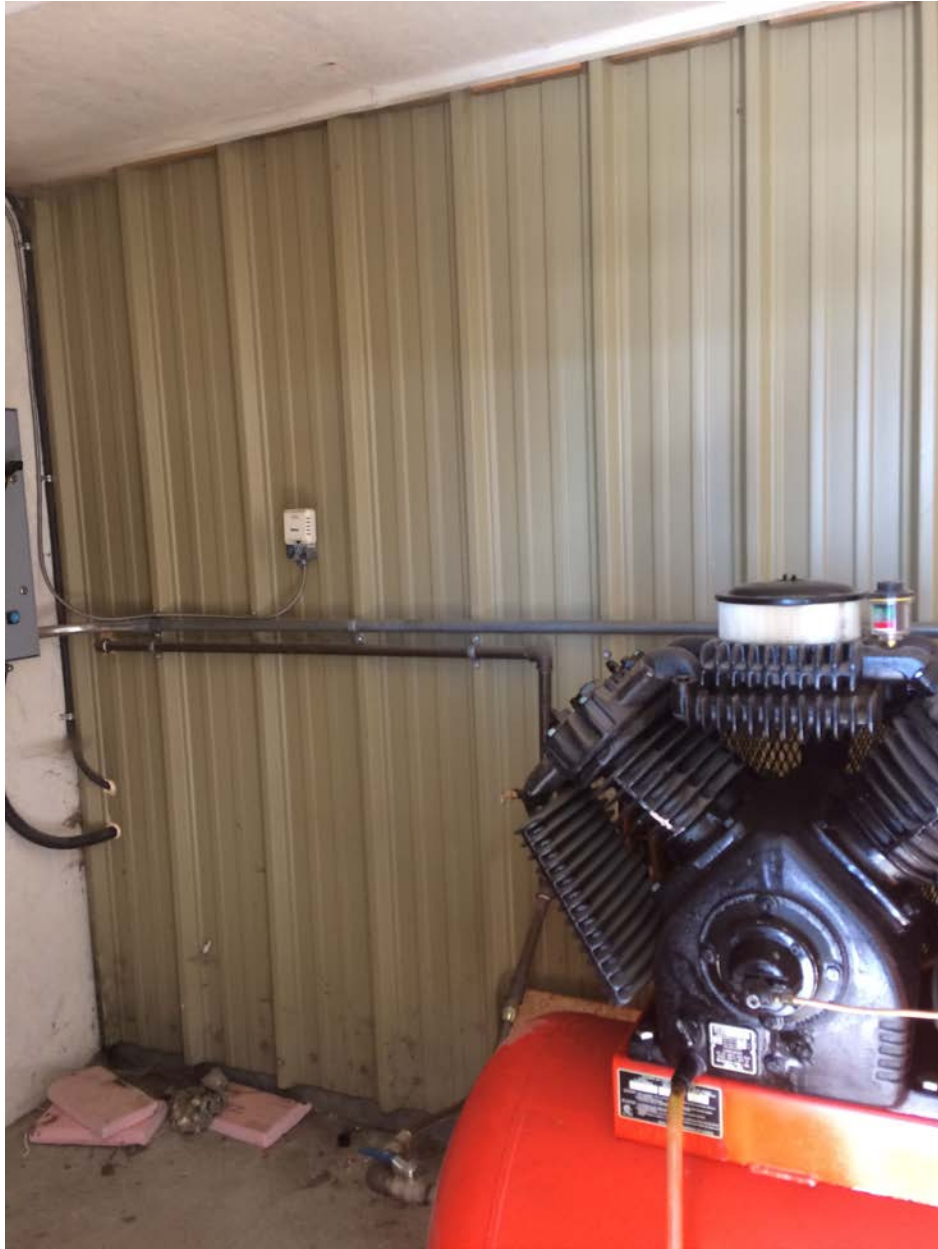
Figure 3- Interior of storage shed.
