**City Hall
Asbestos Survey Report**

January 2015

Prepared For: City of Saskatoon Infrastructure Services - Facilities Branch
3130 Laurier Drive, Saskatoon, SK.
Attn: Brent Anderson

Prepared By: Bersch & Associates Ltd.
Project No. : B67SRA14

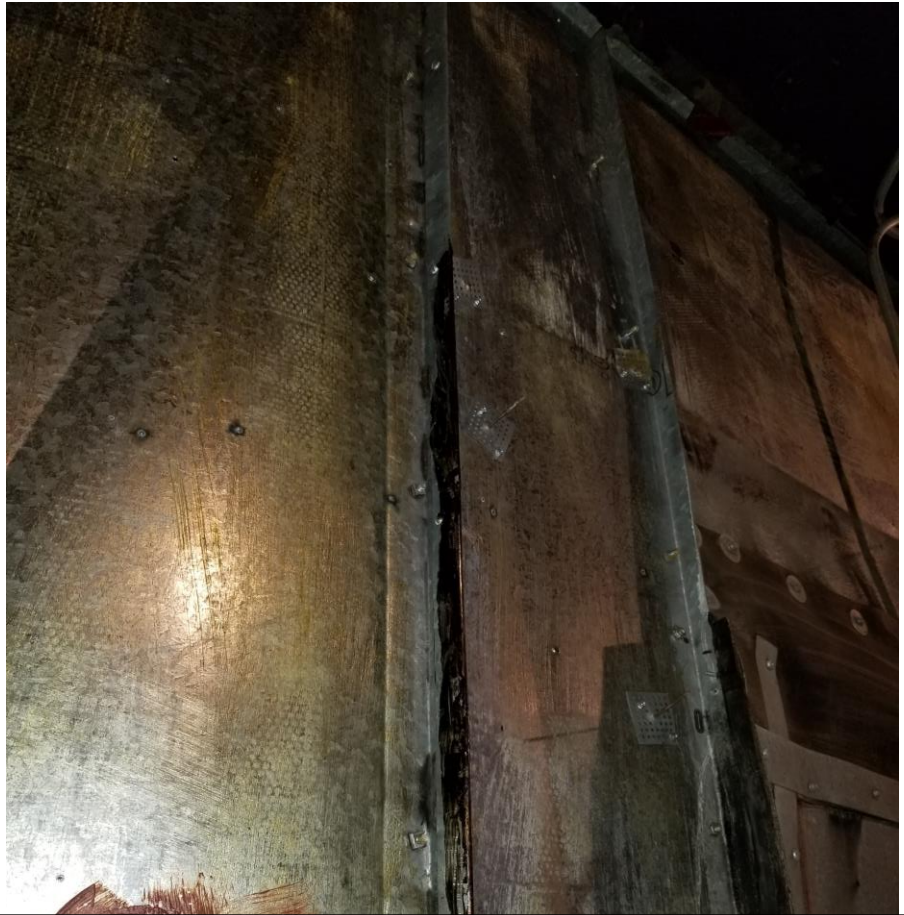
B67IRC28J - 002

Tar on the Angle Iron.

Right side of doorway in F17
suction side of wall.

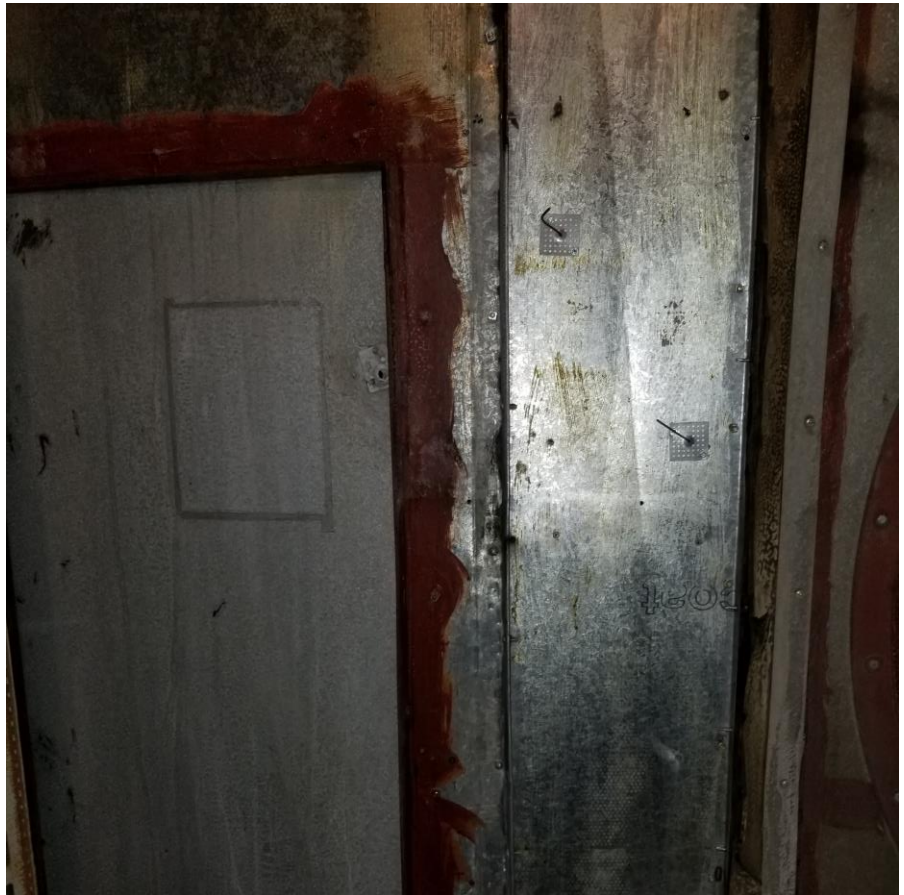
B67IRC28J - 003

Red Sealant on the doorway.

F17 suction side.

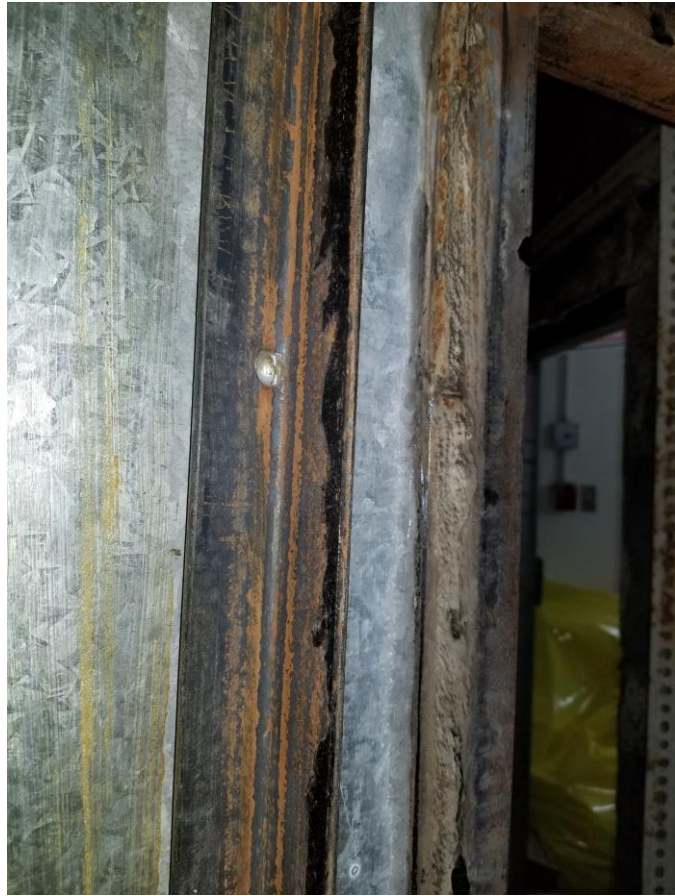
B67IRC28J - 004

Tar on the Angle Iron.
Left side of doorway in F17 coil or
discharge side of wall.

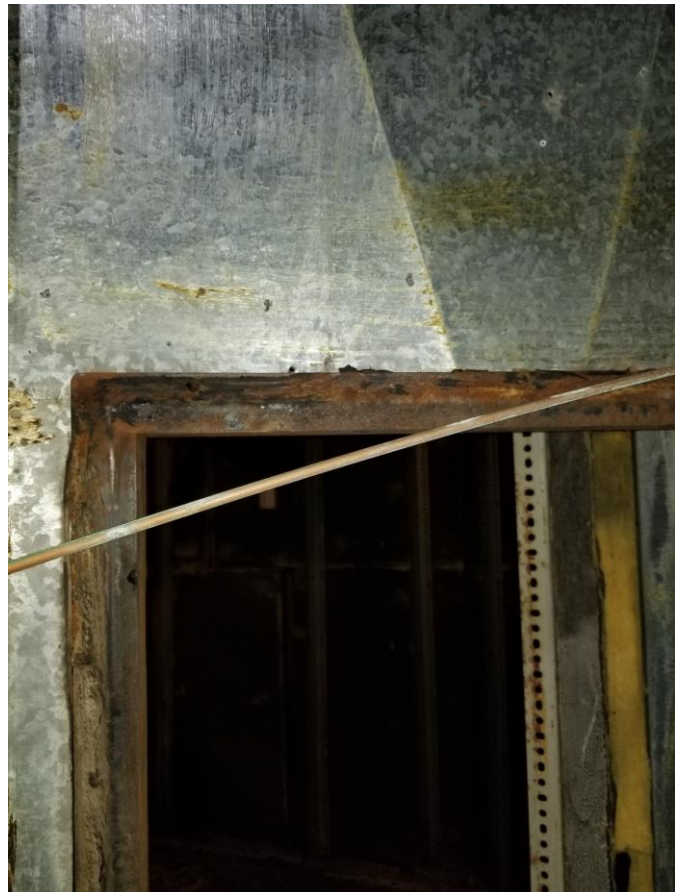
B67IRC28J - 005

Tar on the Angle Iron.
Above the doorway in F17 coil or
discharge side of wall.

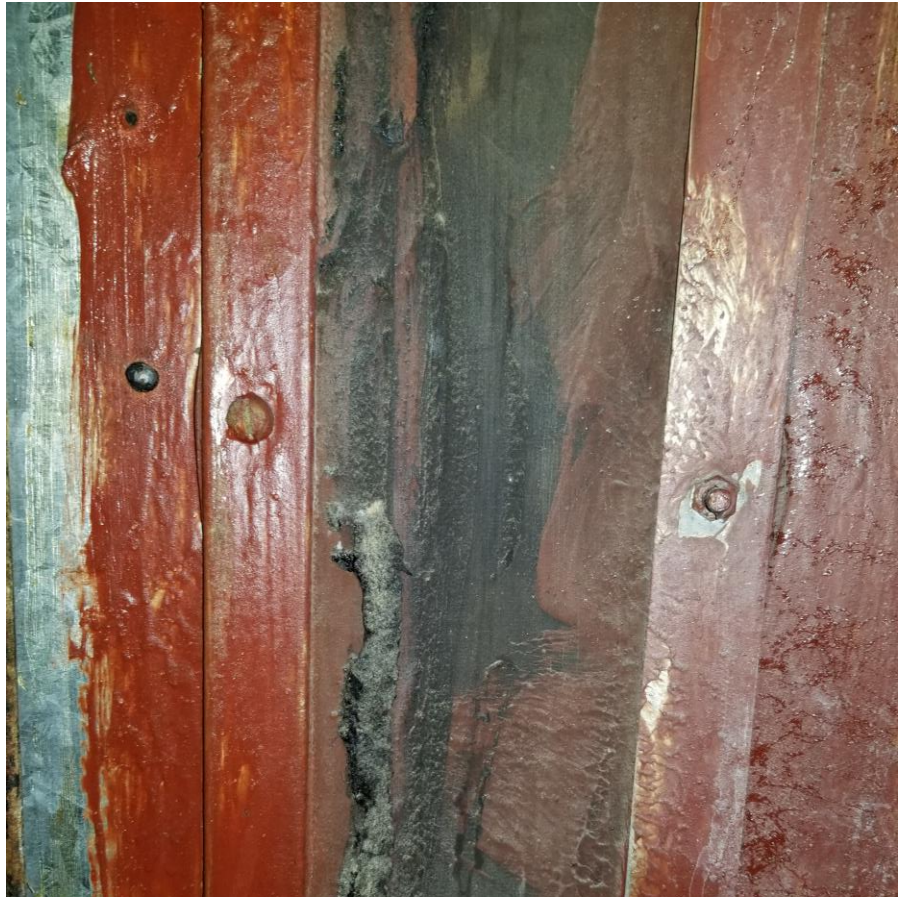
B67IRC28J - 006

Tar on the rubber gasket.
F17 & F18 rubber gasket surrounding the fan housing where it enters the suction and discharge wall.

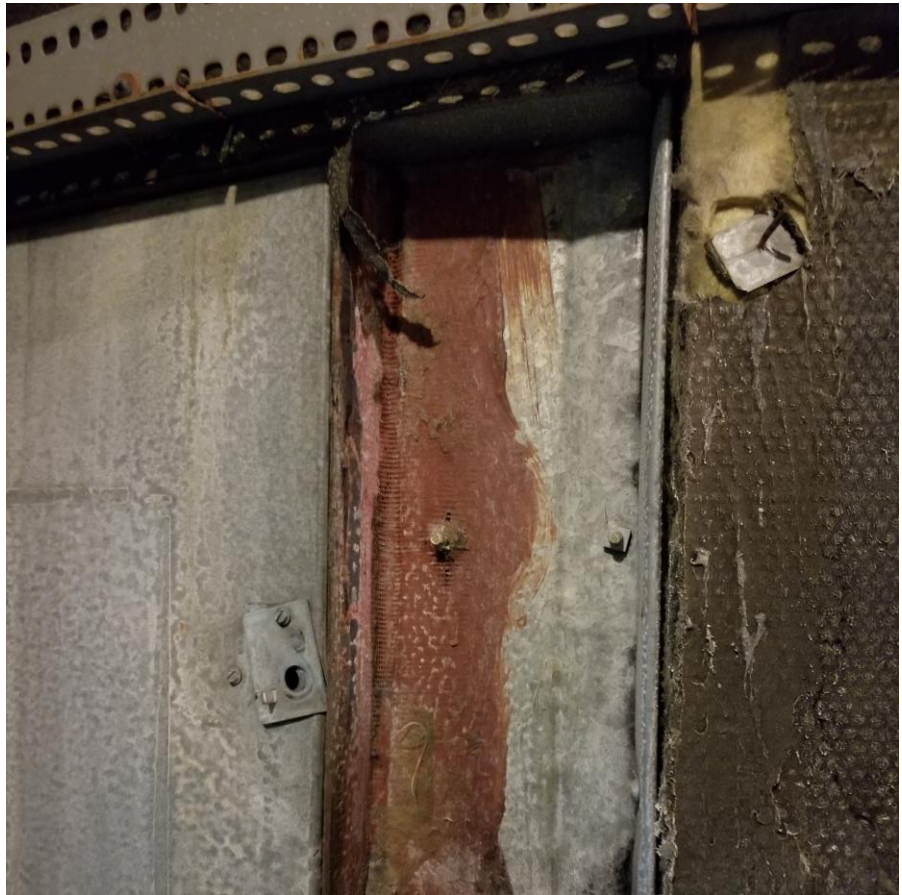
Red Sealant on the right side of the doorway behind the insulation.
F17 suction side.
