**Cosmo Civic Centre  
Saskatoon, SK.**

**Asbestos Survey Report  
March 2015**

**Prepared By: Bersch & Associates Ltd.**  
**Project No. : B67SRL17**

**Subject: Pre-Renovation Assessment – Cosmo Civic Centre – South Ramp Replacement**

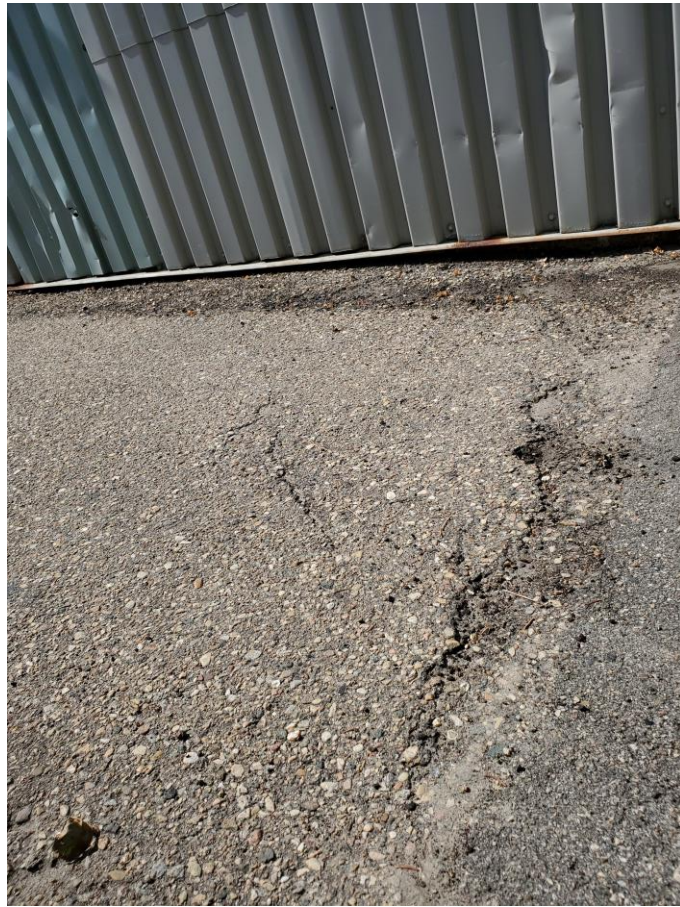
B67PRG13J - 001

Non-asbestos asphalt.

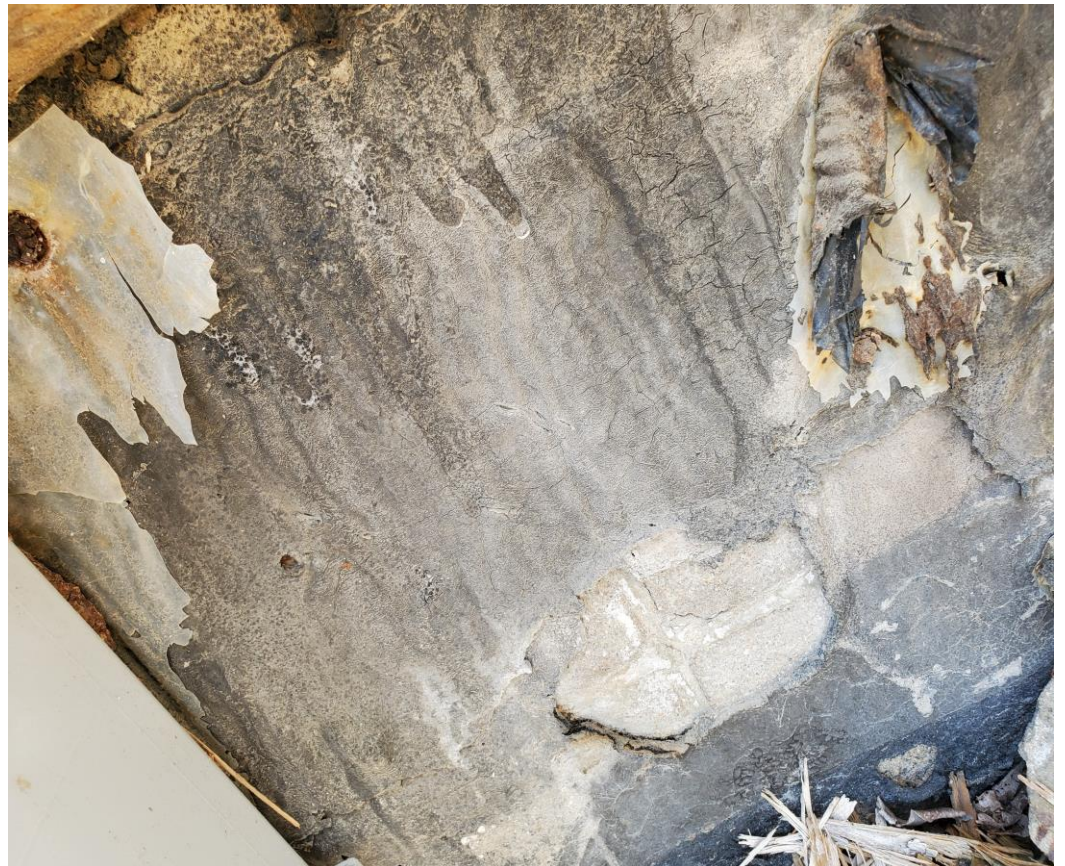
B67PRG13J - 002

Non-asbestos tar wall membrane.

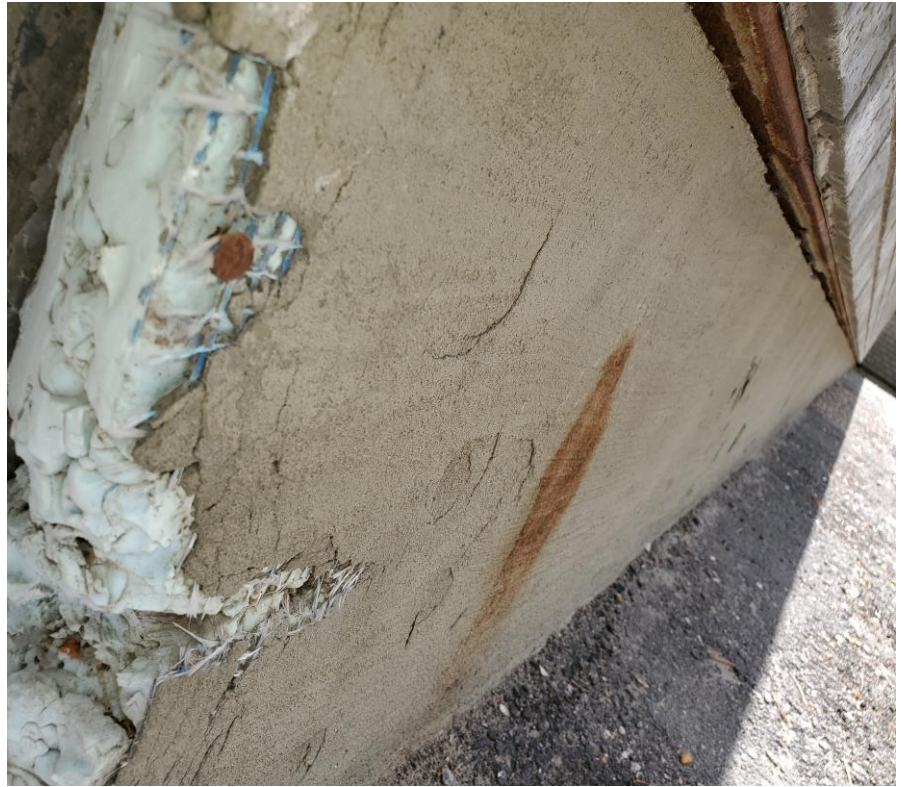
B67PRG13J - 003

Non-asbestos parging.

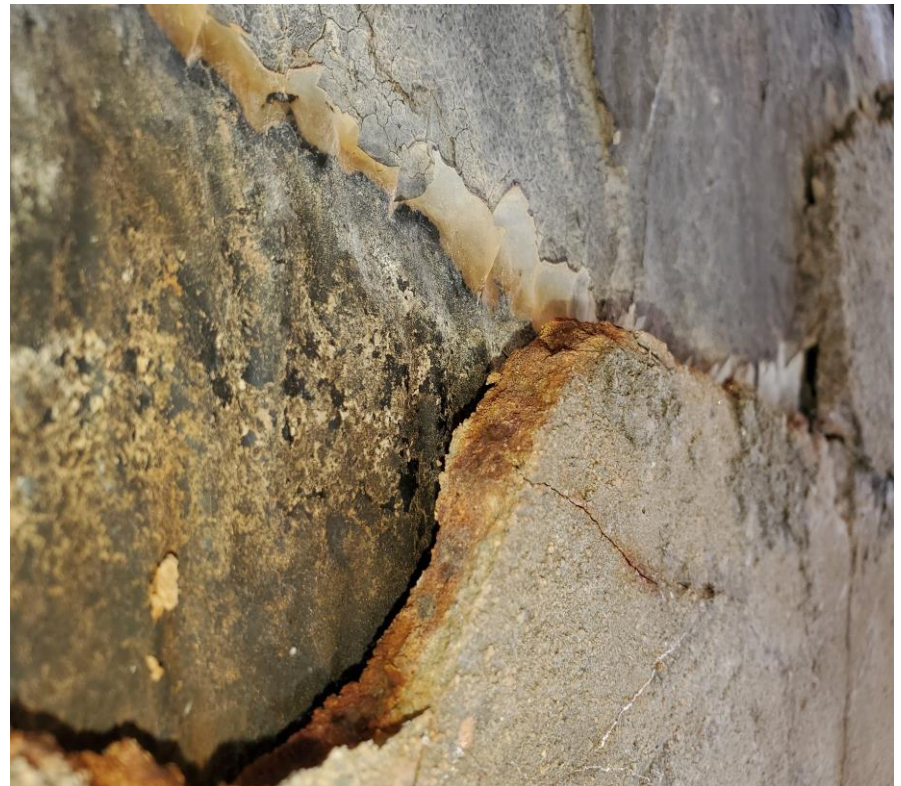
B67PRG13J - 004

Non-asbestos parging.

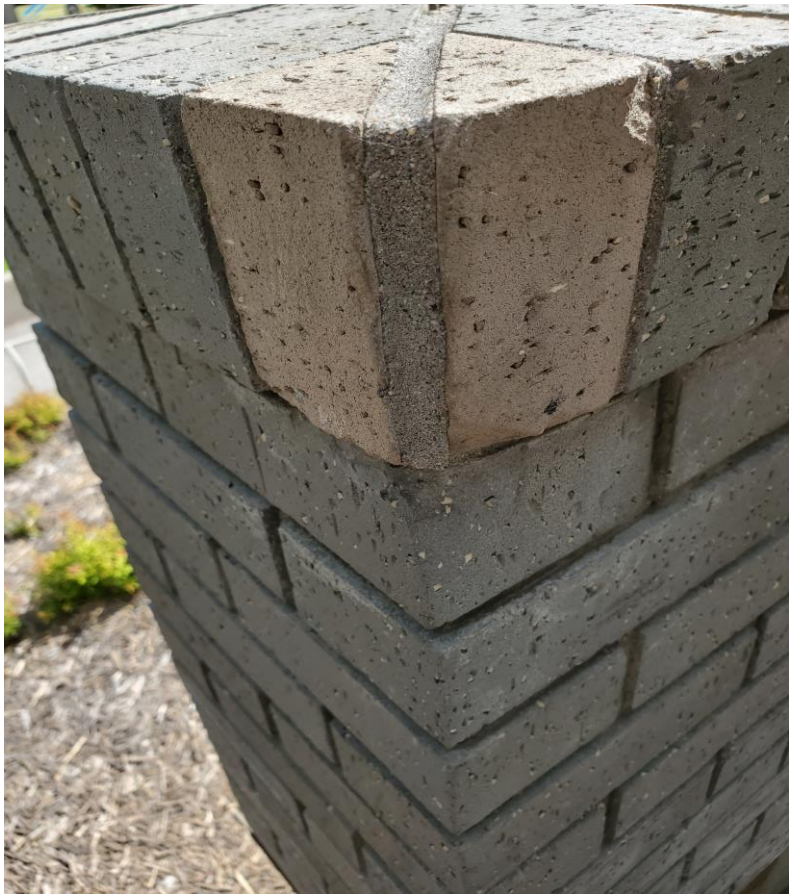
B67PRG13J – 005

Non-asbestos brick mortar.

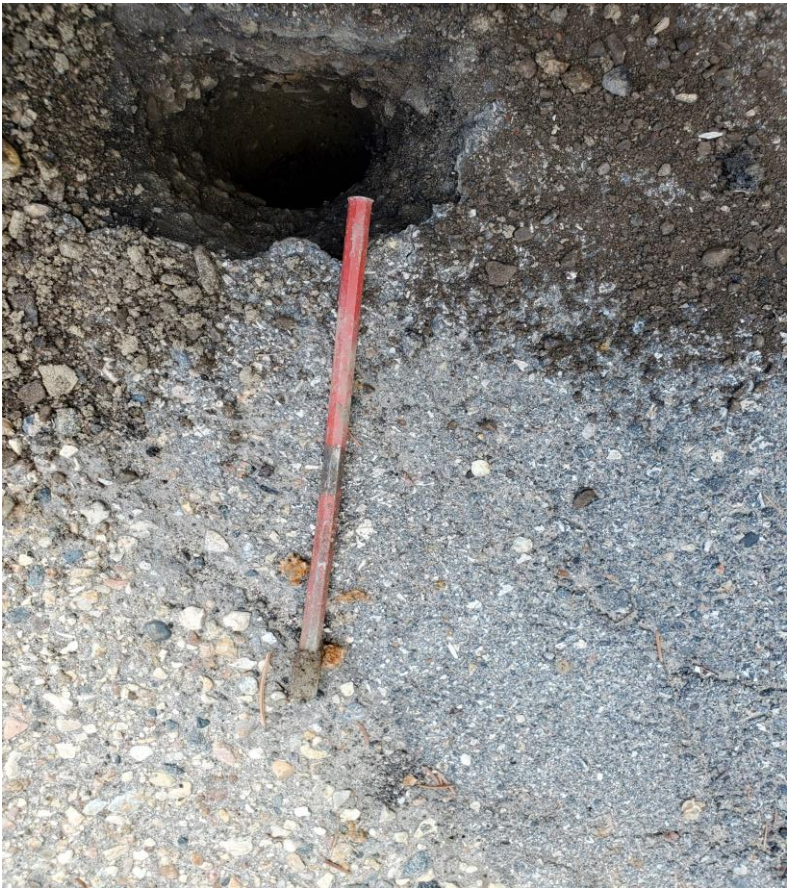
B67PRG13J – 006

Non-asbestos tar waterproofing.

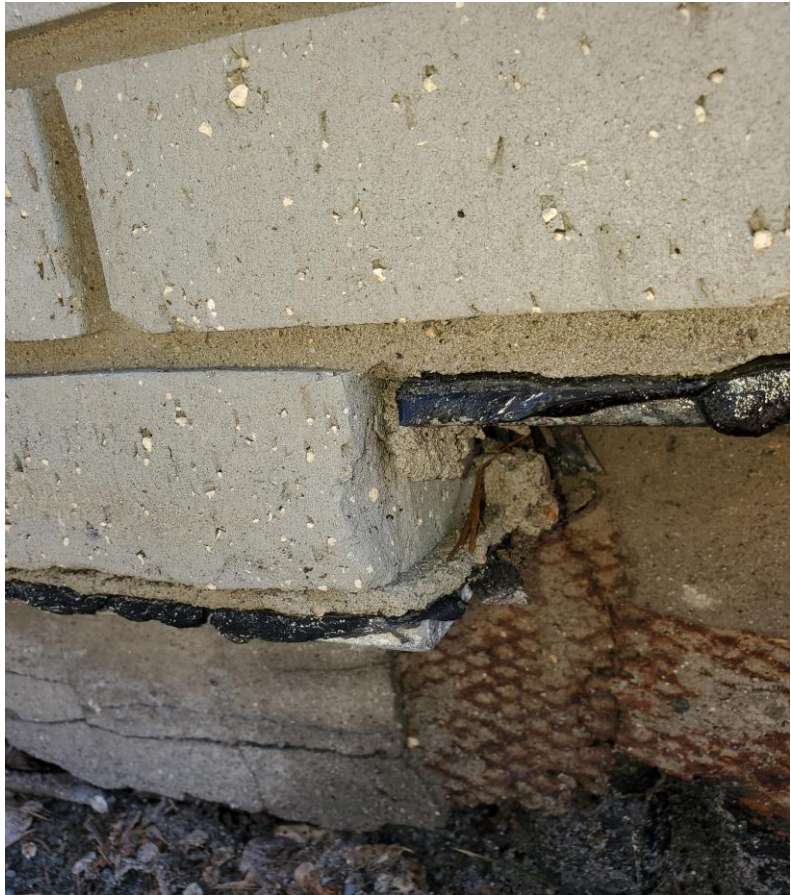
B67PRG13J – 007

Asbestos containing flashing membrane.

Based on the site investigation and bulk sample results there is asbestos concerns regarding the renovation of the Cosmo Civic Centre – South Ramp located at 3130 Laurier Drive, Saskatoon, Saskatchewan. As per the Occupational Health & Safety Regulations the tar layer, thru-wall flashing and waterproofing coating itemized above will require abatement.

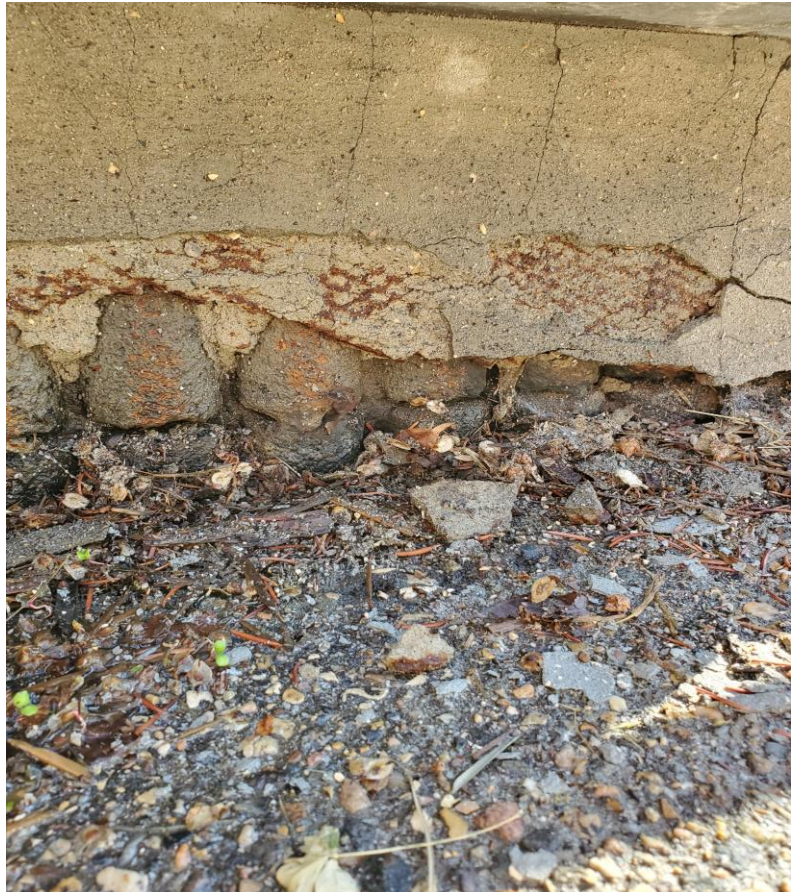
B67PRG13J – 008

Non-asbestos parging.

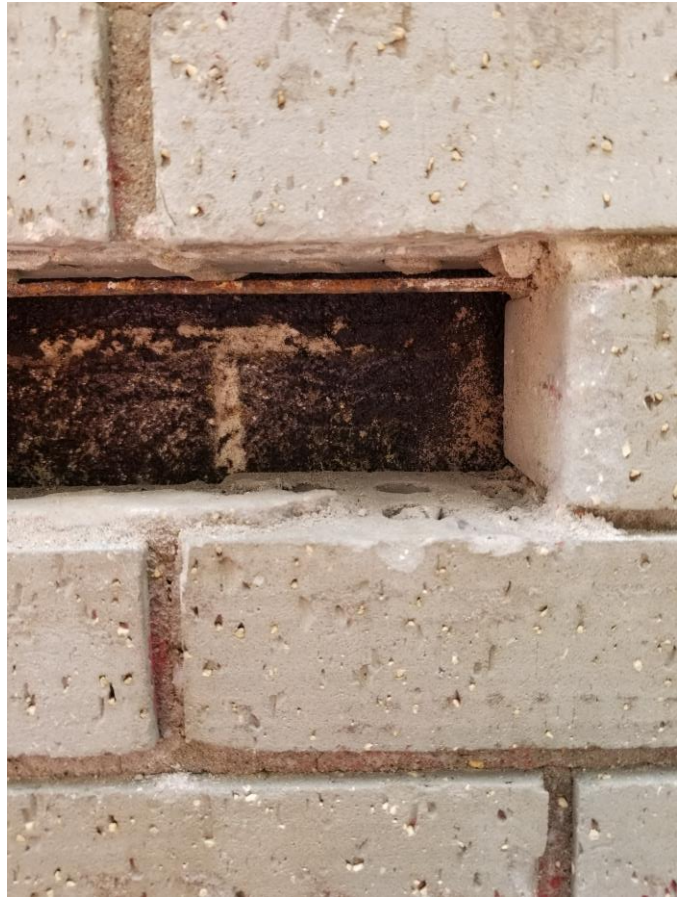
B67PRG13J – 009

Asbestos containing waterproofing.

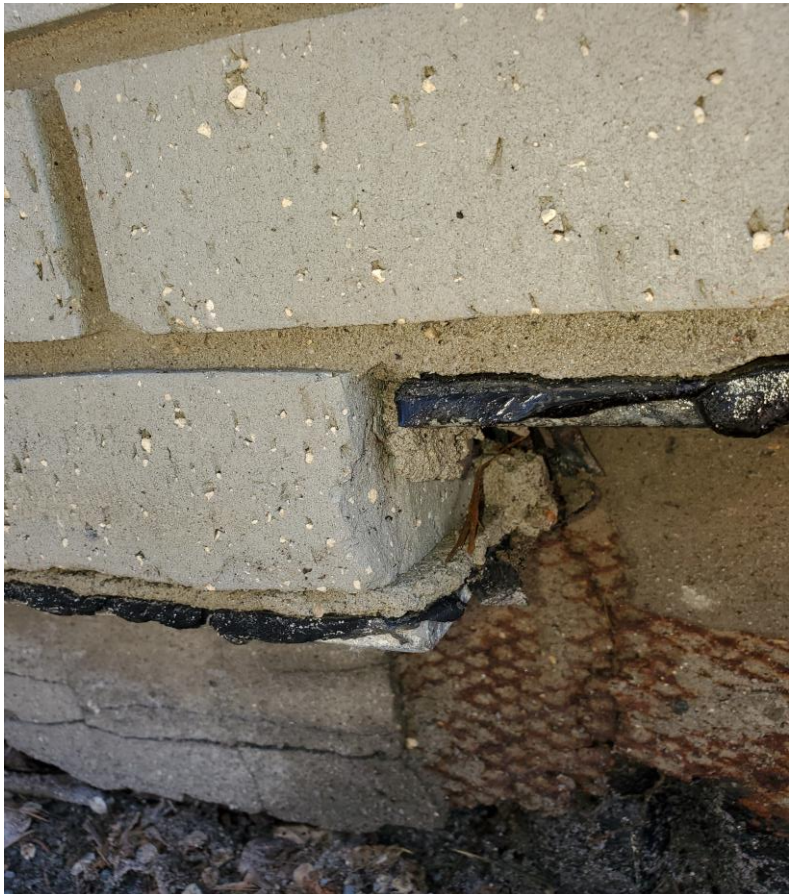
B67PRG13J – 010

Asbestos containing.

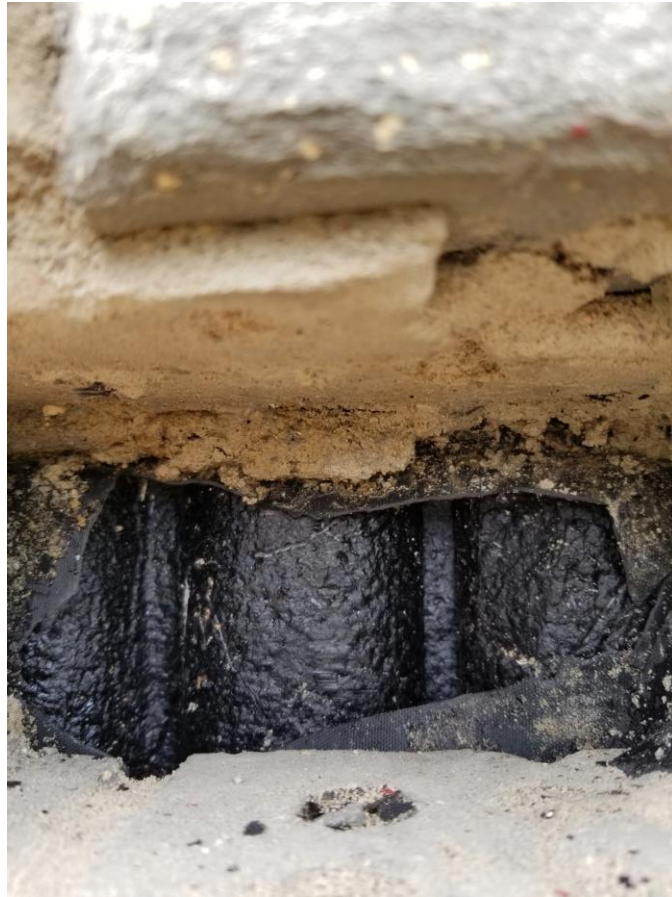
B67PRG13J – 011

Asbestos containing.

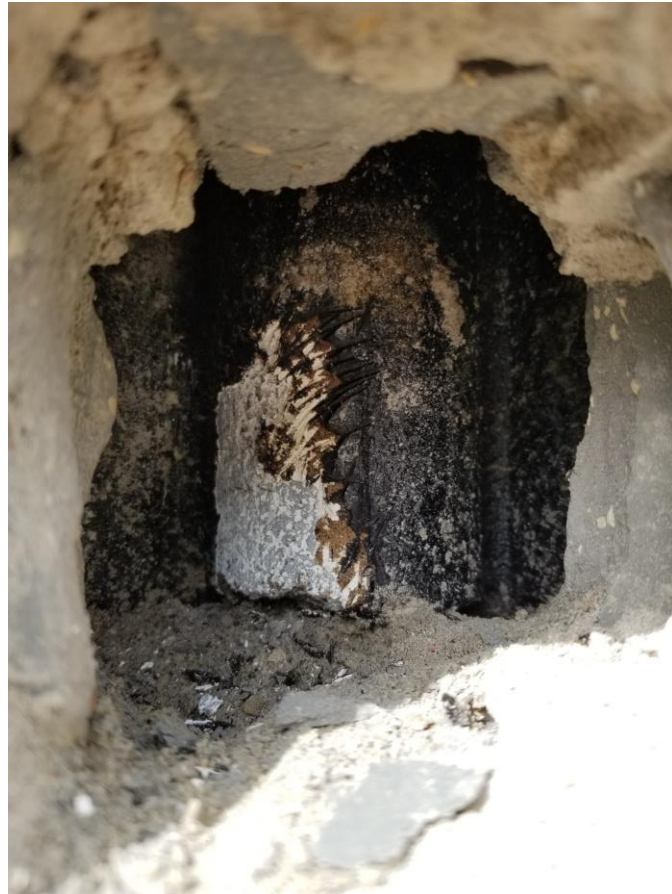
B67PRG13J – 012

Asbestos containing  
waterproofing.

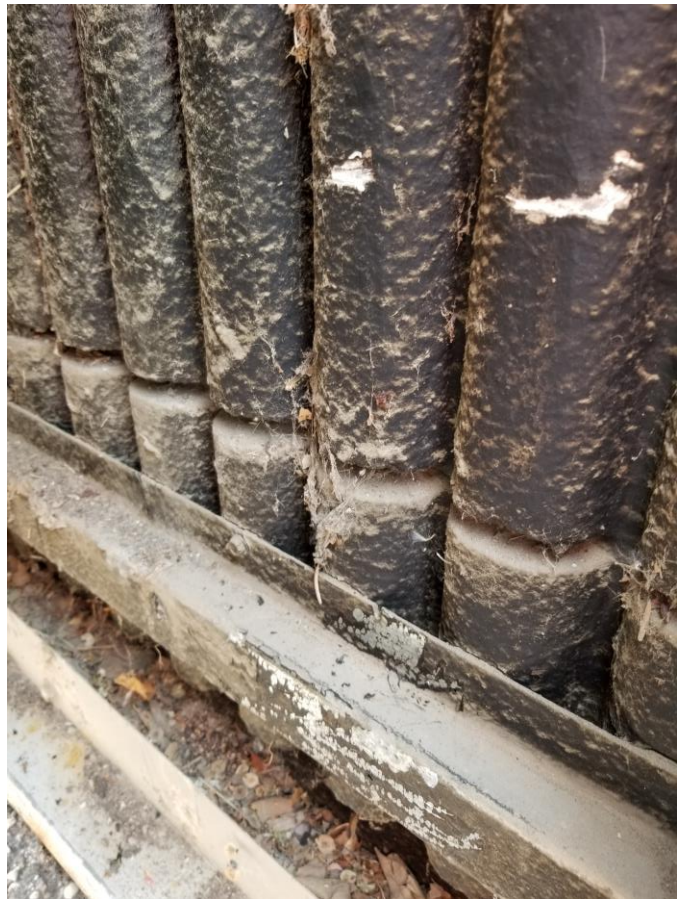
B67PRG13J – 013

Asbestos containing  
waterproofing.
