Pre- Renovation Assessment

December 18, 2018

File Number: B67PRL10H- Old Bunkhouse

Project: Forestry Farm – Old Bunkhouse – Investigation of Main Floor Living Room

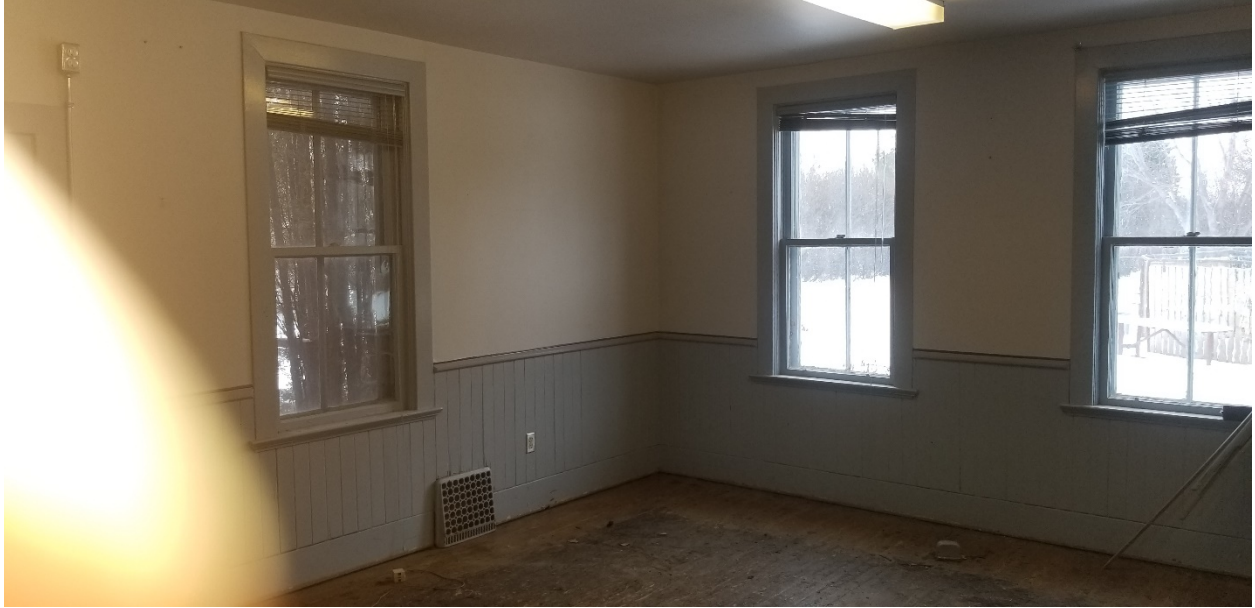
Photo 001- The main floor living room, investigated for the relocation of electrical sockets.

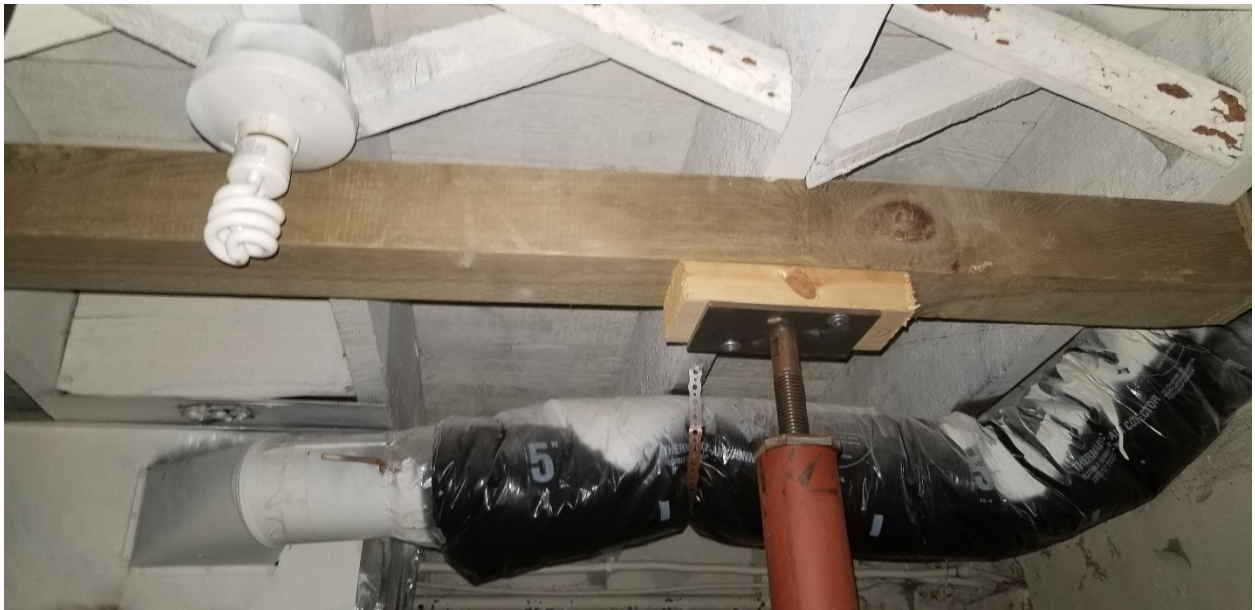
Photo 002- The basement below the main floor living room. No insulation or asbestos containing materials were identified within the truss spaces.

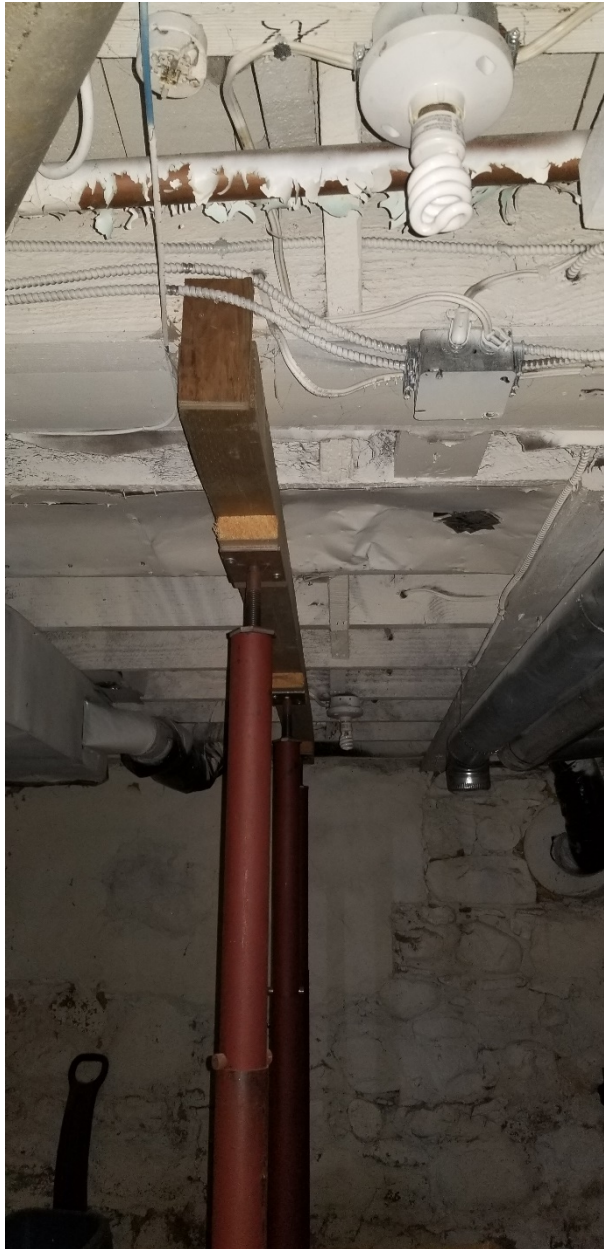
Photo 003- The basement below the main floor living room. No insulation or asbestos containing materials were identified within the truss spaces.

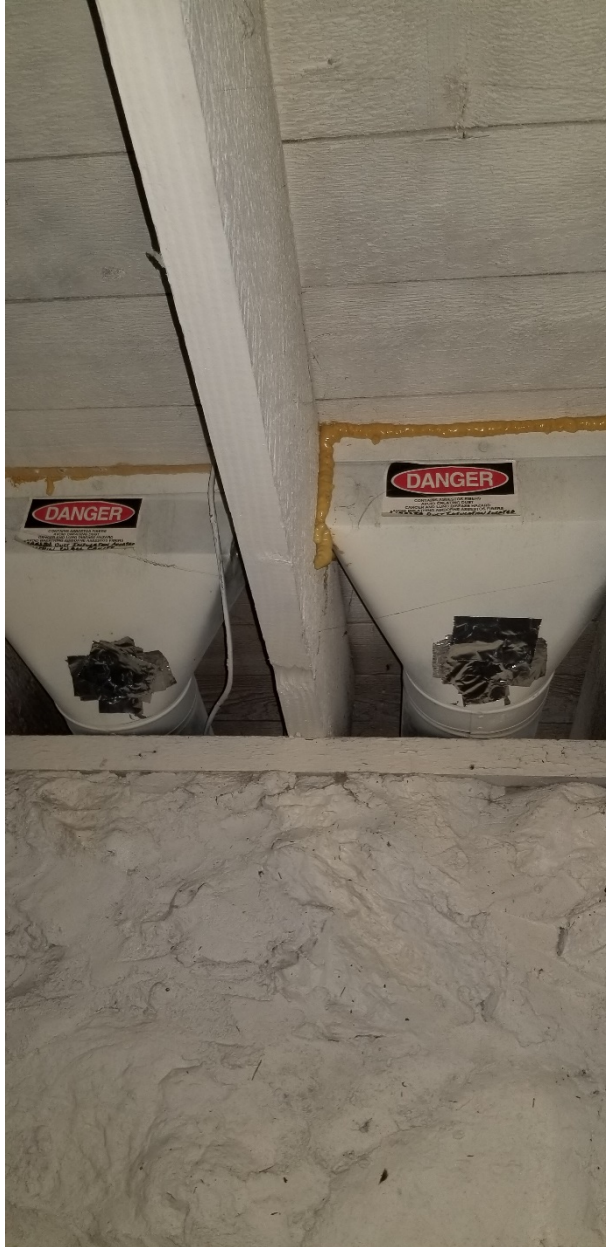
Photo 004- The basement below the main floor living room. Asbestos labels refer to asbestos duct wrap within the wall cavity above the floor.

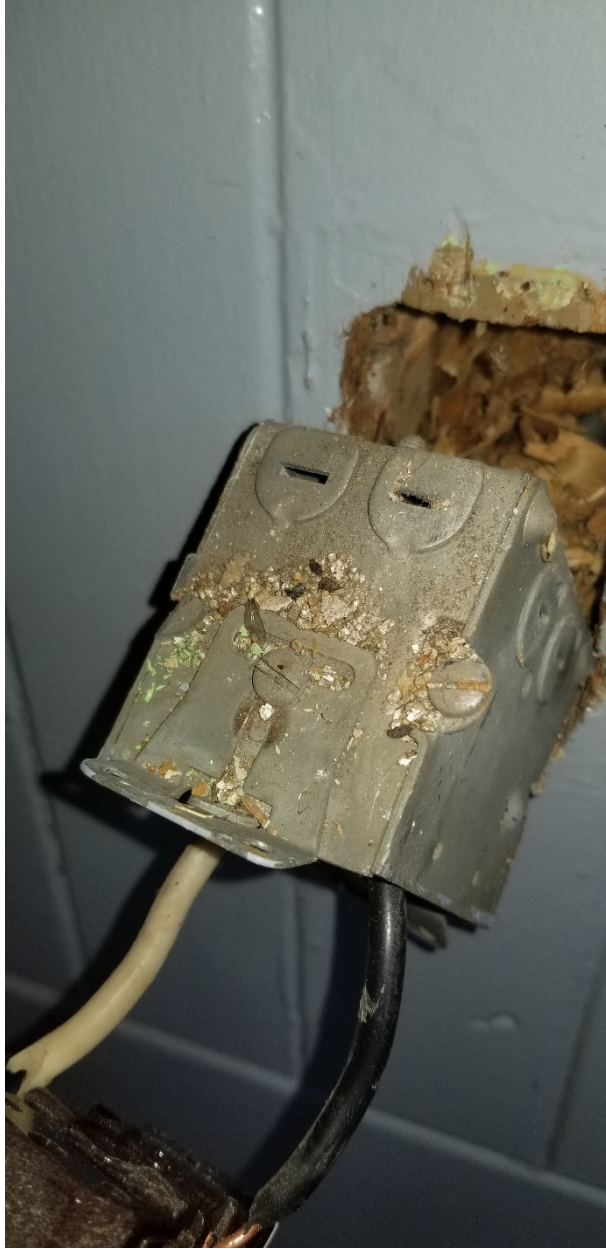
analyzed for the presence/absence of asbestos. Asbestos was not detected within the samples. In order to determine the contents of the ceiling space, one light fixture was removed. The ceiling space adjacent the electrical outlet was observed to be void and empty of any insulation. Please see **Appendix II** for site photos pertaining to this area. In order to investigate the wall insulation one electrical box was removed from the wall. The wall is largely insulated with wood (cellulose) shavings, however trace amounts of vermiculite were identified on the wall socket. Asbestos was not detected within the wall insulation however the potential does remain for asbestos-containing vermiculite to have contaminated the wall insulation in small amounts. Please see **Appendix II** for site photos pertaining to this area. This vermiculite likely originated in the attic and “settled” through penetrations in the walls and ceilings. Vermiculite in the walls of the old bunkhouse may be present in small amounts, unpredictably, throughout the building.

Photo 005- Trace amounts of vermiculite in wall insulation.

While performing work that involves drilling into walls or ceilings, behind which is a cavity, workers should be made aware of the possibility of vermiculite insulation and be equipped with the proper PPE, such as Niosh approved half-mask respirator.

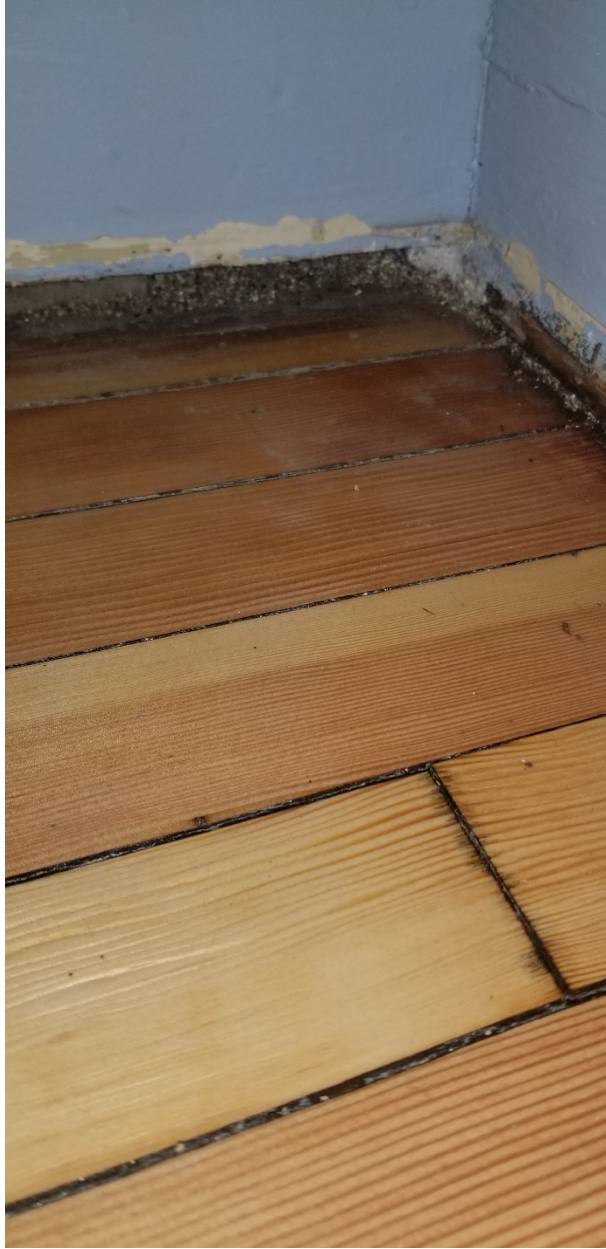
The second area of investigation was on the second floor, southeast bedroom. While the floor was being refinished, workers complained about a small amount of debris draining from a corner. The material was identified as vermiculite insulation and one sample was collected for analysis. Asbestos **was** detected within the sample. This vermiculite was present in an interior wall; like the vermiculite on the main floor this vermiculite is likely a result of attic insulation settling into wall cavities through penetrations. This insulation may be present sporadically and unpredictably throughout wall spaces and ceiling space.

Photo 006- Vermiculite draining from wall in upstairs bedroom.
