**CITY OF SASKATOON – FIRE ALARM BUILDING
ASBESTOS SURVEY REPORT**

MAY 2013

Prepared By: Bersch & Associates Ltd.
Project No. : B67SRE01FA

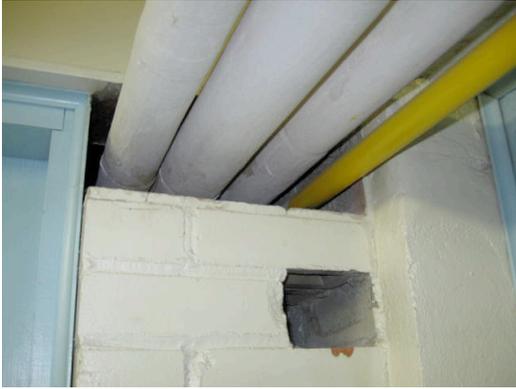
#1) Mortar at Pipe Penetration

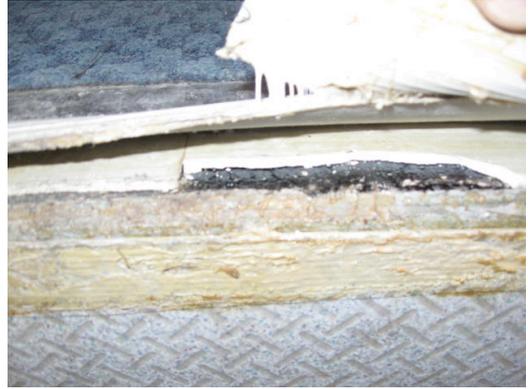
#2) 1' X 1' Floor Tile

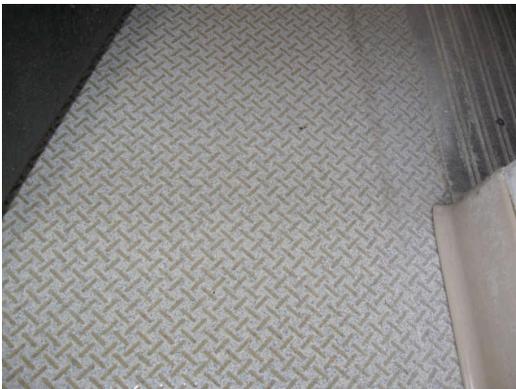
#3) Sheet Floor Covering

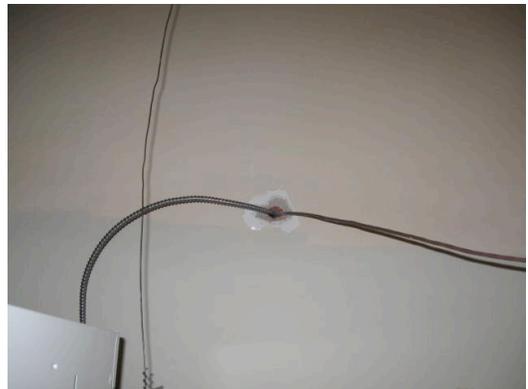
#4) Brick Mortar
