SUBJECT: Fire Hall #4 - Asbestos Registry Report

PROJECT NO. B67.13**CLIENT: City of Saskatoon****Infrastructure Services - Facilities Branch****Contact: Brent Anderson****Location: Fire Hall #4 - 2106 Faithful Avenue, Saskatoon, SK.**

BULK SAMPLE ANALYSIS REPORT

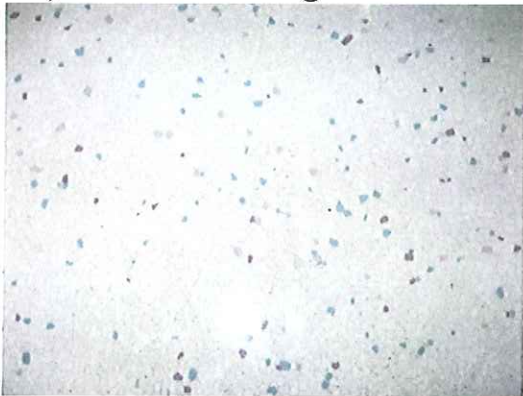
#3) Sheet Flooring

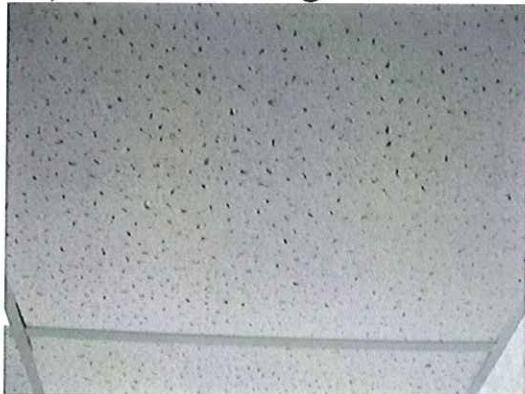
#5) 2' x 4' Ceiling Tile
