**SUBJECT: Fire Hall #6 - Asbestos Registry Report**

**BULK SAMPLE ANALYSIS REPORT**

**FINAL**  
**Limited Asbestos  
Building Materials  
Assessment**

Fire Hall #6 Cable Drop Project  
3309 Taylor Street East,  
Saskatoon, Saskatchewan

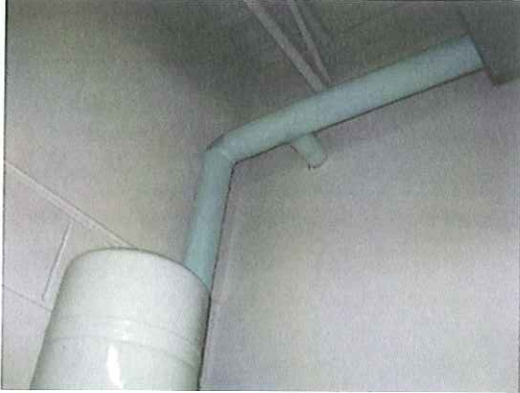
#1) Pipeline Fitting

NO.	DATE	SAMPLE INFORMATION	ASBESTOS	%	ANALYST
B1	6-May-13	114 - Pipeline fitting on small green line	None detected		WB
B2	6-May-13	121 - Pipeline fitting on small white line, overhead adjacent unit heater in the northeast corner	None detected		WB
B3	6-May-13	103 - Pipeline fitting above ceiling tile adjacent women's dorm entry	None detected		WB
B4	6-May-13	124 - Duct expansion gasket on ducting in upper deck	None detected		WB
B5	6-May-13	102 - Sheet flooring- tan, beige and blue stone pattern	None detected		WB
B6	6-May-13	112 - Sheet flooring- grey, white and black stone pattern	None detected		WB

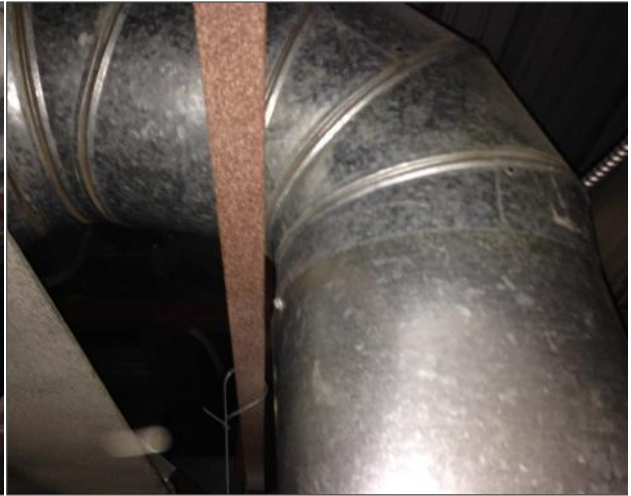
Photo 2: Un-insulated metal duct with no mastic above acoustic ceiling tiles in Men's Washroom (Location 105).

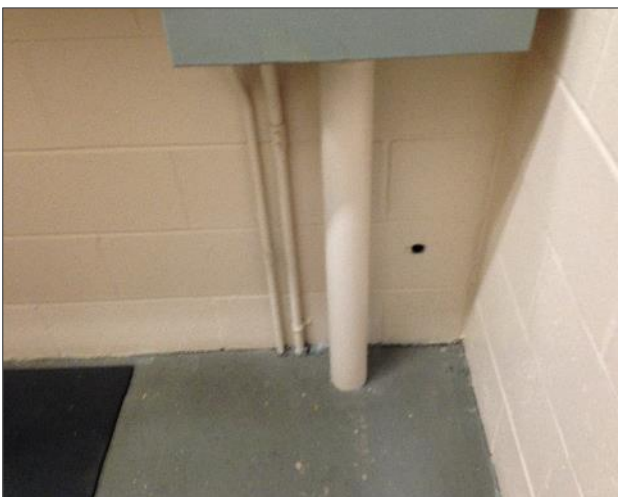
Destructive testing was conducted of masonry block walls. The masonry block wall, between the Study (Location 119) and the Compressor Room (Location 118), was penetrated in one location, loose fill vermiculite is not present. The location of destructive testing are indicated on the drawings in Appendix I.

Photo 3: Intrusive hole in concrete block wall that separates the Compressor Room (Location 118) and the Study Room (Location 119). No insulation was found.

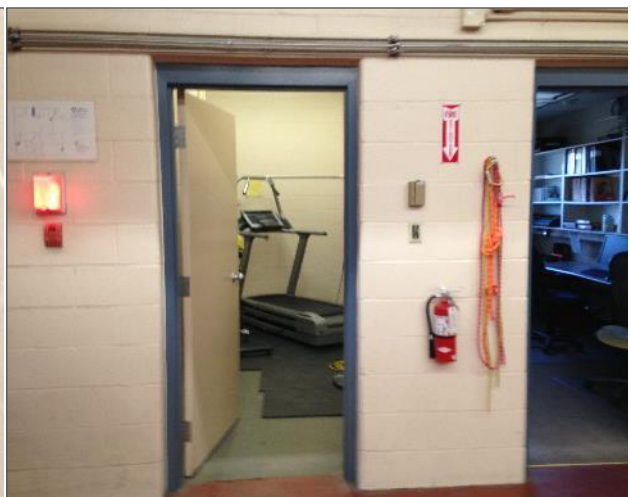
Photo 4: Compressor Room (Location 118) on left and the Study Room (Location 119) on the right.

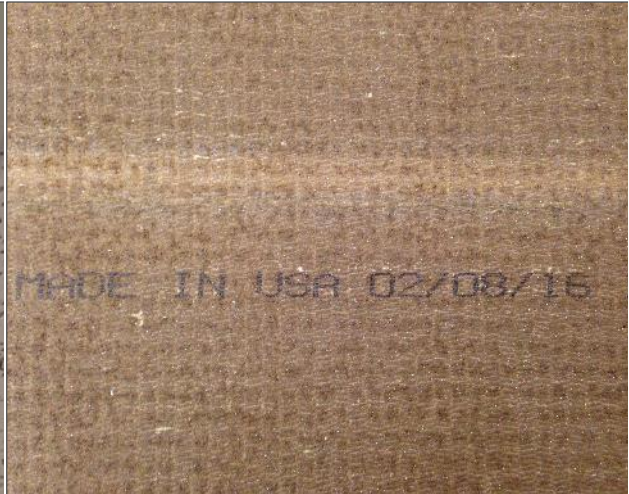
Photo 6: Acoustic Ceiling Tiles, 24"x48" Pinhole and Fissure (Non-asbestos containing Date Stamp 02/08/16), Men's Washroom (Location 105)
