December 7, 2017

CITY OF SASKATOON

# Asbestos-Containing Building Materials Assessment Report - Fire Station No. 7

**Report Number: 1667963**

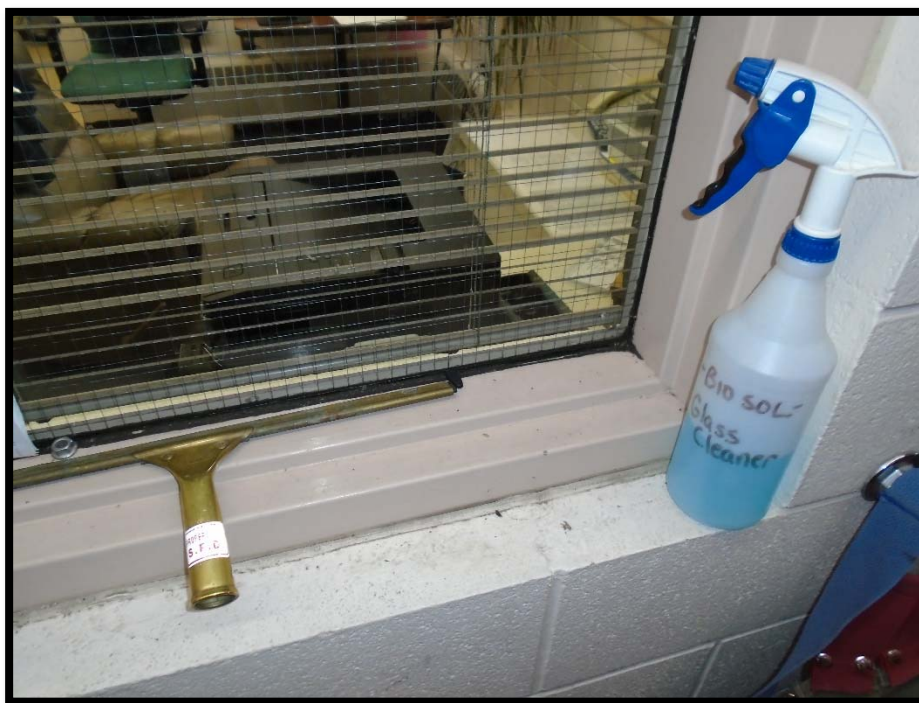
Two (2) samples of black window caulking were collected during the assessment. One of the samples collected was found to contain 3.8% Chrysotile asbestos. Asbestos-containing black window caulking (see Photograph 1 in Appendix B) was observed in the following location:

- Room 120 (approximately 10 linear feet).

**Photograph 1: Asbestos-Containing Black Window Caulking.**

If scheduled for impact, asbestos-containing black window caulking should be abated following low-risk abatement work procedures as outlined in the *Saskatchewan Asbestos Abatement Manual* (2017). Alternatively, as the black window caulking was observed in good condition, and with a priority rating of 5 (please see the room by room spreadsheet provided in Appendix C for a description of the priority ratings), it can be managed in place if not scheduled for impact.

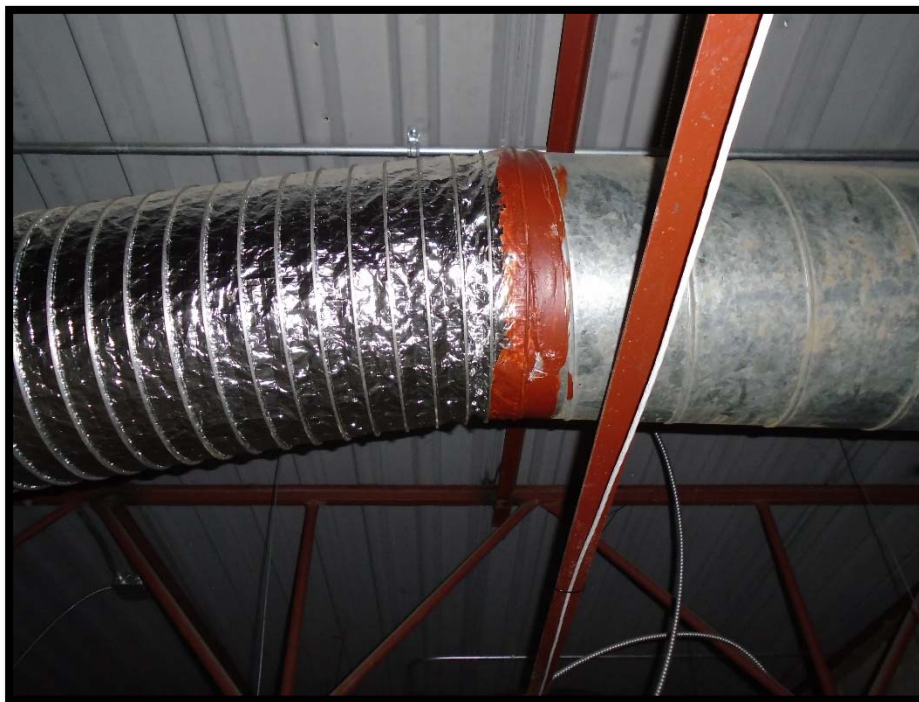
One (1) sample of red/brown duct mastic was collected during the assessment. The sample collected was found to contain 3.4% Chrysotile asbestos. Asbestos-containing red/brown duct mastic (see Photograph 2 in Appendix B) was observed in the following locations:

- Room 109 (approximately 15 linear feet);
- Room 110 (approximately 40 linear feet);
- Room 113 (approximately 5 linear feet);

- Room 114 (approximately 3 linear feet);
- Room 116 (approximately 5 linear feet);
- Room 117 (approximately 20 linear feet);
- Room 118 (approximately 5 linear feet);
- Room 119 (approximately 3 linear feet);
- Room 121 (approximately 3 linear feet);
- Room 122 (approximately 3 linear feet); and
- Room 123/124 (approximately 3 linear feet).

**Photograph 2: Asbestos-Containing Red/Brown Duct Mastic.**

If scheduled for impact, asbestos-containing red/brown duct mastic should be abated following low-risk abatement work procedures as outlined in the *Saskatchewan Asbestos Abatement Manual* (2017). Alternatively, as the red/brown duct mastic was observed in good condition, and with a priority rating of 5 (please see the room by room spreadsheet provided in Appendix C for a description of the priority ratings), it can be managed in place if not scheduled for impact.
