**CITY OF SASKATOON – FIRE MAINTENANCE BUILDING  
ASBESTOS SURVEY REPORT**

**MAY 2013**

**Prepared By: Bersch & Associates Ltd.**  
**Project No. : B67SRE01FM**

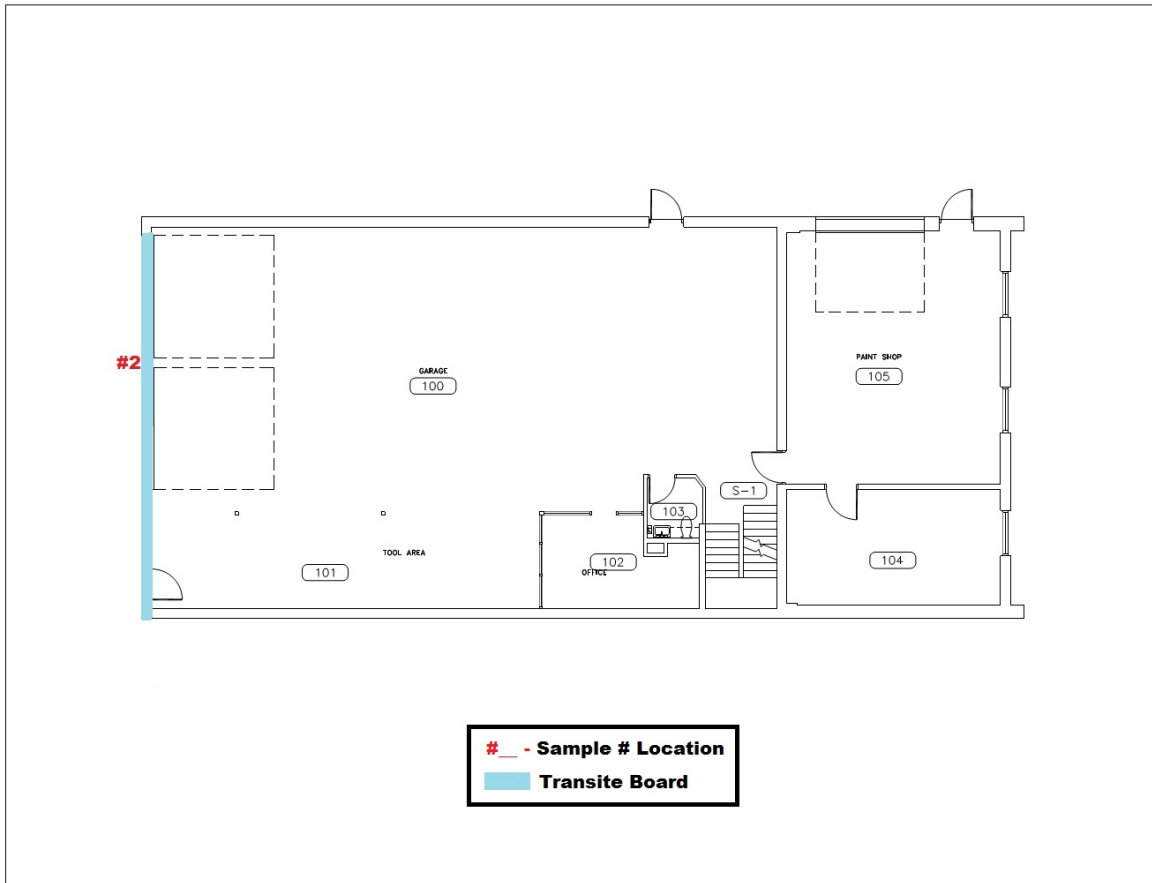
Main Floor  
Base Plan

- Asbestos containing **transite board** has been identified as ACM on the exterior west side of the building. This material has been identified on the floor plans in appendix II.
- **Any material located within ceilings, wall cavities, pipe chases or other inaccessible areas or areas of limited access shall be considered asbestos-containing until testing of the material can determine the presence or absence of asbestos.**

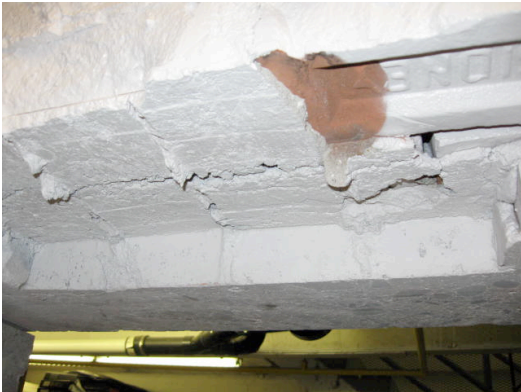
#1) Brick Mortar

NO.	DATE	SAMPLE INFORMATION	ASBESTOS	%	ANALYST
B1	1-May-13	Room B02 - Brick mortar above the doorway cutout to the west of the stairwell	None detected		WB
B2	1-May-13	Building Exterior - Black transite board on the exterior west wall surrounding the overhead doors	Chrysotile	30	WB

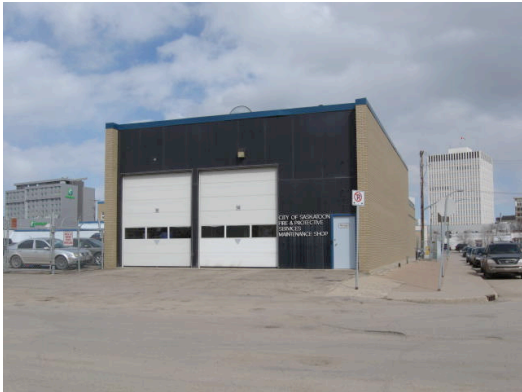
#2) Transite Board

**Transite asbestos board** was identified as containing asbestos. This material was observed to be in good condition with a low potential for disturbance. The material is the black board surrounding the overhead doors on the exterior wall surface. The material may be managed.

<b>PRIORITY:</b>	<b>THREE</b>
<b>CONDITION:</b>	<b>GOOD</b>
<b>POTENTIAL FOR DISTURBANCE:</b>	<b>LOW</b>
<b>ACTION:</b>	<b>MANAGE</b>

For the specifics of this report Management of the asbestos containing materials is the recommended planned activity. In the event of renovations or maintenance to areas containing asbestos materials, written procedures must be developed to conduct the activity or prior removal if the situation warrants.
