SUBJECT: Gordon Howe Campground - Asbestos Registry Report

Location: Gordon Howe Campground - 1640 Avenue P South, Saskatoon, SK.

BULK SAMPLE ANALYSIS REPORT

SUBJECT: Bulk Sample Analysis Report – Gordon Howe Campground – Living Quarters

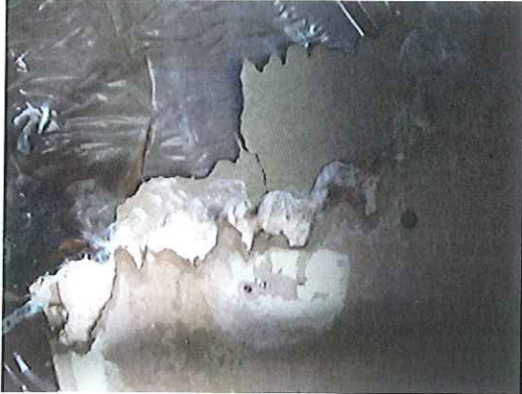
#1) Ceiling Drywall

NO.	DATE	SAMPLE INFORMATION	ASBESTOS	%	ANALYST
B1	15-May-13	119 Furnace Room - Ceiling drywall & insulation	None detected		WB
B2	15-May-13	114 Mechanical - 1' x 1' floor tile	None detected		WB
B3	15-May-13	107 Washroom - Sheet flooring, sandstone	None detected		WB
