**Harry Bailey Aquatic Centre
Asbestos Survey Report**

July 2015

Prepared For: City of Saskatoon Infrastructure Services - Facilities Branch
3130 Laurier Drive, Saskatoon, SK.
Attn: Brent Anderson

Prepared By: Bersch & Associates Ltd.
Project No. : B67SRG10

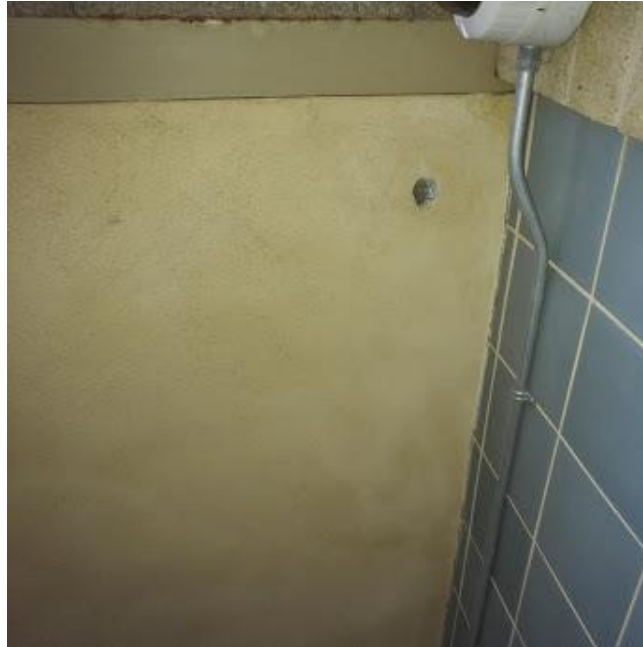
Photo 1: Underside of Main Entrance Overhang Plaster

Sample Number	Sample Date	Sample Material	Sample Location and Information	Asbestos	%	Analyst
1	2018-06-17	Beige Skim Coat	Main Entrance – Plaster on the Underside of the Overhang	No Asbestos Detected		EMSL
2	2018-06-17	Grey Base Coat	Main Entrance – Plaster on the Underside of the Overhang	No Asbestos Detected		EMSL
3	2018-06-17	Exterior Brick Mortar	Composition Sample of the Grey Mortar on the East Wall Adjacent the Main Entrance & the Wall Adjacent the North Ambulance Entry	No Asbestos Detected		EMSL
4	2018-06-17	Exterior Brick	Composition Sample of the Brick on the East Wall Adjacent the Main Entrance & the Wall Adjacent the North Ambulance Entry	No Asbestos Detected		EMSL
