**Holiday Park Golf Course  
1630 Avenue U South, Saskatoon, SK.**

**Asbestos Survey Report  
January 2014**

**Prepared For: City Of Saskatoon- Infrastructure Services Department**  
1101 Avenue P North, Saskatoon, SK.  
Attn: Brent Anderson

**Prepared By: Bersch & Associates Ltd.**  
**Project No. : B67SRA28**

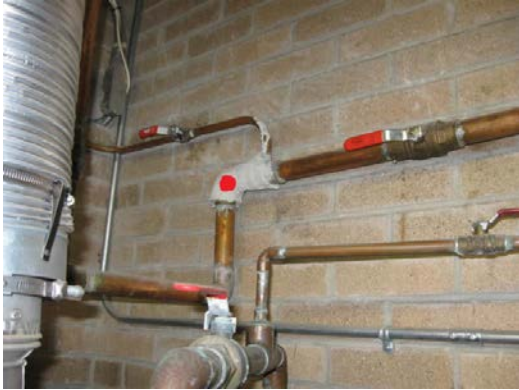
#1) Pipeline Fitting

- **Pipeline Fitting Compound** is located within the utility room 118.
- **Asbestos Floor Tile** is located in kitchen storage 123 within the facility.
- **Vermiculite Insulation** is located in the corridor 102 within the facility.

<b>NO.</b>	<b>DATE</b>	<b>SAMPLE INFORMATION</b>	<b>ASBESTOS</b>	<b>%</b>	<b>ANALYST</b>
1	16-May-13	119 - Pipeline fitting above hot water heater	Chrysotile	60	WB
2	16-May-13	102 Corridor - Vermiculite insulation found on top of suspended ceiling tiles adjacent 108	Actinolite/ Tremolite	> 0.1	WB
3	16-May-13	107 - 1' x 1' floor tile, white with brown streak	None detected		WB
4	28-Jan-14	B02- Rubber-like black flooring	None detected		WB
5	28-Jan-14	117- Rudder- like 2' x 2' brownish flooring	None detected		WB
6	28-Jan-14	118- Sheet flooring grey with white and black stones	None detected		WB

- All accessible asbestos-containing pipeline fittings have been identified with a red dot of spray paint. **All pipefitting mud compound located within enclosed or inaccessible areas shall assume to be asbestos containing until laboratory analysis proves otherwise.**
- Asbestos Floor Tile is identified on the Floor Plans in Appendix III of this report.
- Vermiculite Insulation is identified on the spreadsheet in Appendix II of this report.

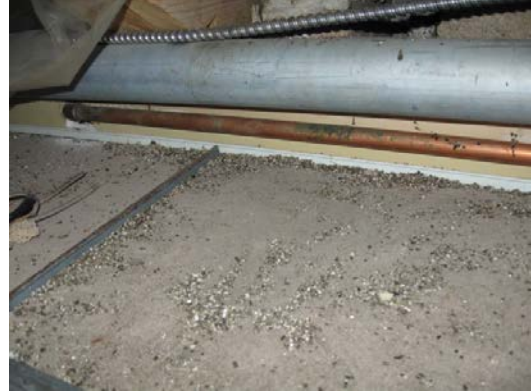
#2) Vermiculite Insulation

Throughout the survey of the Holiday Park Golf Course the Asbestos Containing Materials were assessed and given a Priority Rating of One, Two or Three, with Priority One being the items requiring the most immediate attention. As a result, “Priority One” items were identified in the form of vermiculite insulation on the ceiling tile within corridor 102. Priority Ratings for all ACM identified is found in the database on a room-by-room account.

SAMPLE DATA													
Floor	Room Number	Use	SAMPLE SAMPLE REP	Sample ID	Date DD/MM/YY	Asbestos Type	% of Asbestos	Tradename ACM Product	Condition	Priority	Description of Sample Location	Asbestos Content In Area	Potential for Disturbance	Recommended Action	Comments	
B	01	Cart Storage Area										No Accessible ACM				
B	02	Driving Range Storage	Sample	B67-ASB.4	28-Jan-14	None		Flooring			B02- Rubber-like black flooring	No Accessible ACM				
B	03	Rental Clubs and Cart Storage										No Accessible ACM				
B	04	Pro Shop Stock Room										No Accessible ACM				
B	05	Washroom										No Accessible ACM				
B	06	Storage										No Accessible ACM				
B	07	Furnace Room										No Accessible ACM				
M	101	Corridor										No Accessible ACM				
M	102	Corridor	Sample	B67-ASB.2	16-May-13	Actinolite/ Tremolite	>0.1	Vermiculite	Poor	1	102 Corridor - Vermiculite insulation found on top of suspended ceiling tiles adjacent 108	Vermiculite	Low/Mod	Cleanup/Manage	Clean up vermiculite laying on ceiling tile adjacent 108.

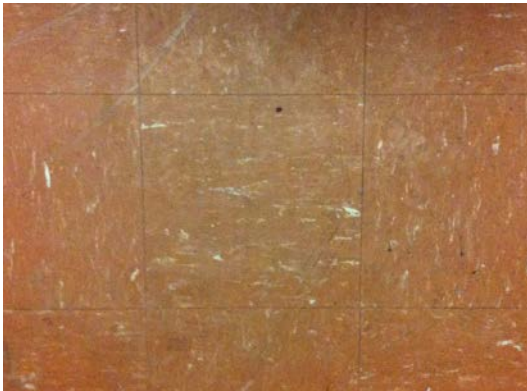
#3) Floor Tile

NO.	DATE	SAMPLE INFORMATION	ASBESTOS	%	ANALYST
7	28-Jan-14	123- 1' x 1' floor tile orange with white streak	None detected		WB
8	28-Jan-14	116- Sheet flooring tiny irregular blue stone pattern	None detected		WB
9	28-Jan-14	104- 1' x 1' 3- toned grey floor tile	Chrysotile	1 to 5	WB
10	28-Jan-14	102 Corridor- 2' x 4' ceiling tile	None detected		WB

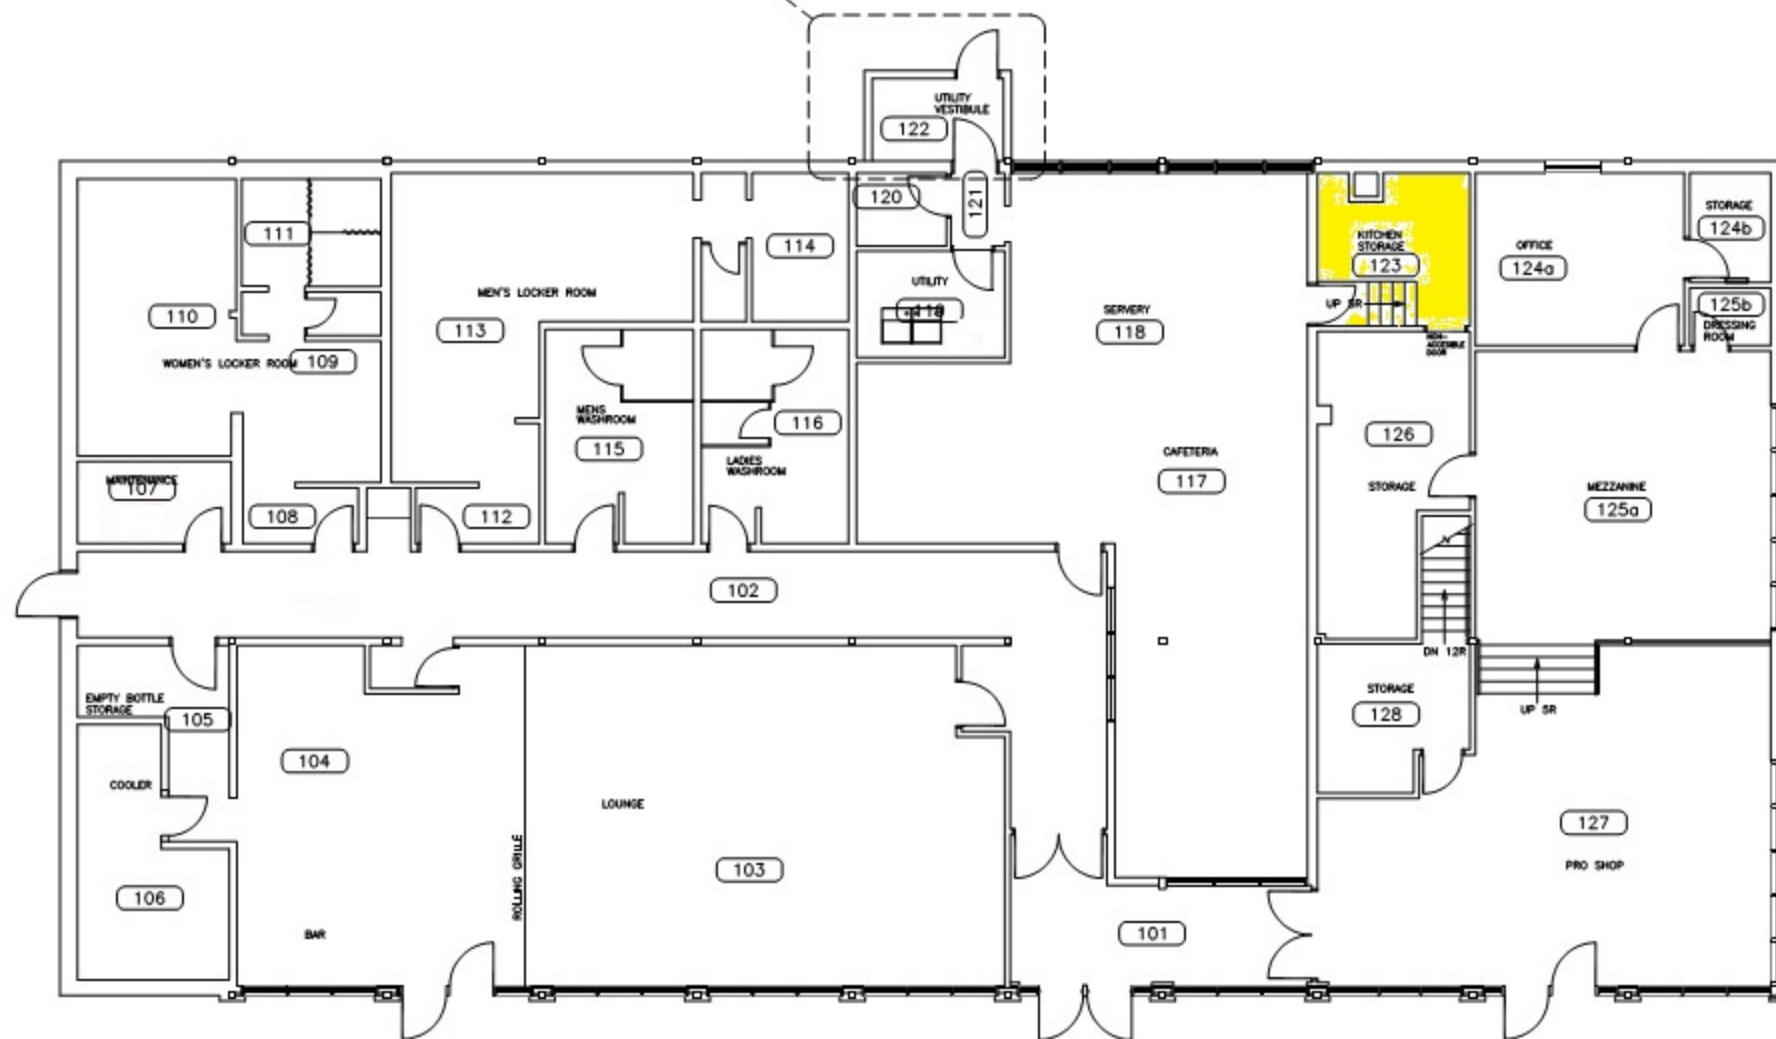
Main Floor  
Base Plan

**ASBESTOS FLOOR TILE**

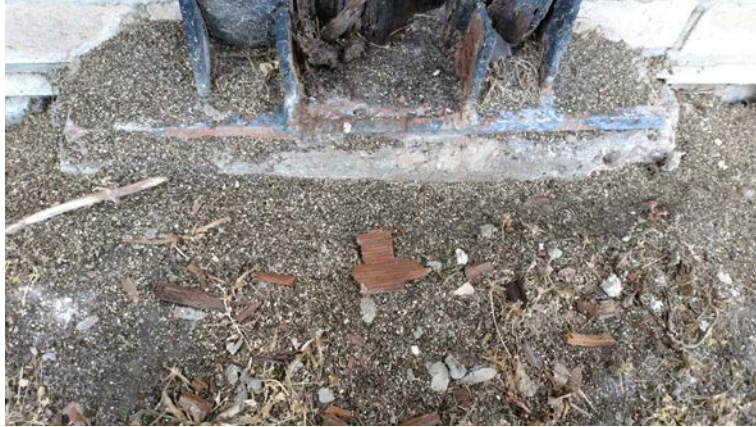
**PHOTO 1 – Exterior Brick Wall**

Exterior Walls "Red brick exterior walls suspected of containing asbestos vermiculite."

Asbestos containing vermiculite insulation was identified in the 2014 Survey, behind the white brick wall and the exterior walls. As a result of the previous bulk sampling and site investigation, there is an asbestos concern that would reflect on the proposed renovations for the area. Hub City Contracting will perform the necessary work to facilitate the project. They will be coring the holes required for the pipe installation into the walls.

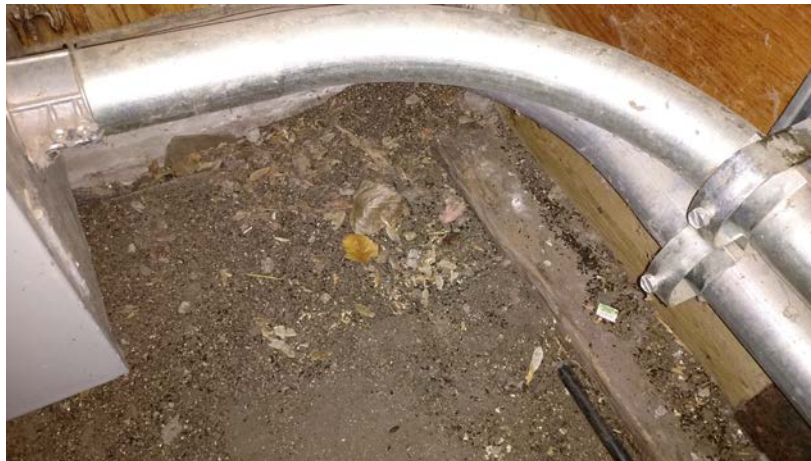
**PHOTO 2 – 122 Utility Vestibule**

Room 122 Utility Vestibule "Red brick exterior wall suspected of containing asbestos vermiculite."
