December 7, 2017

CITY OF SASKATOON

Asbestos-Containing Building Materials Assessment Report - Inventory and Disposal Services Building

Report Number: 1667963

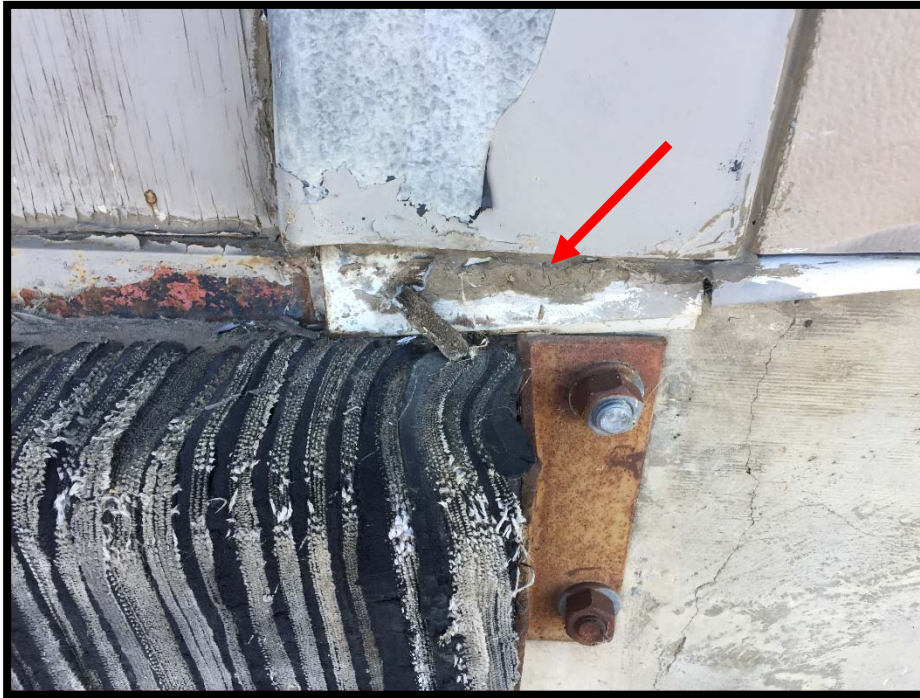
Grey Overhead Door Caulking

One (1) sample of grey overhead door caulking was collected during the assessment. The sample collected was found to contain 2.8% Chrysotile asbestos. Asbestos-containing grey overhead door caulking (see Photograph 1 in Appendix B) was observed in the following location:

- Exterior (approximately 200 linear feet).

Photograph 1: Asbestos-Containing Grey Overhead Door Caulking.

Grey Overhead Door Caulking

If scheduled for impact, asbestos-containing grey overhead door caulking should be abated following low-risk abatement work procedures as outlined in the *Saskatchewan Asbestos Abatement Manual (2017)*. Alternatively, as the grey overhead door caulking was observed in good condition, and with a priority rating of 5 (please see the room by room spreadsheet provided in Appendix C for a description of the priority ratings), it can be managed in place if not scheduled for impact.

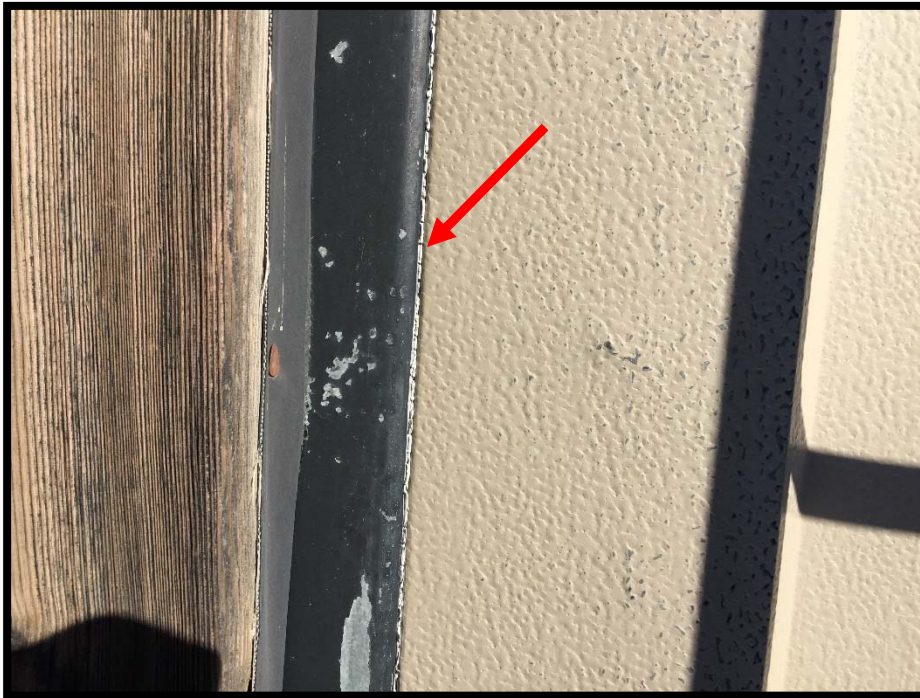
White Overhead Door Caulking

Two (2) samples of white overhead door caulking were collected during the assessment. One of the samples collected was found to contain 4.1% Chrysotile asbestos. Asbestos-containing white overhead door caulking (see Photograph 2 in Appendix B) was observed in the following location:

- Exterior (approximately 400 linear feet).

Photograph 2: Asbestos-Containing White Overhead Door Caulking.

White Overhead Door Caulking

If scheduled for impact, asbestos-containing white overhead door caulking should be abated following low-risk abatement work procedures as outlined in the *Saskatchewan Asbestos Abatement Manual (2017)*. Alternatively, as the white overhead door caulking was observed in good condition, and with a priority rating of 5 (please see the room by room spreadsheet provided in Appendix C for a description of the priority ratings), it can be managed in place if not scheduled for impact.

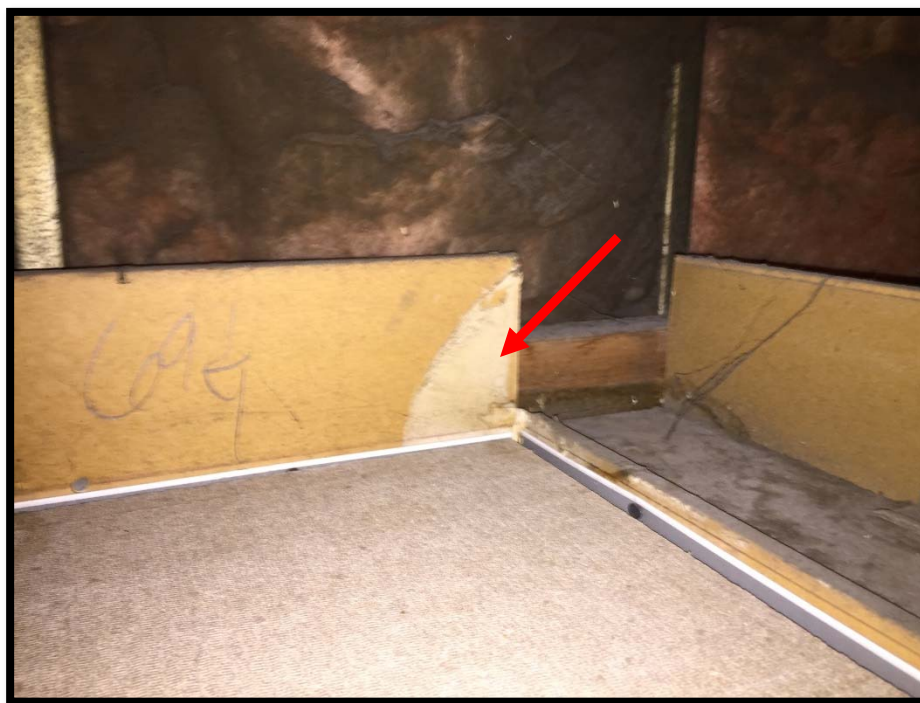
Drywall Joint Compound

Five (5) samples of drywall joint compound were collected during the assessment. One of the samples collected was found to contain 3.1% Chrysotile asbestos. Asbestos-containing drywall joint compound (see Photograph 3 in Appendix B) was observed in the following locations:

- Room 100 (approximately 325 ft²);
- Room 100.1 (approximately 160 ft²);
- Room 100.2 (approximately 400 ft²);
- Room 100.3 (approximately 400 ft²);
- Room 101 (approximately 250 ft²);
- Room 102 (approximately 425 ft²);
- Room 103 (approximately 200 ft²);
- Room 104 (approximately 500 ft²);
- Room 105 (approximately 500 ft²);
- Room 106 (approximately 550 ft²); and
- Room 107 (approximately 500 ft²).

Based upon the representative sampling guidelines outlined within the *Saskatchewan Asbestos Abatement Manual* (2017), all drywall joint compound throughout the Site should be treated as asbestos-containing. During our assessment, there were two types of drywall joint compound observed, a white and a tan. The tan drywall joint compound was the sample found to contain asbestos, and it is suspected that this is original drywall joint compound that was not impacted by renovation activities within the office area. This tan drywall joint compound is suspected to be located along the exterior walls of the offices. Based upon the information provided by the Site Representative, no known renovations took place within the facility therefore this could not be confirmed. Additionally, the drywall joint compound within the majority of the office area was painted, and therefore, a colour could not be observed.

Photograph 3: Asbestos-Containing Drywall Joint Compound.

Drywall Joint Compound

If scheduled for impact, asbestos-containing drywall joint compound should be abated following low-risk abatement work procedures as outlined in the *Saskatchewan Asbestos Abatement Manual (2017)*. Alternatively, as the drywall joint compound was observed in good condition, and with a priority rating of 5 (please see the room by room spreadsheet provided in Appendix C for a description of the priority ratings), it can be managed in place if not scheduled for impact.
