**J.S. Wood Library  
Asbestos Survey Report**

**December 2014**

**Prepared For: City Of Saskatoon- Infrastructure Services Department**  
1101 Avenue P North, Saskatoon, SK.  
Attn: Brent Anderson

**Prepared By: Bersch & Associates Ltd.**  
**Project No. : B67SRL04**

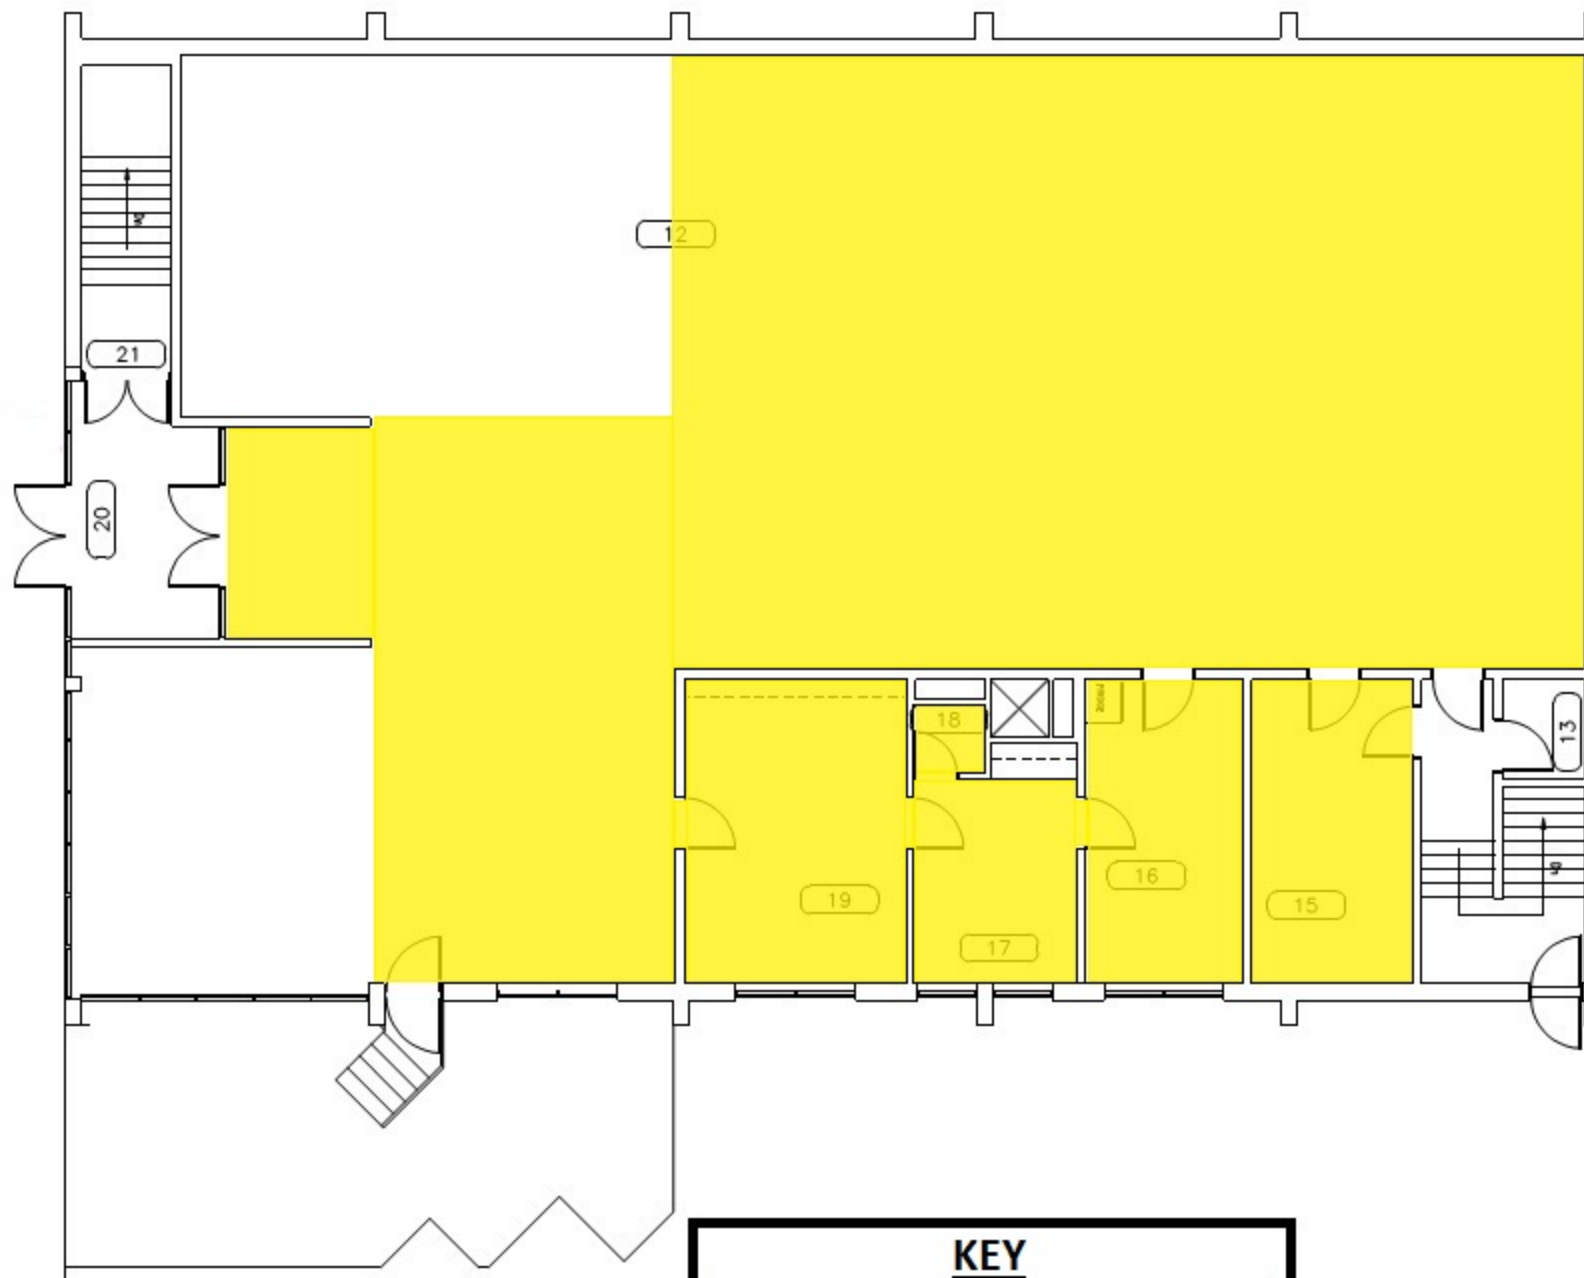
**Main Floor  
Base Plan**

- **Vinyl Asbestos Floor Tile** is located on the Main Floor Library and Offices. The Asbestos Floor Tile is identified on the **Floor Plans** in **Appendix III** of this report.

Vinyl Asbestos Floor Tile
