## John Deere Building Saskatoon, SK.

## Asbestos Survey Report February 2015

**Prepared By:** Bersch & Associates Ltd.  
**Project No. :** B67SRB05

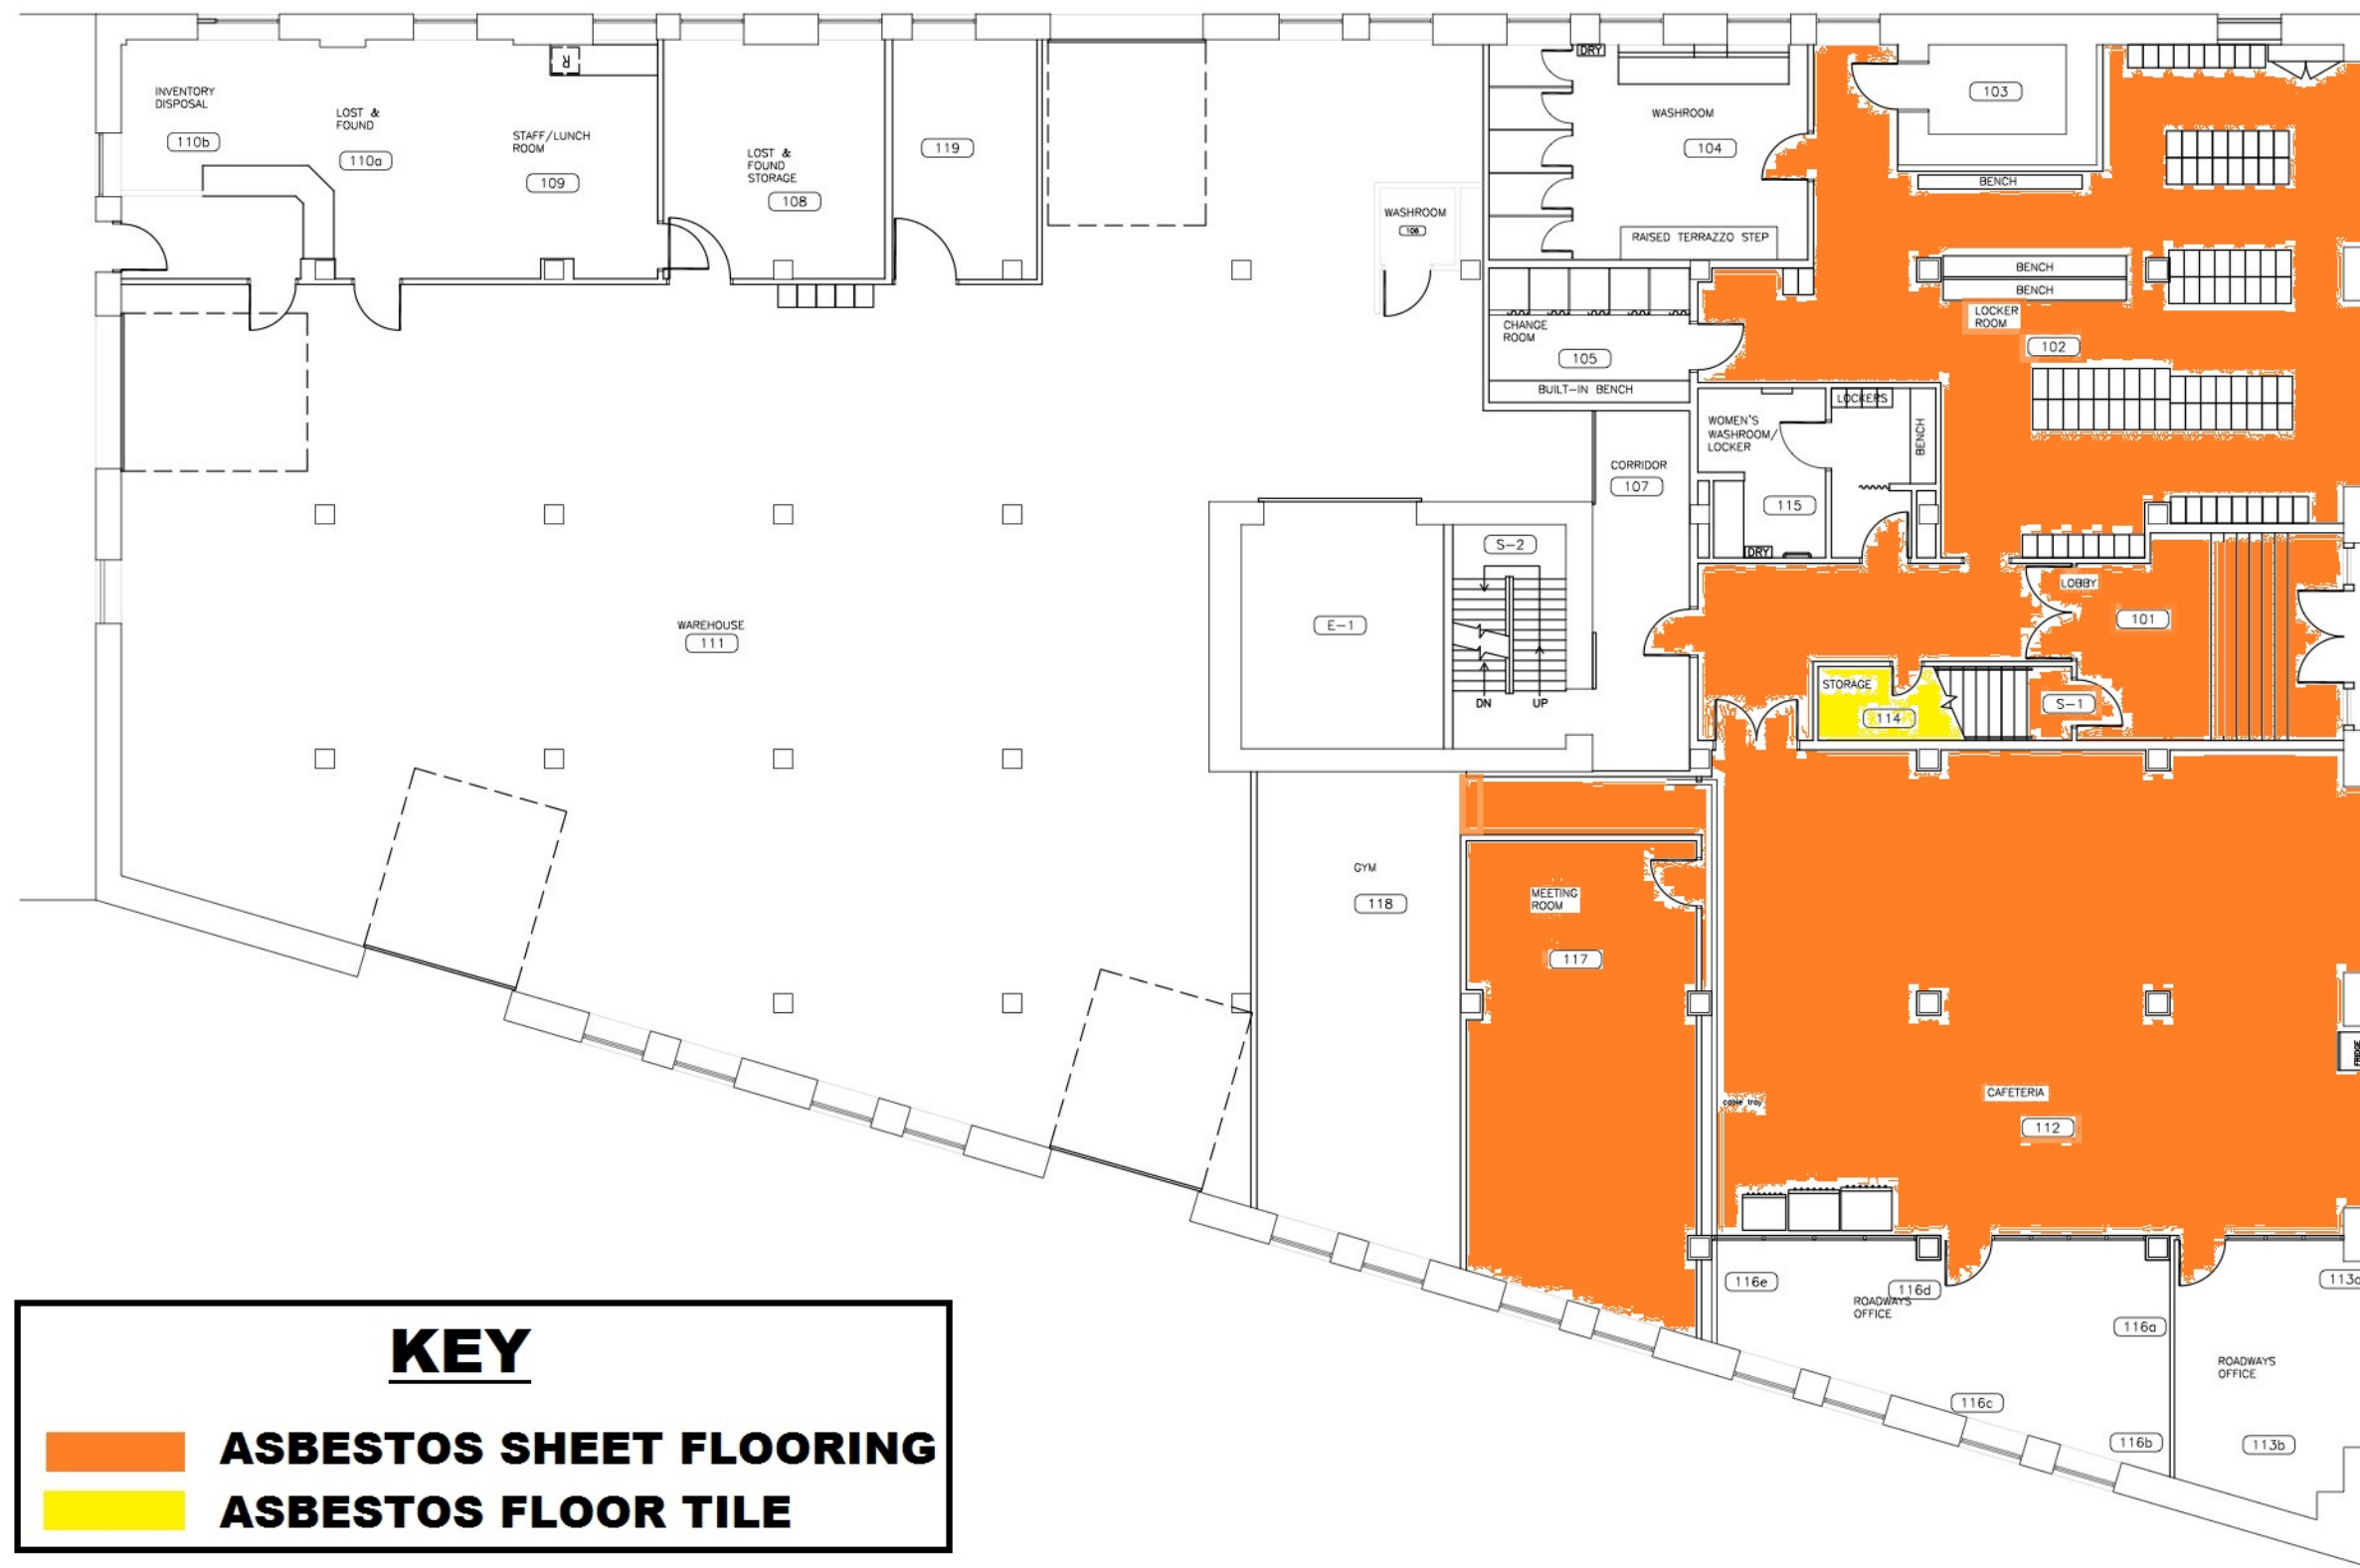
SHEET NAME	Asbuilt
Main Floor Base Plan

- **Vinyl Asbestos Sheet Flooring** is located on the Main Floor of the facility. Due to the poor condition of the sheet flooring in several areas, remediation is required. Please refer to Appendix III for the locations on the floor plans.

- **9" x 9" Vinyl Asbestos Floor Tile** was identified within Storage Room 114. The flooring was observed in good condition with no further action required. Please refer to Appendix III for the location on the floor plans.

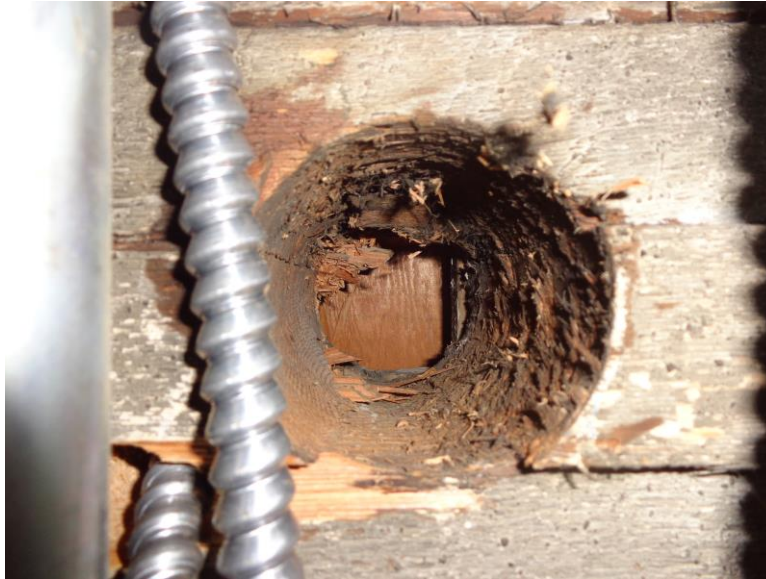
**AREA 1:** Basement Level Room 001 Looking Up Through the Penetration at the Column Adjacent the Training Room 112 Projector Screen. Fir Timber on Edge, Plywood Floor, Asbestos Floor Tile and Asbestos Sheet Flooring in the 112 Floor Composition.

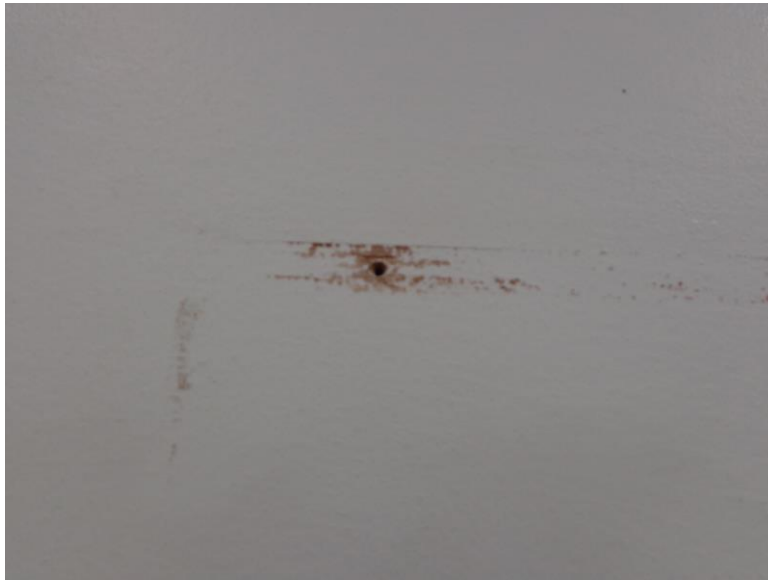
**AREA 5:** First Level – Room 112, No Asbestos Detected on West Wall Surface Where the Projector Screen is Mounted to. The Surface Consists of Painted 3/8” Plywood.

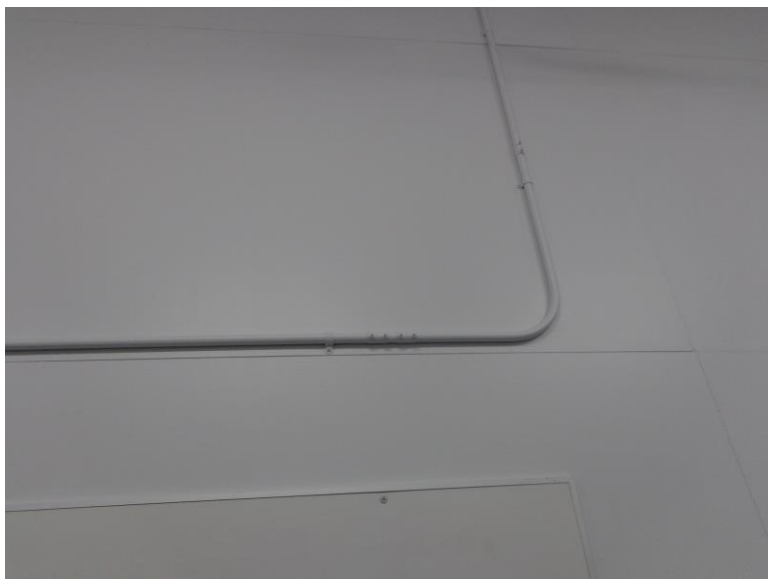
**AREA 6:** First Level – Room 118, No Asbestos Detected on North Wall Surface Where the Conduit is Mounted to. The Surface Consists of Painted 3/8” Plywood.

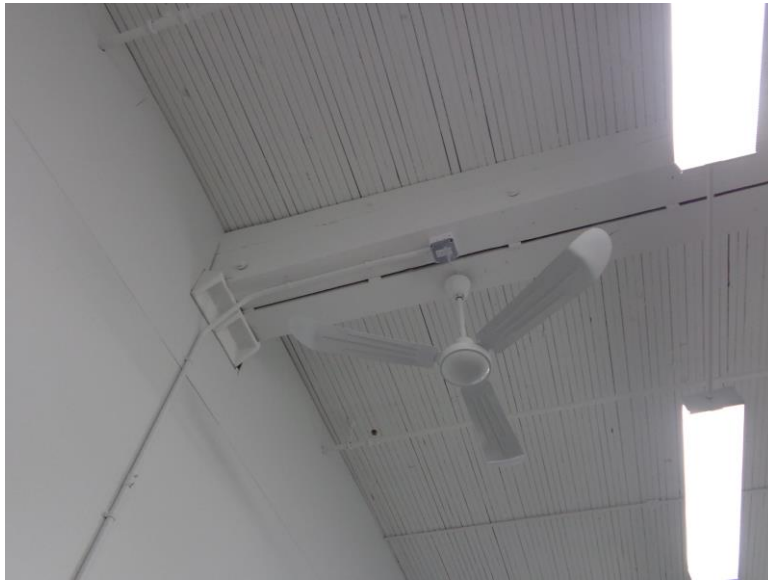
**AREA 7:** First Level – Room 118, No Asbestos Detected on Overhead Fir Beam Surface the Fan is Mounted to.

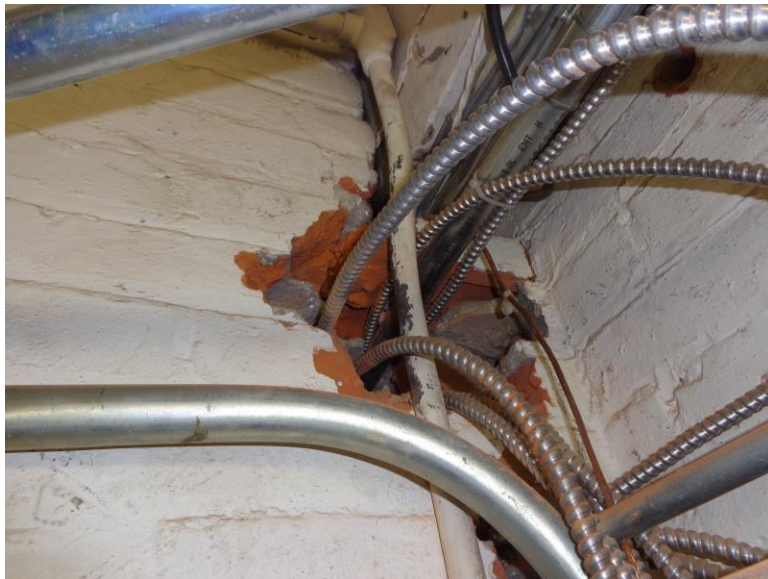
**AREA 8:** Second Level – 2S2 Stairwell Upper Northeast Corner Adjacent 2A Electrical Panel. No Asbestos Material Detected in #32 Clay Brick or #33 Brick Mortar Bulk Samples. Refer to the Attached Bulk Analysis Report.

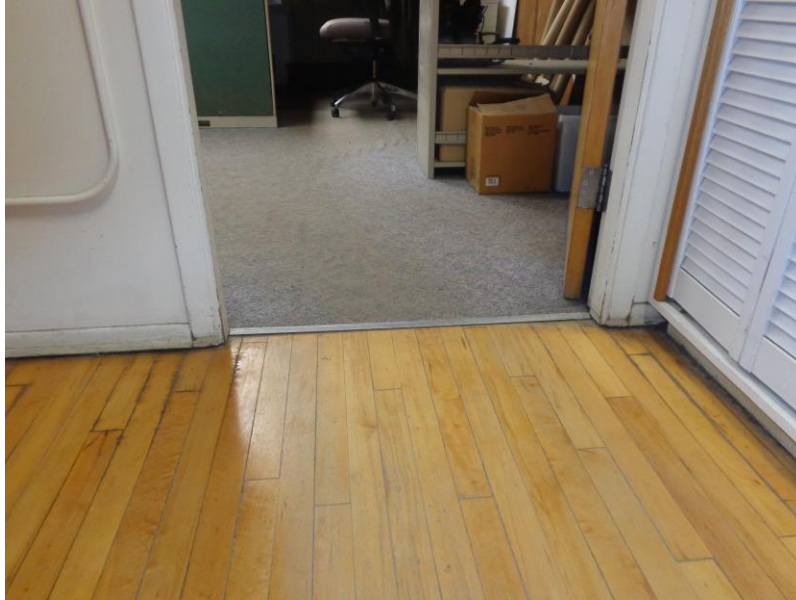
**AREA 11:** Second Level – Room 30 Hardwood Floor Continues Beneath Carpet.

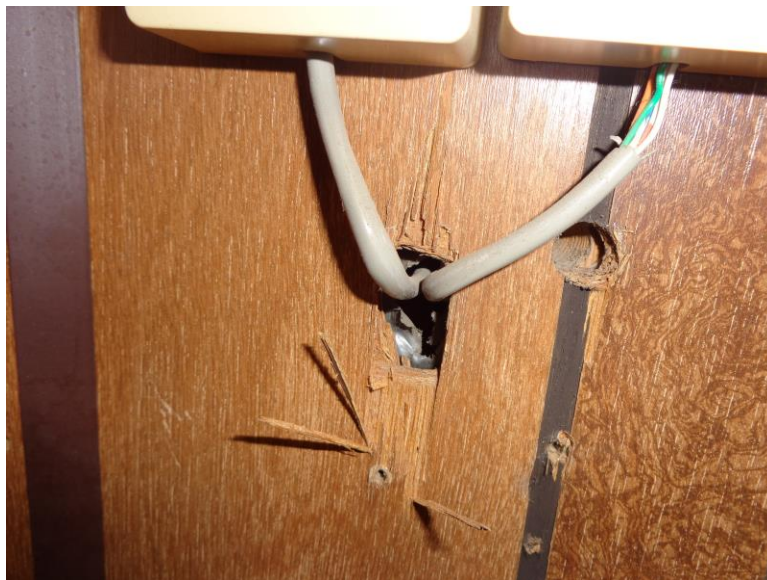
**AREA 12:** Second Level – Room 30 Lower Southwest Corner Wall Composition. Panel Board and Wall Cavity Directly Behind. No Asbestos Material Observed on the Surface or Directly Behind the Paneling on all Four Walls.

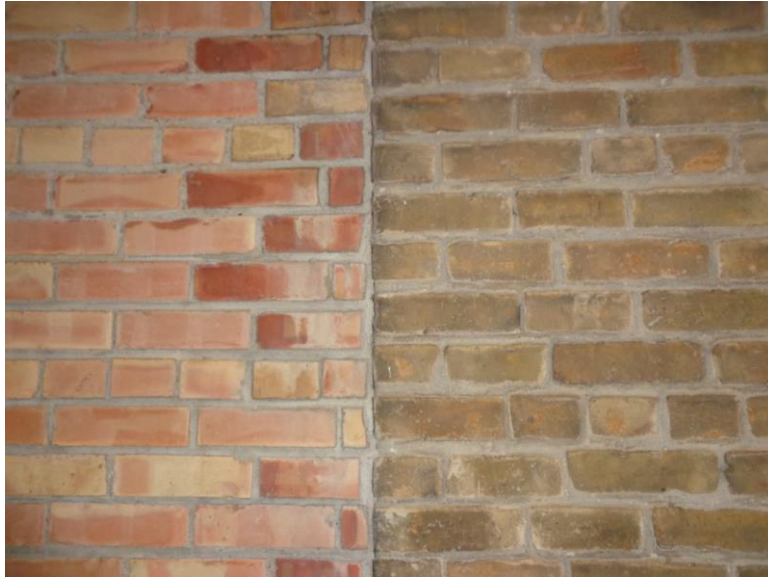
**AREA 15:** North Exterior Wall. Mortar Within Either Brick Does Not Contain Asbestos.
