**City of Saskatoon
Kilburn Park Building
Asbestos Survey Report**

December 2015

**Prepared For: City of Saskatoon – Recreation Facilities and Fleet Management
Kilburn Park Building
1510 Kilburn Avenue, Saskatoon SK, Canada S7M 0K3
Attn: Dale Hrynuik**

**Prepared By: Bersch & Associates Ltd.
Project No. : B67SRL03**

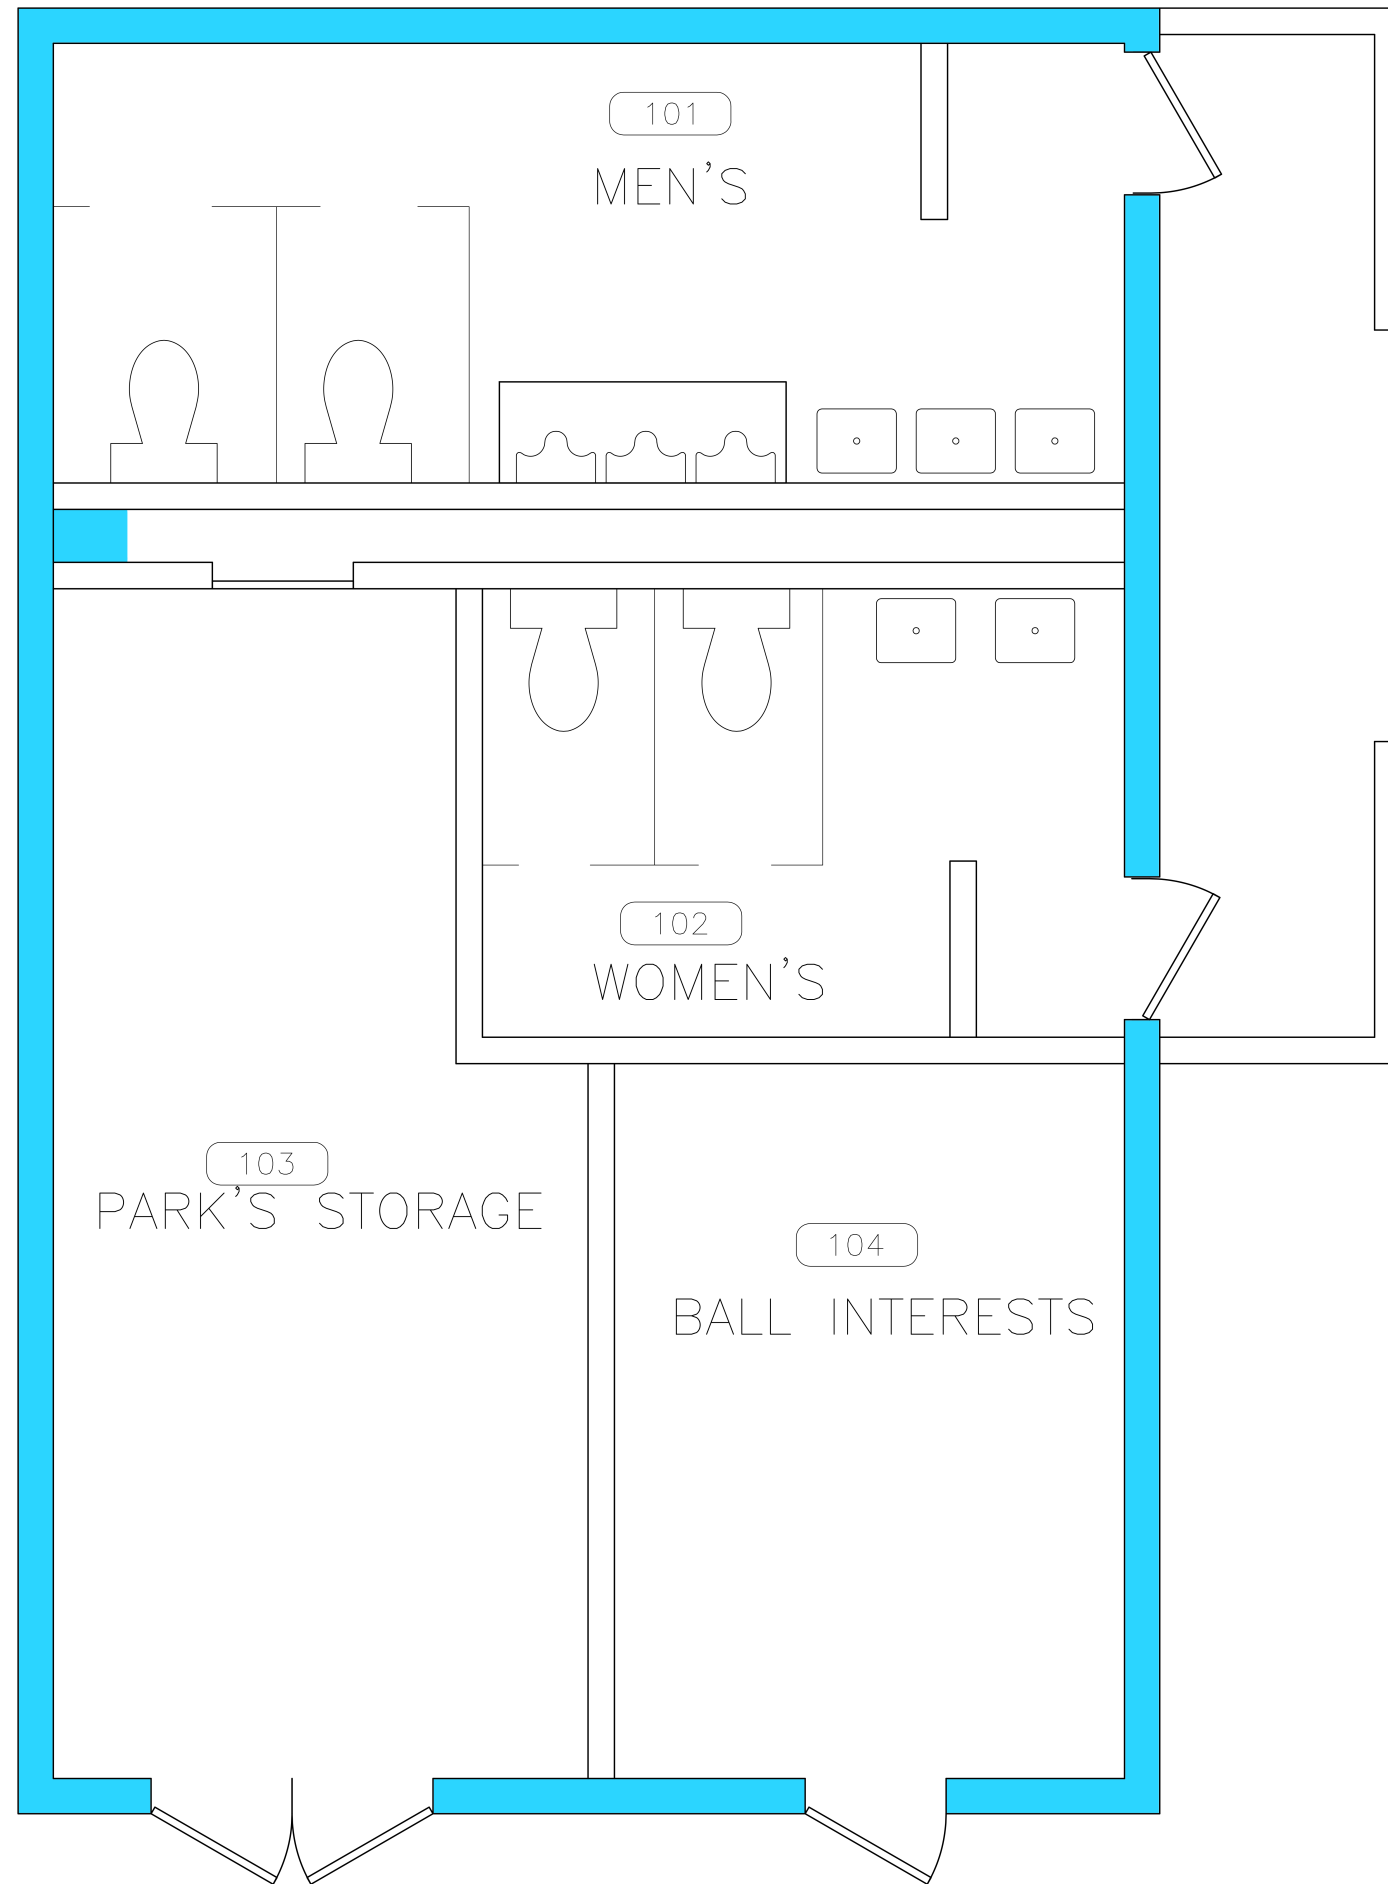
SHEET NAME
**Main Floor
 Floor Plan**

- **Vermiculite** block wall insulation has been identified within the Kilburn Park Building. The samples were collected from Room 103 Park’s Storage and Room 104 Balls Interest from an existing wall penetration and the pipe chase. All perimeter walls are assumed to contain vermiculite insulation. The interior block walls shall also be considered suspect of containing vermiculite insulation.

Asbestos containing vermiculite is present within the facility. This material is located within the exterior block walls of the facility. The material for the most part is in good condition with the exception of the vermiculite debris within the pipe chase. Bersch recommends HEPA vacuuming the vermiculite insulation within the bathroom pipe chase. Consider all block walls to be asbestos containing.

PRIORITY:	ONE
CONDITION:	POOR
POTENTIAL FOR DISTURBANCE:	LOW
ACTION:	CLEANUP/MANAGE

Throughout the survey of the Kilburn Park Building, the Asbestos Containing Materials were assessed and given a Priority Rating of One, Two or Three, with Priority One being the items requiring the most immediate attention. As a result, a Priority One item was identified as cleanup of the vermiculite insulation within the 103 Parks Storage Bathroom Pipe Chase. The actions to be implemented in the facility is Cleanup and Management. ***Consider all Block Walls to contain Asbestos Vermiculite Insulations.***
