July 14, 2017

CITY OF SASKATOON

# Asbestos-Containing Building Materials Assessment Report - Kiwanis Memorial Park Shed

**Report Number: 1667963**

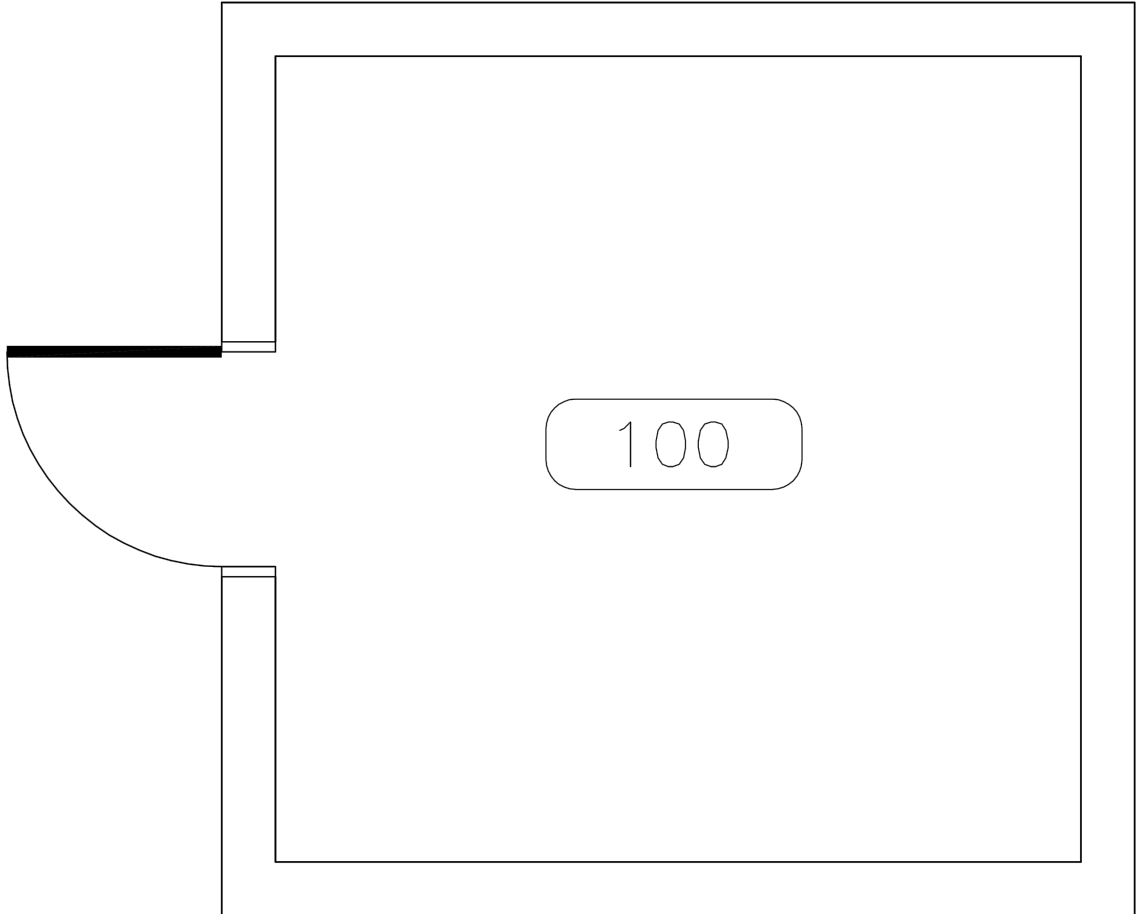
TITLE  
**MAIN FLOOR**

During the assessment, no suspect asbestos-containing materials were observed. The Shed was observed to be constructed of concrete walls, ceiling, and flooring. Potential asbestos-containing components may be located within the electrical panels on Site.

No suspect asbestos-containing materials were observed within the Kiwanis Memorial Park Shed.

- The electrical panels and associated components were not inspected by Golder during the assessment. If the panels are to be removed or impacted by future renovation or demolition activities, additional investigation and sampling of suspect materials may be required.

If suspect asbestos-containing building materials are encountered during renovation or demolition activities, sampling should be undertaken to evaluate asbestos content.
