August 8, 2017

CITY OF SASKATOON

# Asbestos-Containing Building Materials Assessment Report - Lakewood Civic Centre and Cliff Wright Library

**Report Number: 1667963**

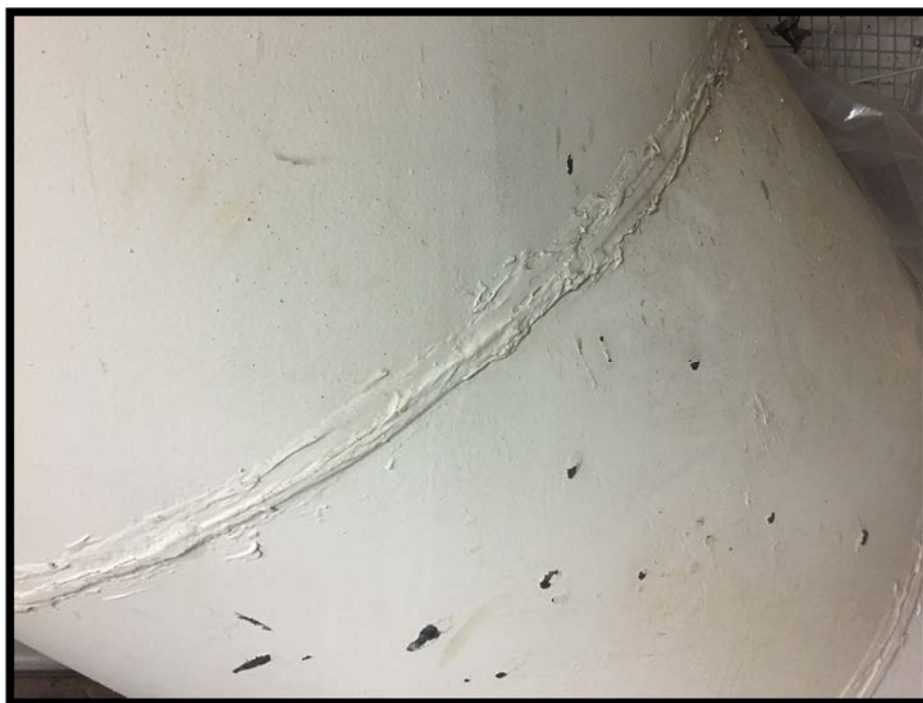
Three (3) samples of duct mastic painted white were collected during the assessment. One of the samples collected was found to contain 0.5% Chrysotile asbestos. Based upon observations on site and from the laboratory analysis report, the sample found to contain asbestos was observed to be white paint over tan mastic. The two remaining white duct mastic samples were observed to be white paint over brown mastic. Due to the white paint concealing the color of the duct mastic, all duct mastic painted white within the lower level should be treated as asbestos-containing until further sampling or historical information is provided. The duct mastic painted white sampled on the main floor (a separate functional space) was observed to be white paint over brown mastic, and other duct mastic painted white on the main floor was observed to be white paint over grey duct mastic, however consideration should be given to conduct further sampling to evaluate if asbestos-containing tan mastic is present below the white paint on the main floor.

Asbestos-containing tan duct mastic (painted white) (see Photograph 1 in Appendix B) was observed in the following locations:

- Room B01 (approximately 40 ft);
- Room B02 (approximately 400 ft); and
- Room B03 (approximately 500 ft).

**Photograph 1: Asbestos-Containing Tan Duct Mastic (Painted White).**

If scheduled for impact, asbestos-containing tan duct mastic (painted white) should be abated following low-risk abatement work procedures as outlined in the *Saskatchewan Asbestos Abatement Manual (2017)*. Alternatively, as the tan duct mastic (painted white) was observed in good condition, and with a priority rating of 5 (please see the room by room spreadsheet provided in Appendix C for a description of the priority ratings), it can be managed in place if not scheduled for impact.

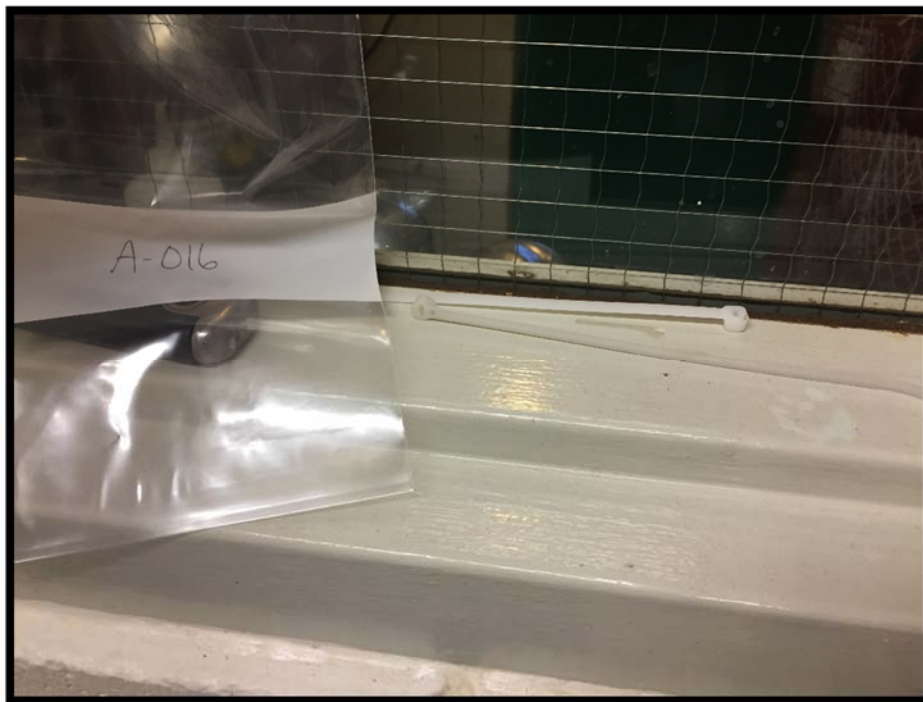
Three (3) samples of interior black window caulking were collected during the assessment. Two of the samples collected were found to contain 4.7% to 5.7% Chrysotile asbestos.

Asbestos-containing interior black window caulking (see Photograph 2 in Appendix B) was observed in the following locations:

- Room 112 (approximately 20 linear feet);
- Vestibule adjacent to Room 122 (approximately 120 linear feet);
- Room 122 (approximately 10 linear feet);
- Corridor 128 (approximately 100 linear feet);
- Room 175 (approximately 65 linear feet);
- Room 187 (approximately 65 linear feet); and
- Room 188 (approximately 200 linear feet).

**Photograph 2: Asbestos-Containing Black Window Caulking.**

If scheduled for impact, asbestos-containing black interior window caulking should be abated following low-risk abatement work procedures as outlined in the *Saskatchewan Asbestos Abatement Manual (2017)*. Alternatively, as the black interior window caulking was observed in good condition, and with a priority rating of 5 (please see the room by room spreadsheet provided in Appendix C for a description of the priority ratings), it can be managed in place if not scheduled for impact.

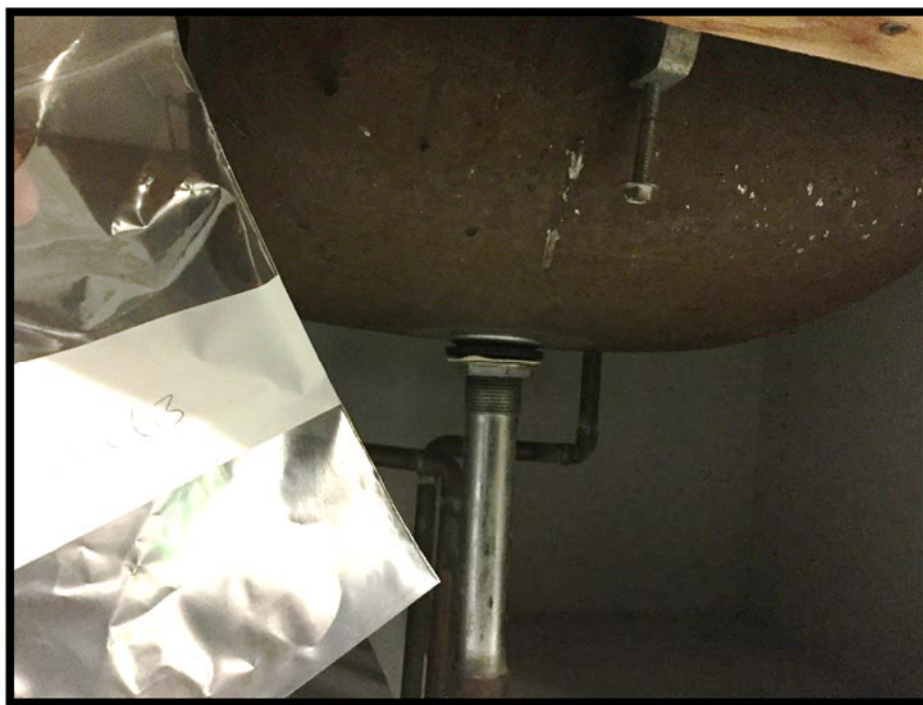
One (1) sample of gold sink undercoat was collected during the assessment. The sample collected was found to contain 0.25% Chrysotile asbestos.

Asbestos-containing gold sink undercoat (see Photograph 3 in Appendix B) was observed in the following location:

- Room 103 (approximately 1 sink).

**Photograph 3: Asbestos-Containing Gold Sink Undercoat.**

If scheduled for impact, asbestos-containing gold sink undercoat should be abated following low-risk abatement work procedures as outlined in the *Saskatchewan Asbestos Abatement Manual (2017)*. Alternatively, as the gold sink undercoat was observed in good condition, and with a priority rating of 5 (please see the room by room spreadsheet provided in Appendix C for a description of the priority ratings), it can be managed in place if not scheduled for impact.

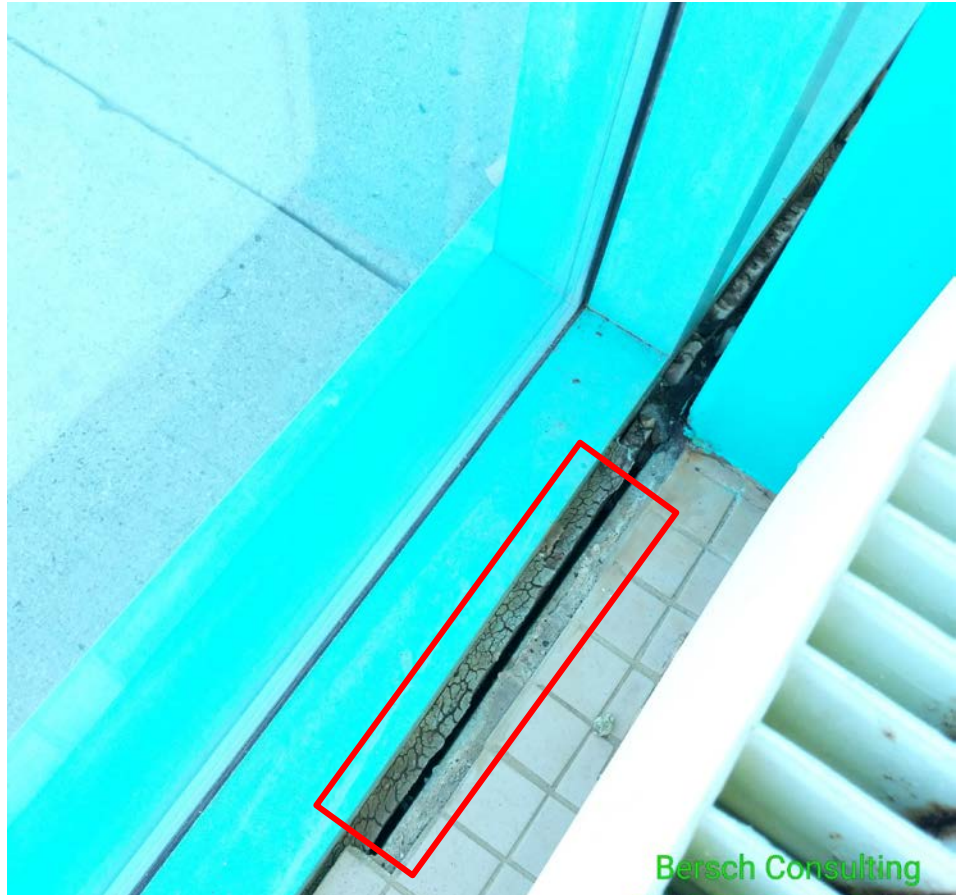
**Photo ID**

Window caulking.  
SW interior window.
