CITY OF SASKATOON

Asbestos-Containing Building Materials Assessment Report - Lathey Pool

Report Number: 1667963

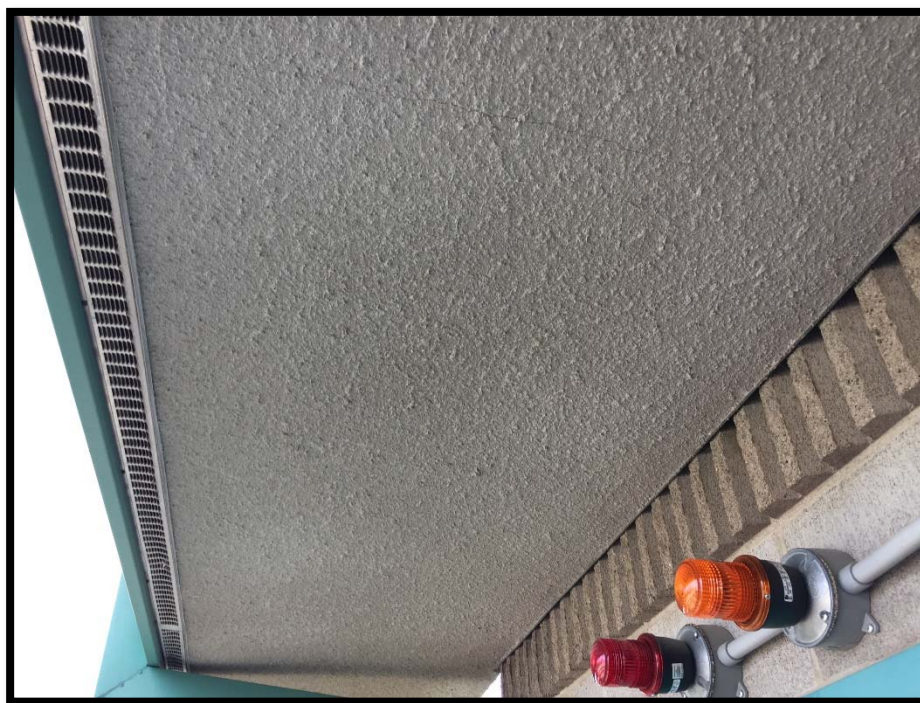
Three (3) samples of concrete texture coat were collected during the assessment. The three samples collected were found to contain 10% Chrysotile asbestos. Asbestos-containing concrete texture coat (see Photograph 1 in Appendix B) was observed in the following location:

- Exterior (approximately 1,600 ft²).

Photograph 1: Asbestos-Containing Concrete Texture Coat.

If scheduled for impact, asbestos-containing concrete texture coat should be abated following high-risk abatement work procedures as outlined in the *Saskatchewan Asbestos Abatement Manual (2017)*. Alternatively, as the concrete texture coat was observed in good condition, and with a priority rating of 5 (please see the room by room spreadsheet provided in Appendix C for a description of the priority ratings), it can be managed in place if not scheduled for impact.

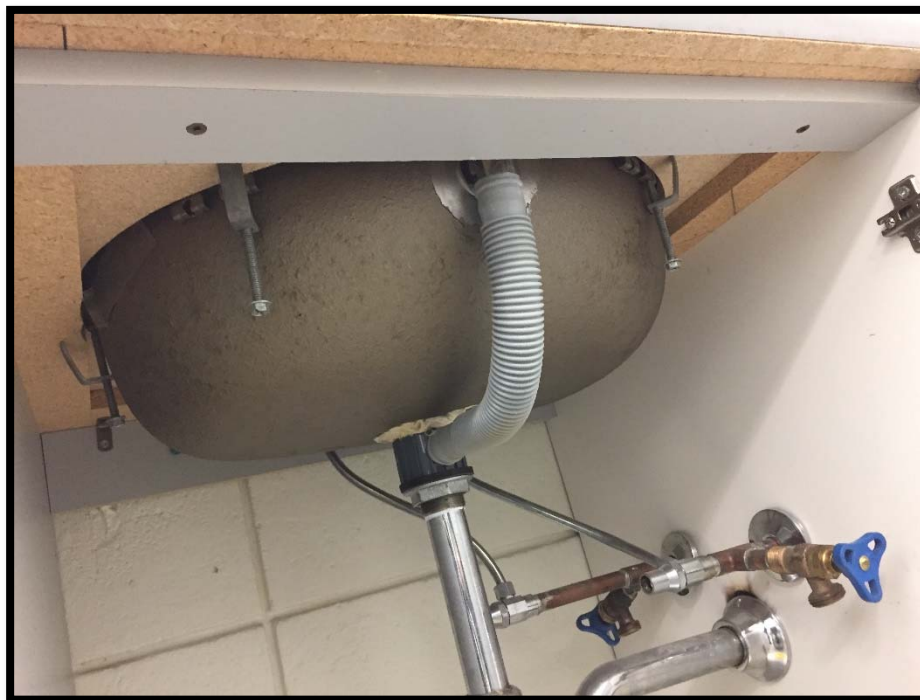
One (1) sample of gold sink undercoat was collected during the assessment. The sample collected was found to contain 1.5% Chrysotile asbestos. Asbestos-containing gold sink undercoat (see Photograph 2 in Appendix B) was observed in the following locations:

- Room 103 (approximately 1 sink);
- Room 105 (approximately 1 sink); and
- Room 114 (approximately 1 sink).

Photograph 2: Asbestos-Containing Gold Sink Undercoat.

If scheduled for impact, asbestos-containing gold sink undercoat should be abated following low-risk abatement work procedures as outlined in the *Saskatchewan Asbestos Abatement Manual (2017)*. Alternatively, as the gold sink undercoat was observed in good condition, and with a priority rating of 5 (please see the room by room spreadsheet provided in Appendix C for a description of the priority ratings), it can be managed in place if not scheduled for impact.

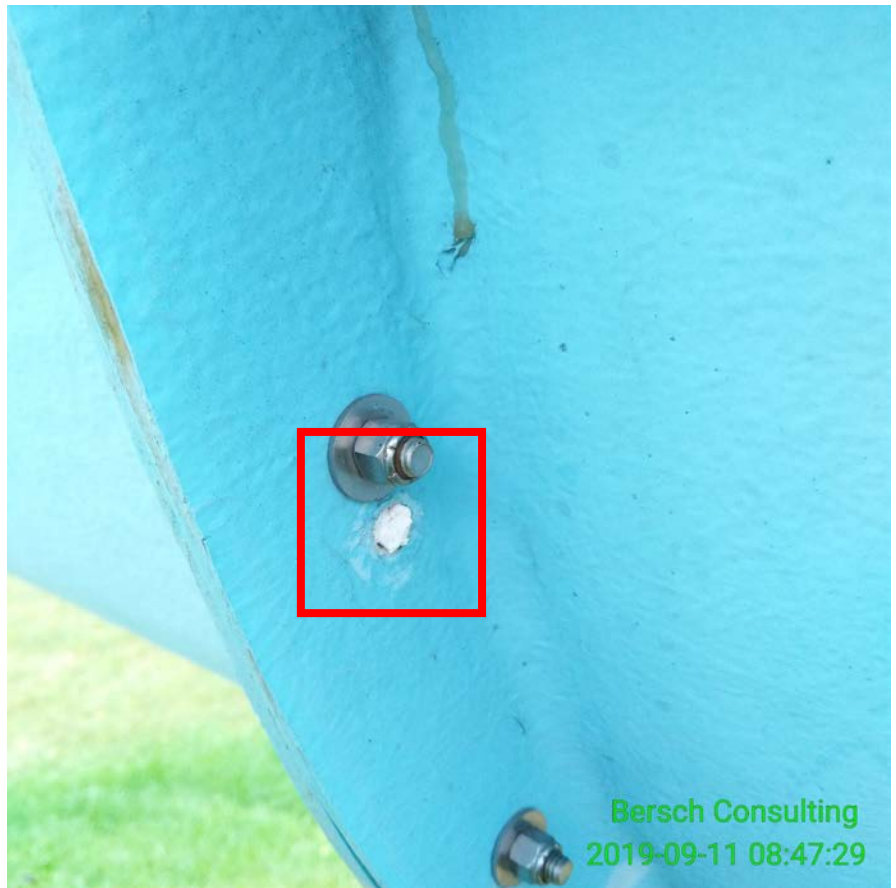
B67PRI11I - 002

White Caulking

Waterslide Section Joint

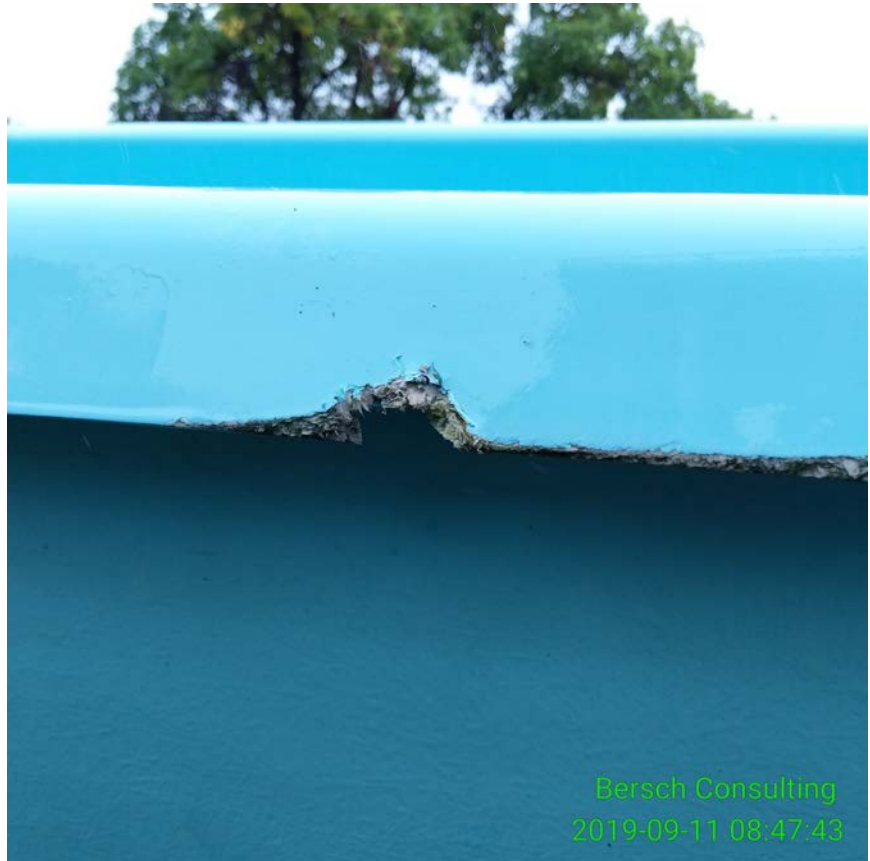
B67PRI11I - 003

Waterslide Material

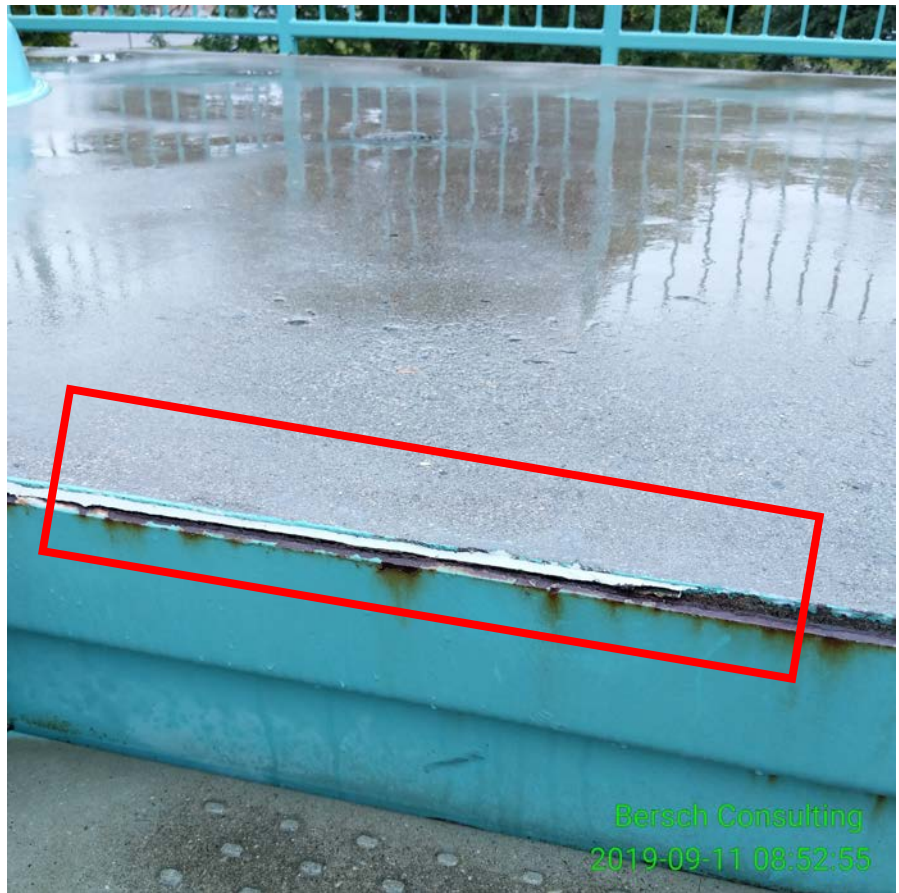
B67PRI11I - 004

Gray Caulking

Stair Edge

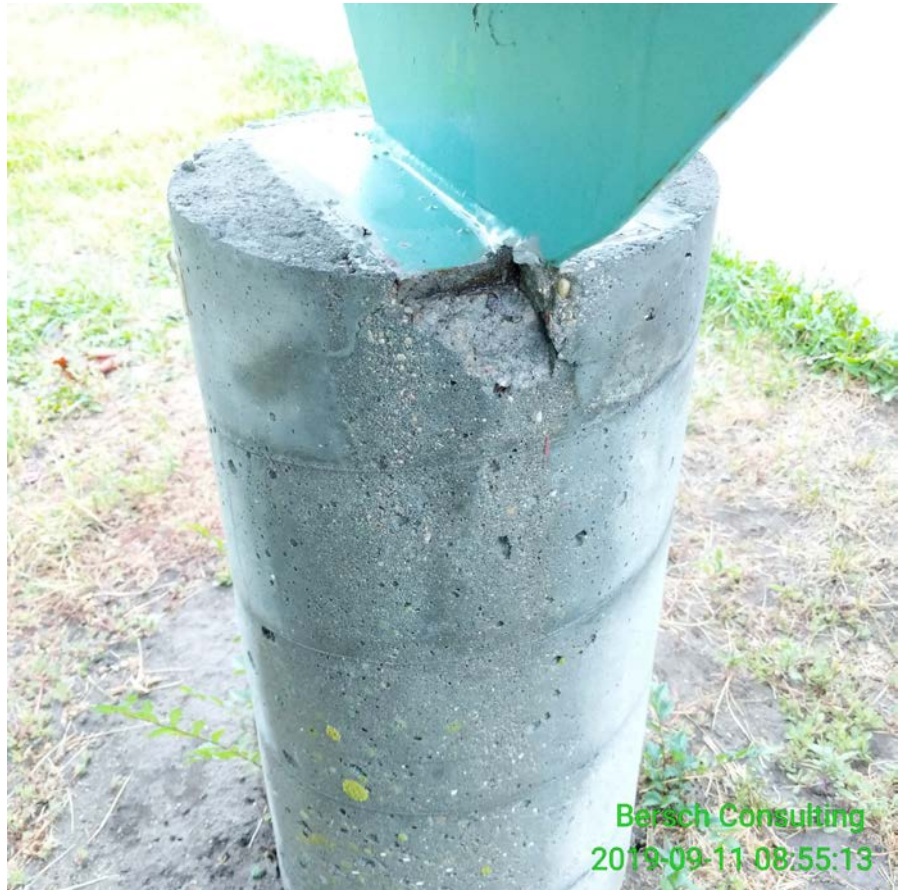
Concrete

Waterslide Support Column
