November 28, 2017

CITY OF SASKATOON

Asbestos-Containing Building Materials Assessment Report - Lathey Pool Concession

Report Number: 1667963

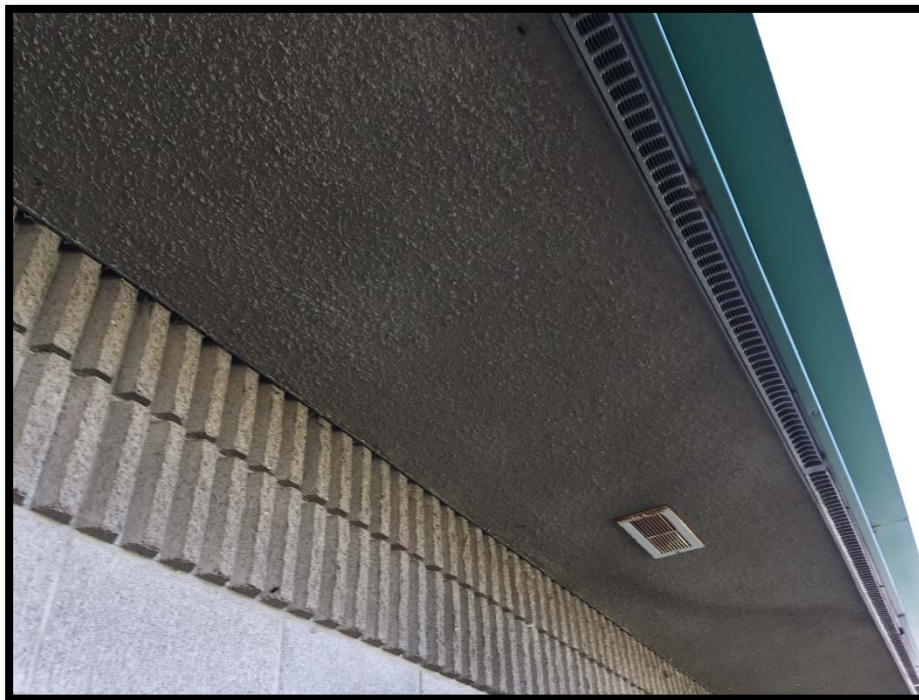
Three (3) samples of concrete texture coat were collected during the assessment. The three samples collected were found to contain 1.3% to 1.6% Chrysotile asbestos. Asbestos-containing concrete texture coat (see Photograph 1 in Appendix B) was observed in the following location:

- Exterior (approximately 750 ft²).

Photograph 1: Asbestos-Containing Concrete Texture Coat.

If scheduled for impact, asbestos-containing concrete texture coat should be abated following high-risk abatement work procedures as outlined in the *Saskatchewan Asbestos Abatement Manual (2017)*. Alternatively, as the concrete texture coat was observed in good condition, and with a priority rating of 5 (please see the room by room spreadsheet provided in Appendix C for a description of the priority ratings), it can be managed in place if not scheduled for impact.
