July 12, 2017

CITY OF SASKATOON

Asbestos-Containing Building Materials Assessment Report - Lawson Heights Civic Centre and Rusty MacDonald Library

Report Number: 1667963

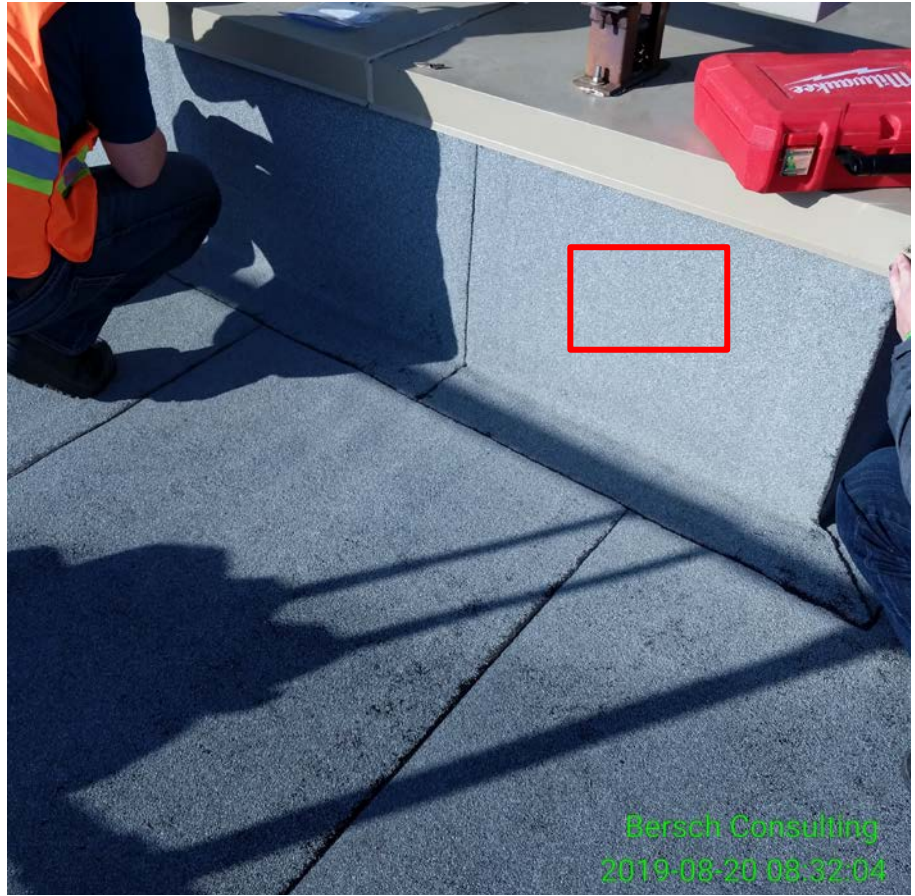
B67BLH20I - 002

Grey/Black Roof Shingle.
Roof Surface Beneath Air Units.

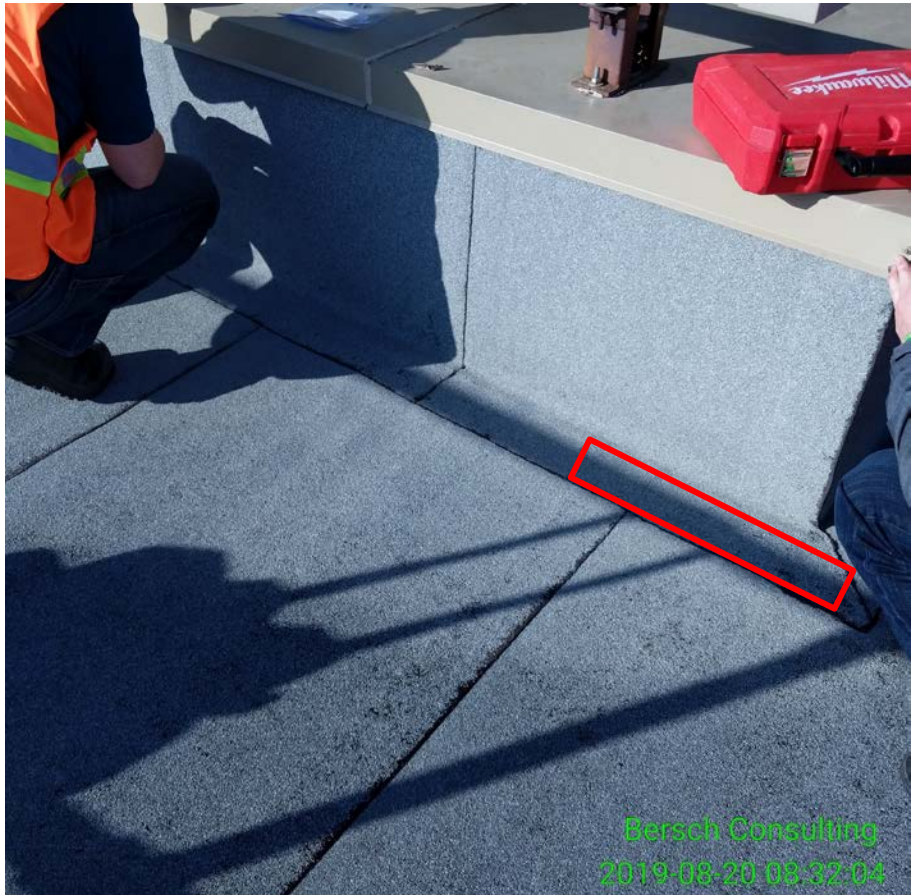
B67BLH20I – 003

Black Roof Membrane.
Roof Surface Beneath Air Units.

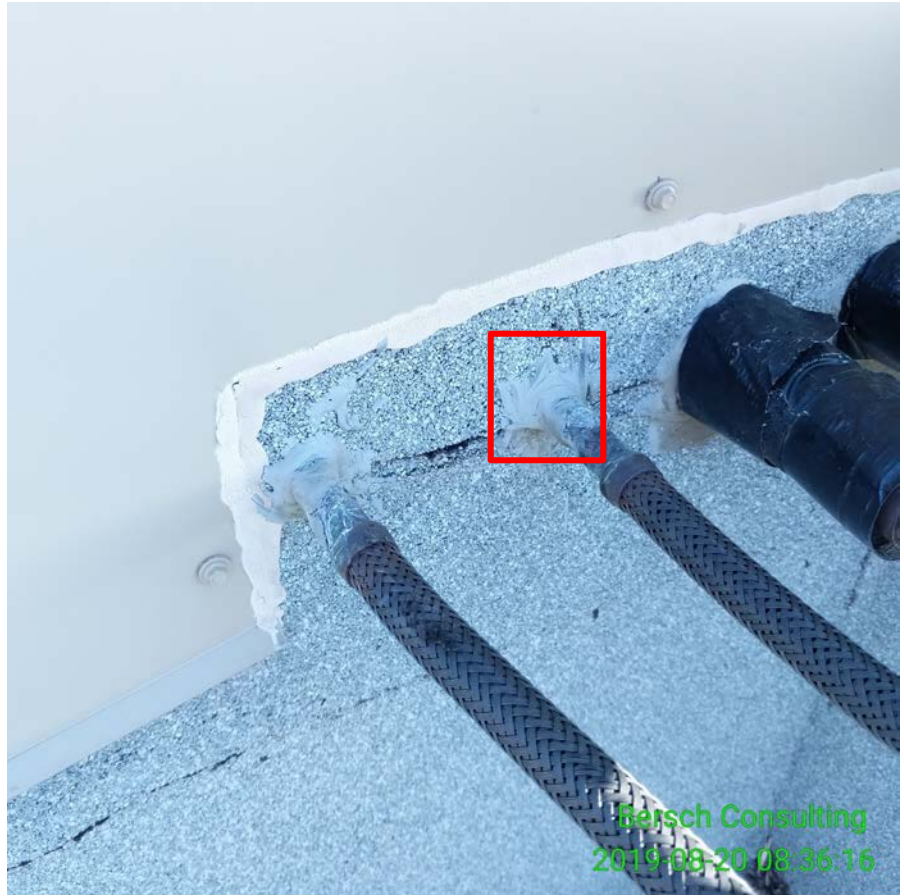
B67BLH20I – 004

Grey Caulking.

Between Conduit and Curb.

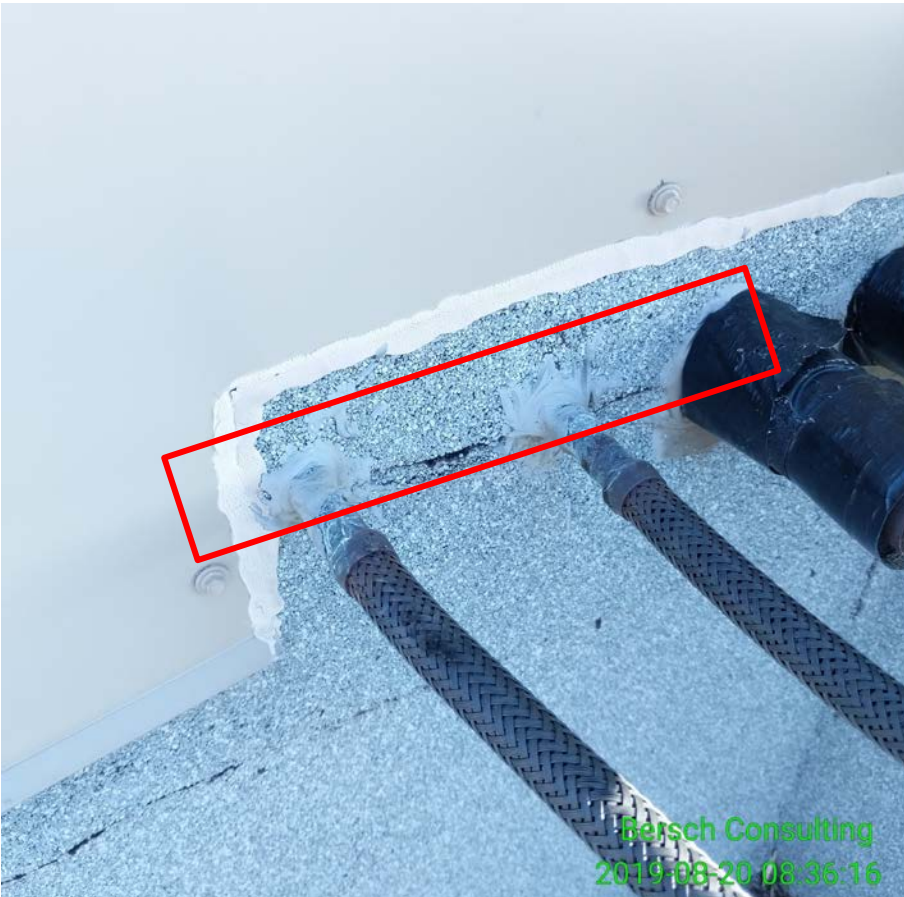
Beige Caulking.

Between Air Unit and Curb.
