CITY OF SASKATOON

Asbestos-Containing Building Materials Assessment Report - Lions Arena

Report Number: 1667963

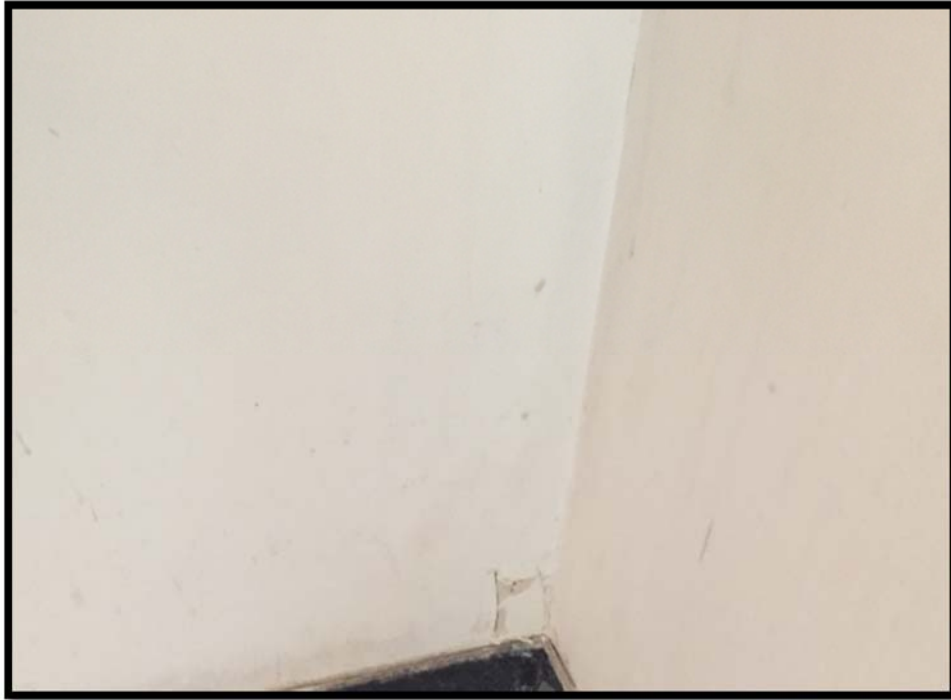
Eight (8) samples of drywall joint compound were collected during the assessment. Three of the samples collected within the second functional space were found to contain 1.8% to 2.1% Chrysotile asbestos. Asbestos-containing drywall joint compound (see Photograph 1 in Appendix B) was observed in the following locations:

- Room 107 (approximately 120 ft²);
- Room 108 (approximately 210 ft²);
- Room 109 (approximately 210 ft²); and
- Room 110 (approximately 120 ft²).

Photograph 1: Asbestos-Containing Drywall Joint Compound.

If scheduled for impact, asbestos-containing grey firestop should be abated following low-risk abatement work procedures as outlined in the *Saskatchewan Asbestos Abatement Manual (2017)*. Alternatively, as the drywall joint compound was observed in good condition, and with a priority rating of 5 (please see the room by room spreadsheet provided in Appendix C for a description of the priority ratings), it can be managed in place if not scheduled for impact.

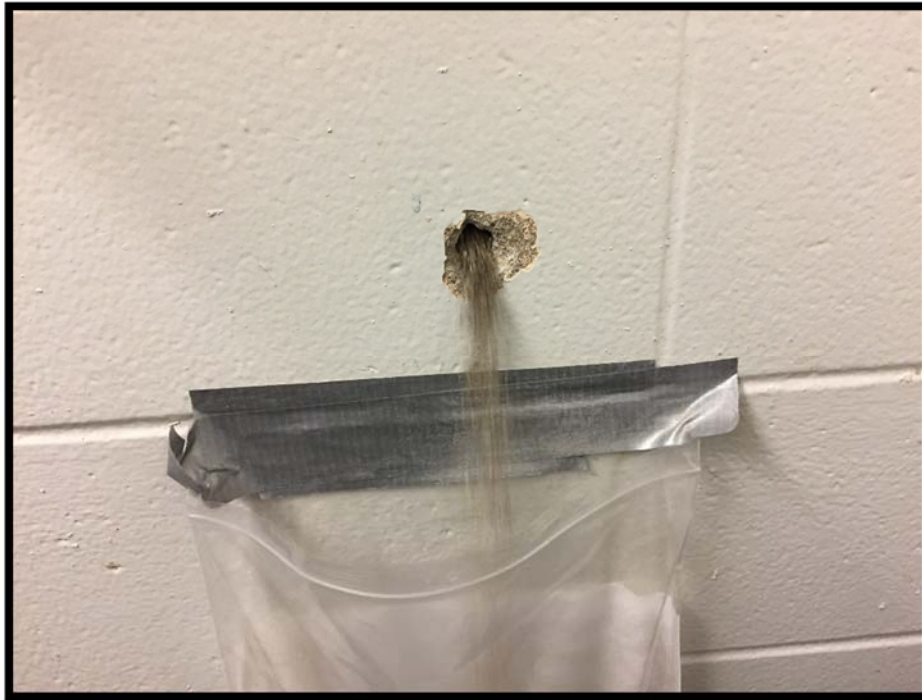
Three (3) samples of vermiculite were collected during the assessment. All three of the samples collected within the second functional space were found to contain 1.2% to 1.5% Actinolite asbestos. Asbestos-containing vermiculite (see Photograph 2 in Appendix B) was confirmed in the following locations:

- Room 104 (approximately 120 ft²);
- Room 112A (approximately 60 ft²); and
- Room 113 (approximately 120 ft²).

During the assessment, Golder cored into approximately 13 locations to evaluate for the presence of absence of vermiculite. The vermiculite insulation was observed to be located sporadically throughout the Site along exterior and interior walls. It is assumed that the vermiculite insulation is located around the perimeter walls of Rooms 113 to 101 based upon where the vermiculite insulation was observed, however this was not confirmed within each room. Please refer to the floor plan provided in Appendix D for the anticipated locations of the vermiculite. Further investigation activities may be required to confirm the exact locations of the vermiculite.

Photograph 2: Asbestos-Containing Vermiculite Insulation.

If scheduled for impact, asbestos-containing vermiculite insulation should be abated following high-risk abatement work procedures as outlined in the *Saskatchewan Asbestos Abatement Manual (2017)*. Alternatively, as the vermiculite insulation is enclosed within block wall, with a priority rating of 5 (please see the room by room spreadsheet provided in Appendix C for a description of the priority ratings), it can be managed in place if not scheduled for impact.

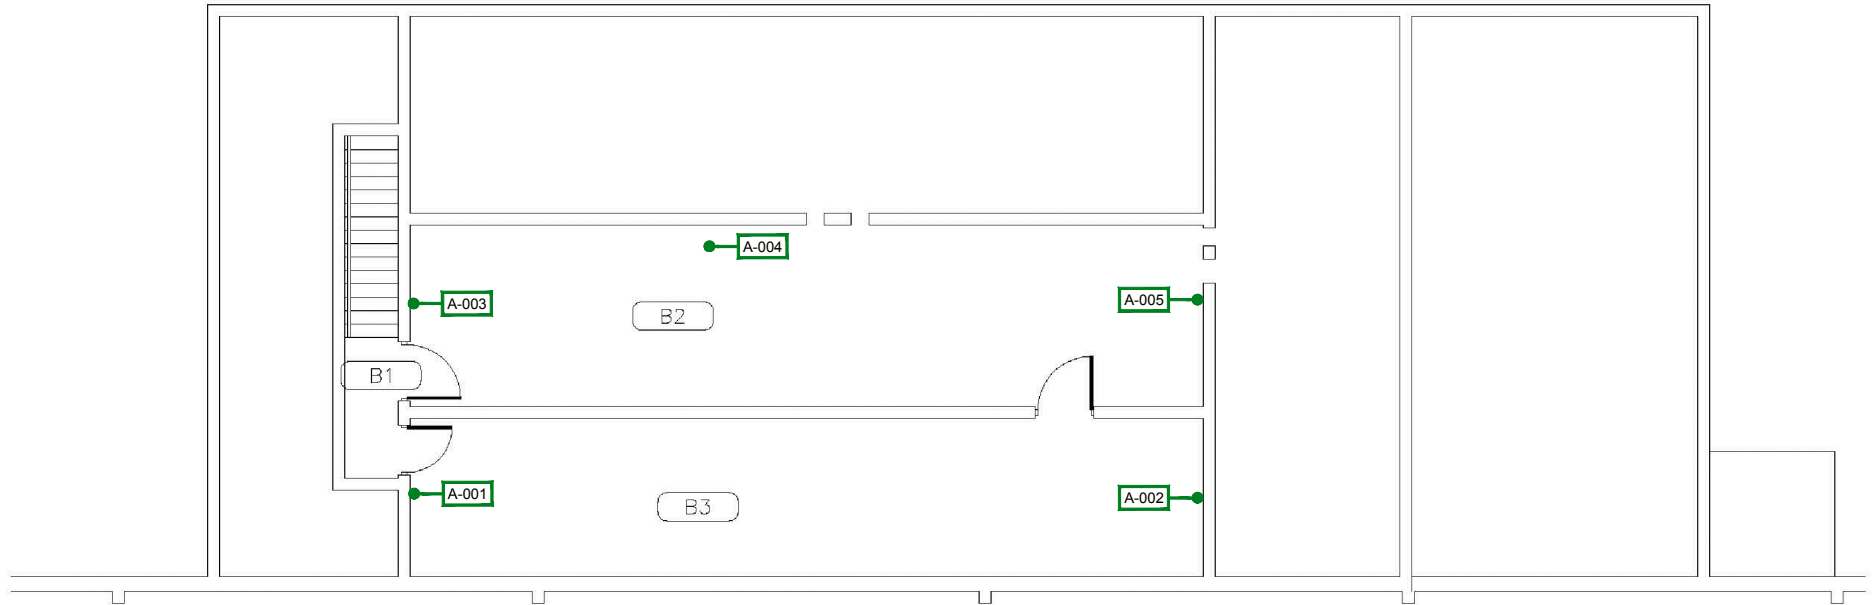
| PROJECT NO. 1667963 | CONTROL 1000-HM-0001 | REV. 0 | FIGURE 1 |

1. ASBESTOS IS A CARCINOGEN. DO NOT BREATHE ASBESTOS DUST.
2. ASBESTOS-CONTAINING VERMICULITE INSULATION WAS IDENTIFIED IN SELECT LOCATIONS OF THE SITE. ADDITIONAL ASBESTOS-CONTAINING VERMICULITE INSULATION MAY BE LOCATED IN ADDITIONAL BLOCK WALL THROUGHOUT THE SITE.

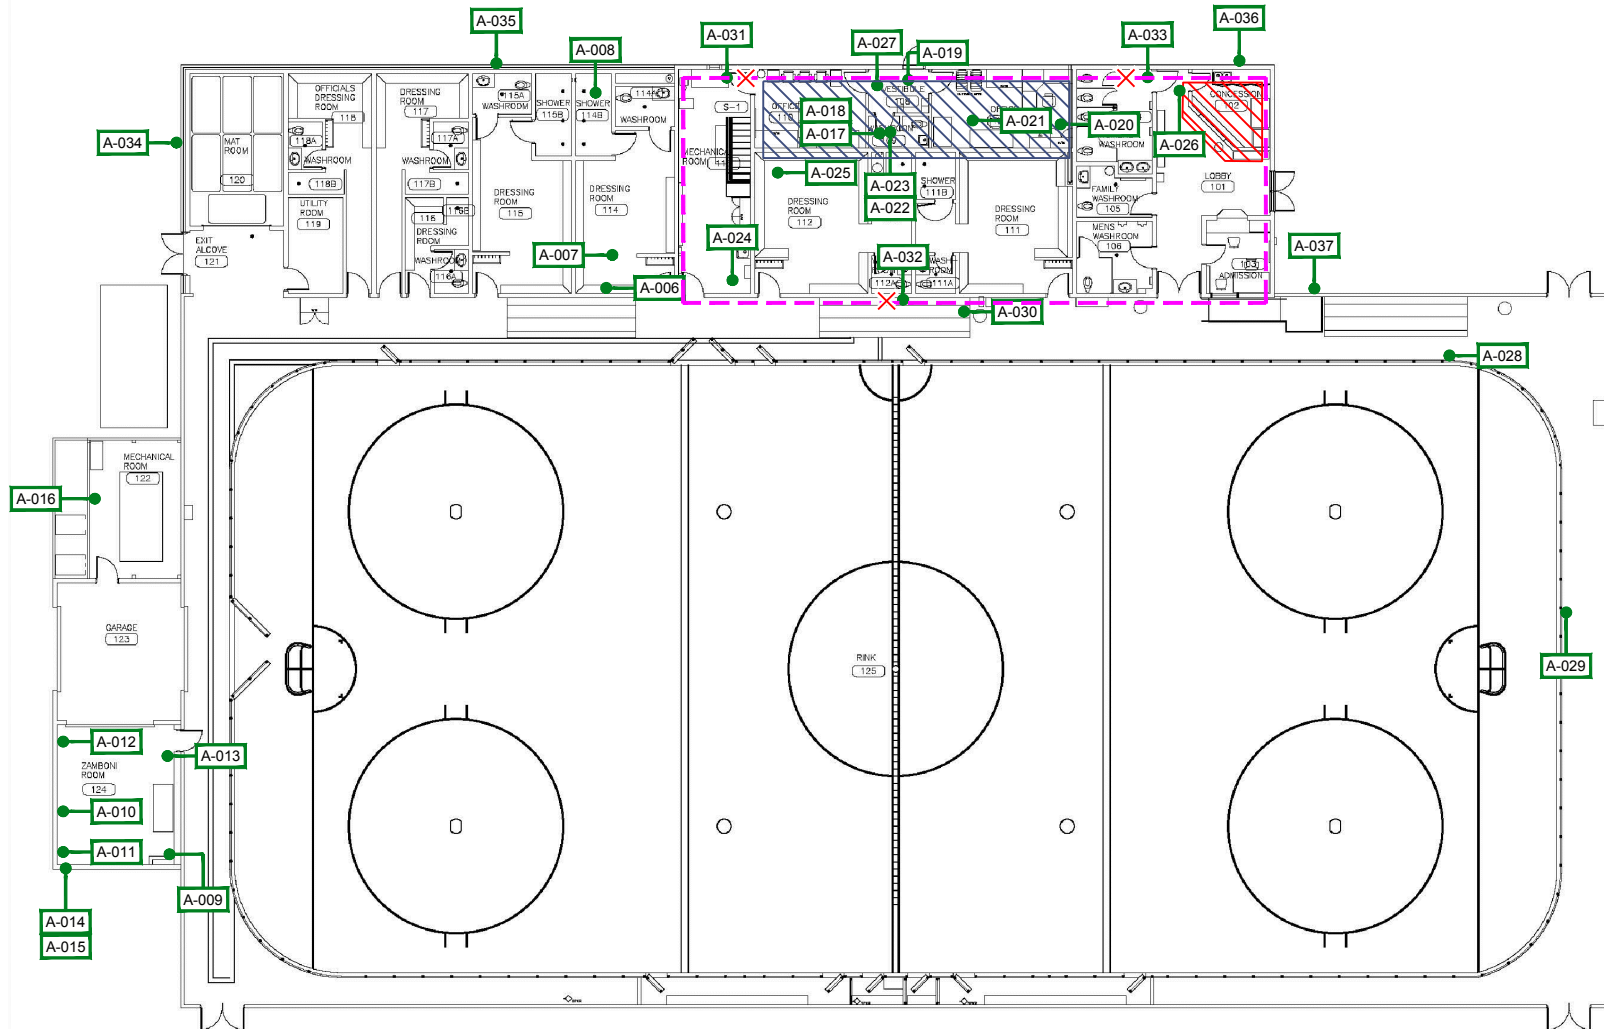
1. ASBESTOS IS A CARCINOGEN. DO NOT BREATHE ASBESTOS DUST.
2. ASBESTOS-CONTAINING VERMICULITE INSULATION WAS IDENTIFIED IN SELECT LOCATIONS OF THE SITE. ADDITIONAL ASBESTOS-CONTAINING VERMICULITE INSULATION MAY BE LOCATED IN ADDITIONAL BLOCK WALL THROUGHOUT THE SITE.

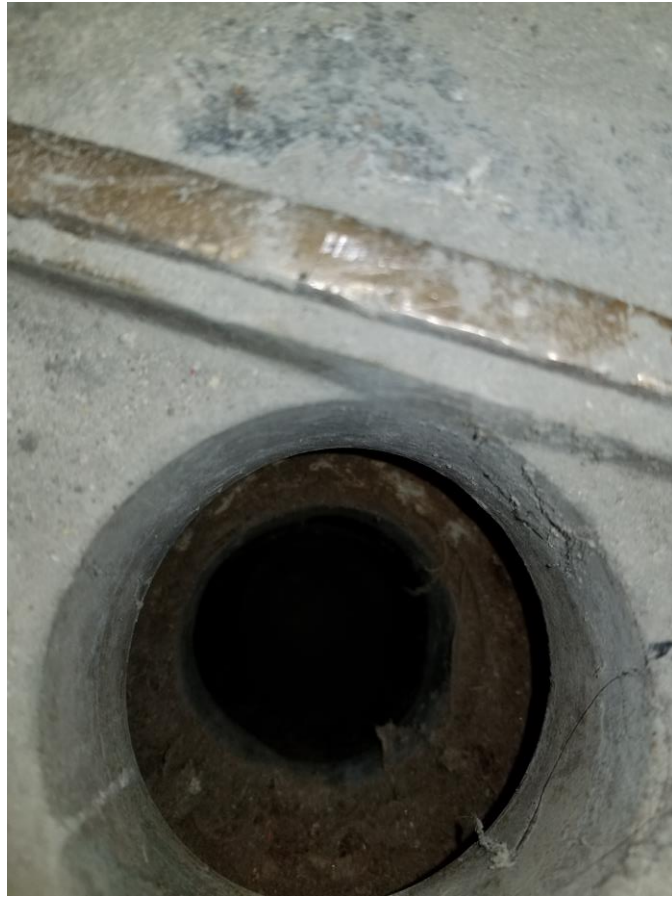
B67BAD07J - 002

Southeast Drainpipe.

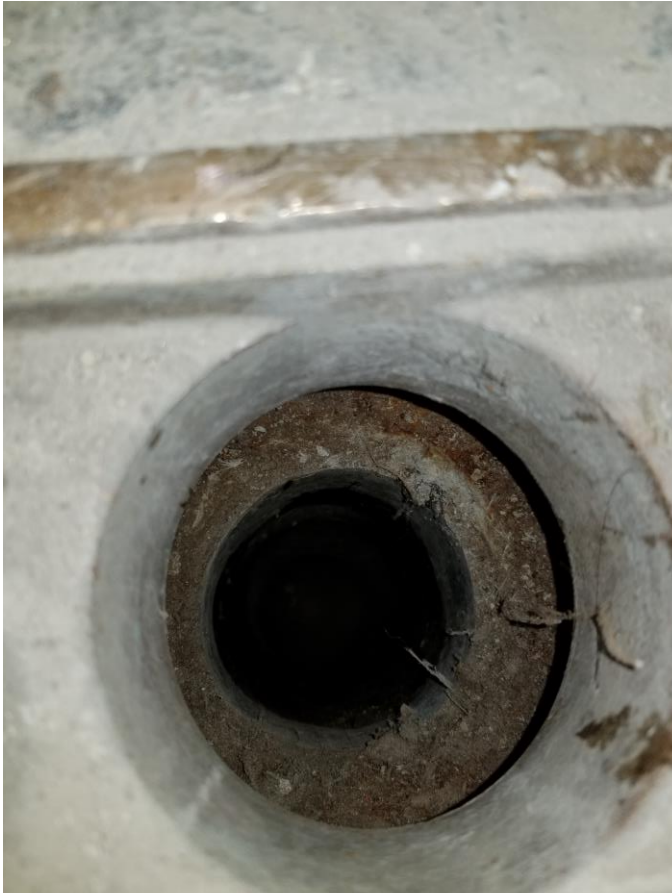
B67BAD07J - 003

Southwest Drainpipe.

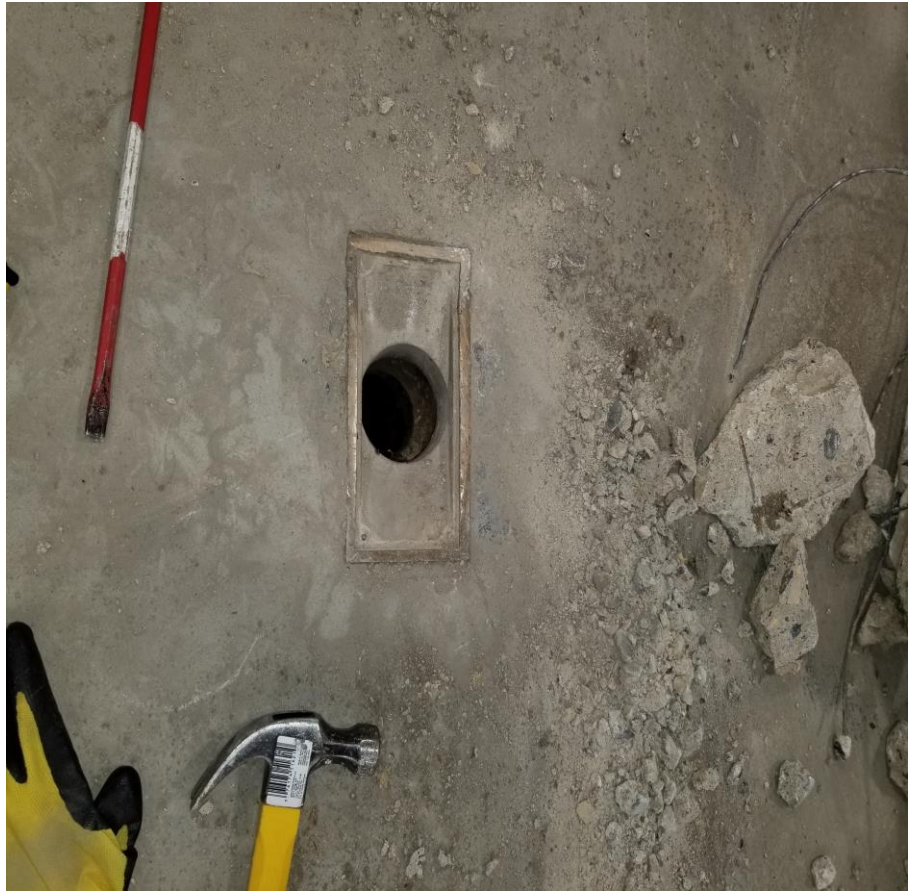
B67PRK13I – 004

Southwest Drainpipe.

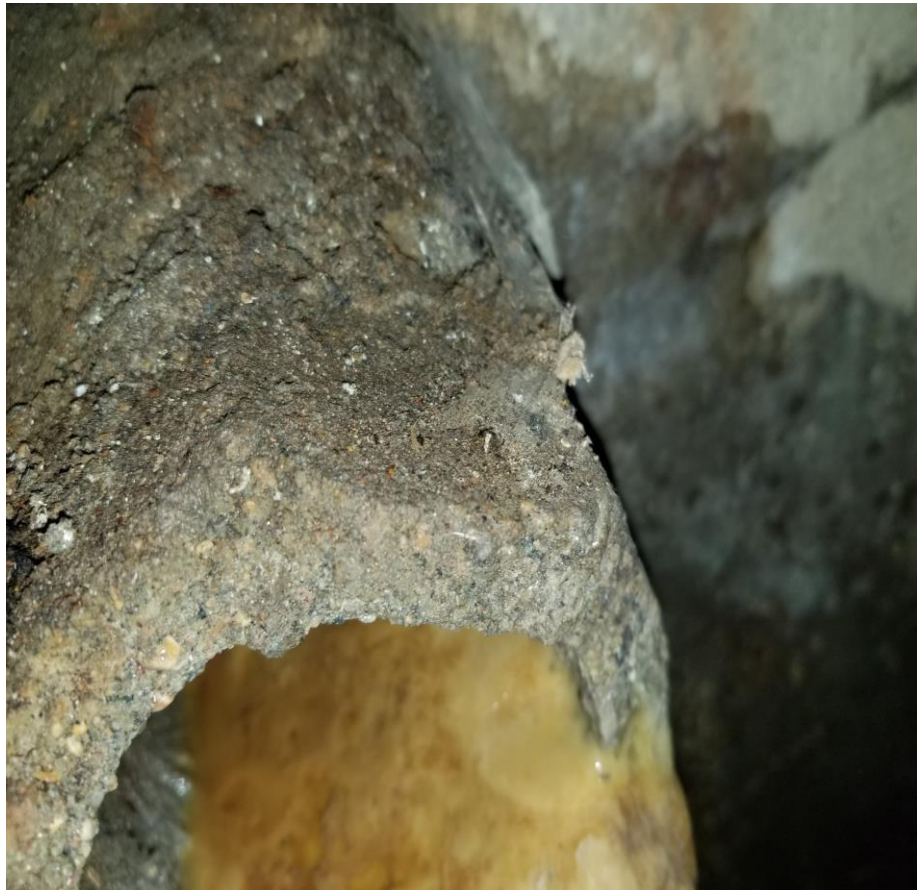
Weeping Tile Below the Slab along the North Side Running East & West.

This photo was taken from the sump pit in the basement mechanical room.
