CITY OF SASKATOON

Asbestos-Containing Building Materials Assessment Report - Low Lift Station

Report Number: 1667963

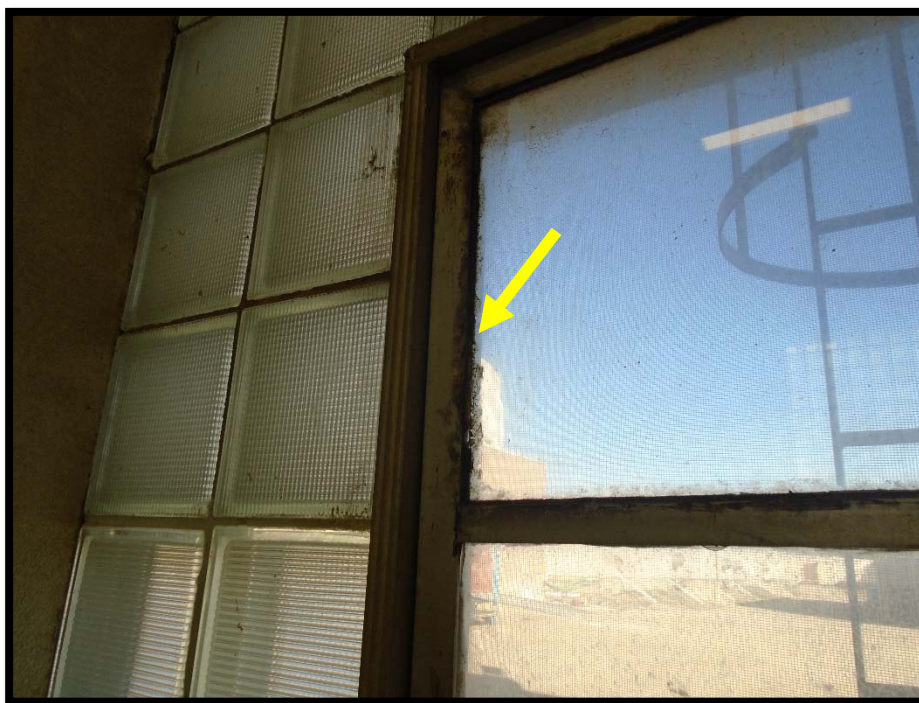
Black Window Glazing

One (1) sample of black window glazing was collected during the assessment. The sample collected was found to contain 2.2% Chrysotile asbestos. Asbestos-containing black window glazing (see Photograph 1 in Appendix B) was observed in the following locations:

- Room 100 (approximately 20 linear ft).

Photograph 1: Asbestos-Containing Black Window Glazing.

If scheduled for impact, asbestos-containing black window glazing should be abated following low-risk abatement work procedures as outlined in the *Saskatchewan Asbestos Abatement Manual* (2017). Alternatively, as the black window glazing was observed in good condition, and with a priority rating of 5 (please see the room by room spreadsheet provided in Appendix C for a description of the priority ratings), the glazing can be managed in place if not scheduled for impact.

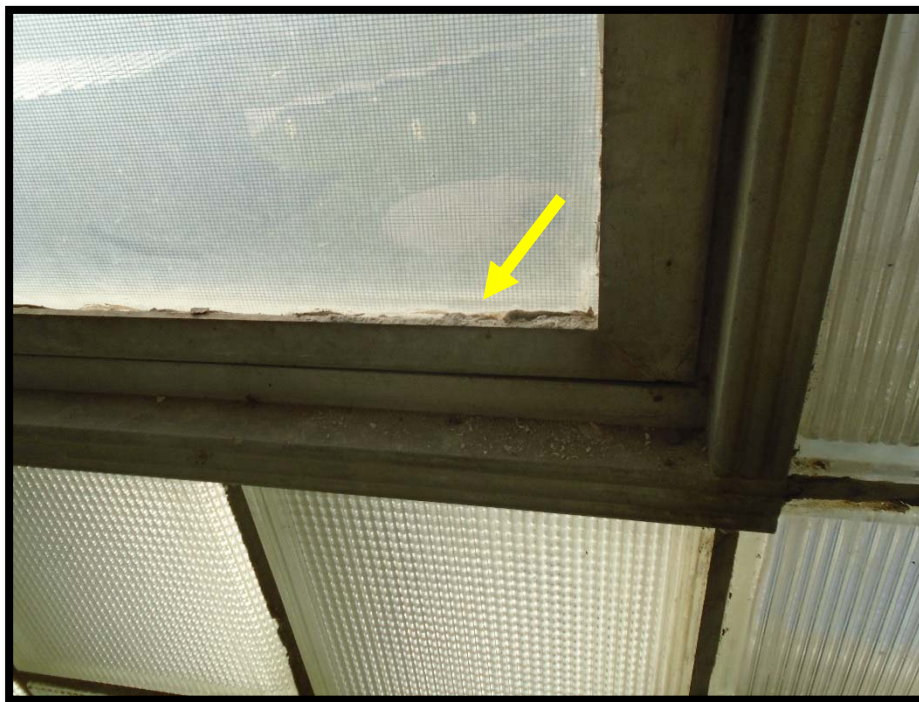
Grey Window Glazing

One (1) sample of white window caulking was collected during the assessment. A second layer described as grey window glazing was identified on the sample and this layer was found to contain 2.4% Chrysotile asbestos. Asbestos-containing grey window glazing (see Photograph 2 in Appendix B) was observed in the following locations:

- Room 100 (approximately 20 linear ft).

Photograph 2: Asbestos-Containing Grey Window Glazing Below White Caulking.

If scheduled for impact, asbestos-containing grey window glazing should be abated following low-risk abatement work procedures as outlined in the *Saskatchewan Asbestos Abatement Manual* (2017). Alternatively, as the grey window glazing was observed in good condition, and with a priority rating of 5 (please see the room by room spreadsheet provided in Appendix C for a description of the priority ratings), the glazing can be managed in place if not scheduled for impact.

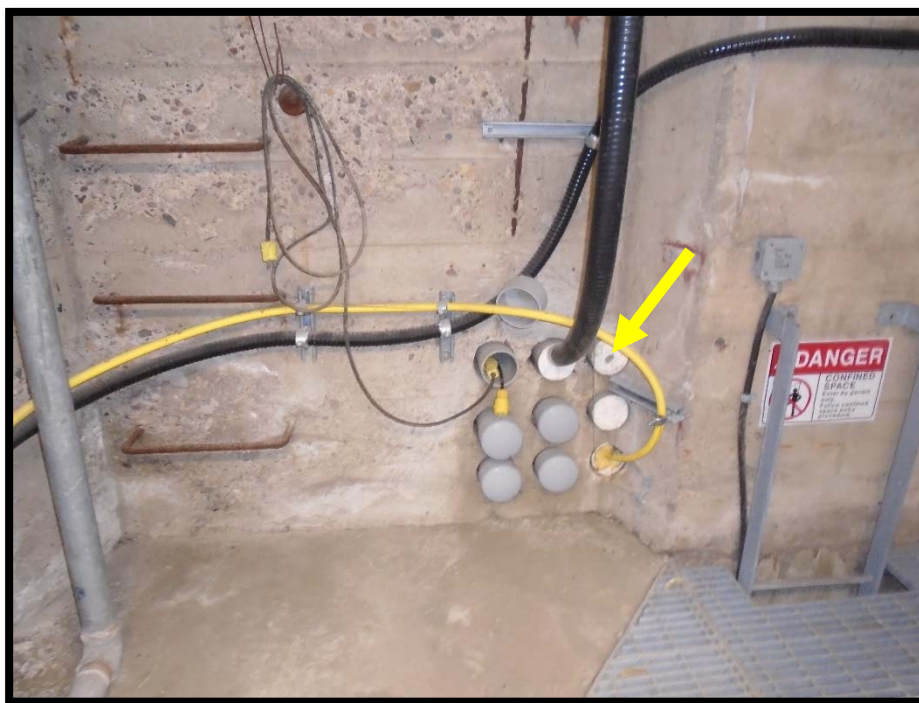
Yellow Insulation

One (1) sample of white firestop was collected during the assessment. A second layer described as yellow insulation was identified on the sample within the cable conduit and this layer was found to contain trace amounts of Chrysotile asbestos. Asbestos-containing yellow insulation (see Photograph 3 in Appendix B) was observed in the following locations:

- Lower Level (approximately 5 linear ft).

Photograph 3: Asbestos-Containing Yellow Insulation Inside Cable Conduit, Behind White Firestop

If scheduled for impact, asbestos-containing yellow insulation should be abated following low-risk abatement work procedures as outlined in the *Saskatchewan Asbestos Abatement Manual* (2017). Alternatively, as the yellow insulation was observed in good condition, and with a priority rating of 5 (please see the room by room spreadsheet provided in Appendix C for a description of the priority ratings), the insulation can be managed in place if not scheduled for impact.

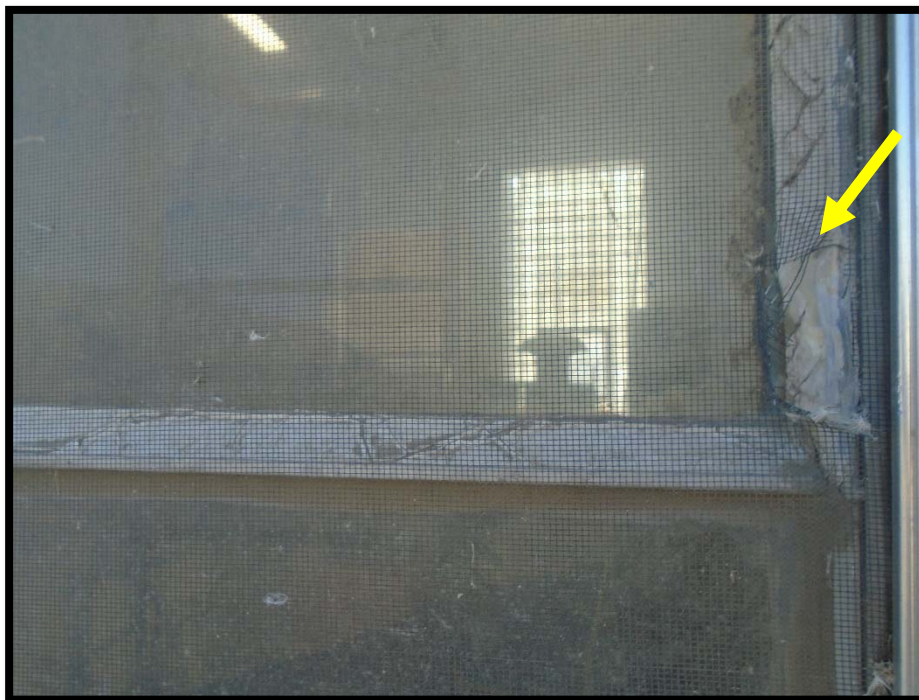
Exterior White Caulking on Window Panes

One (1) sample of exterior white window caulking on the window panes was collected during the assessment. The sample collected was found to contain 0.25% Tremolite asbestos. Asbestos-containing exterior white caulking (see Photograph 4 in Appendix B) was observed in the following locations:

- Exterior, on window panes (approximately 50 linear ft).

Photograph 4: Asbestos-Containing Exterior White Caulking on Window Pane

If scheduled for impact, asbestos-containing exterior white caulking should be abated following low-risk abatement work procedures as outlined in the *Saskatchewan Asbestos Abatement Manual* (2017). Alternatively, as the white caulking was observed in good condition, and with a priority rating of 5 (please see the room by room spreadsheet provided in Appendix C for a description of the priority ratings), the caulking can be managed in place if not scheduled for impact.

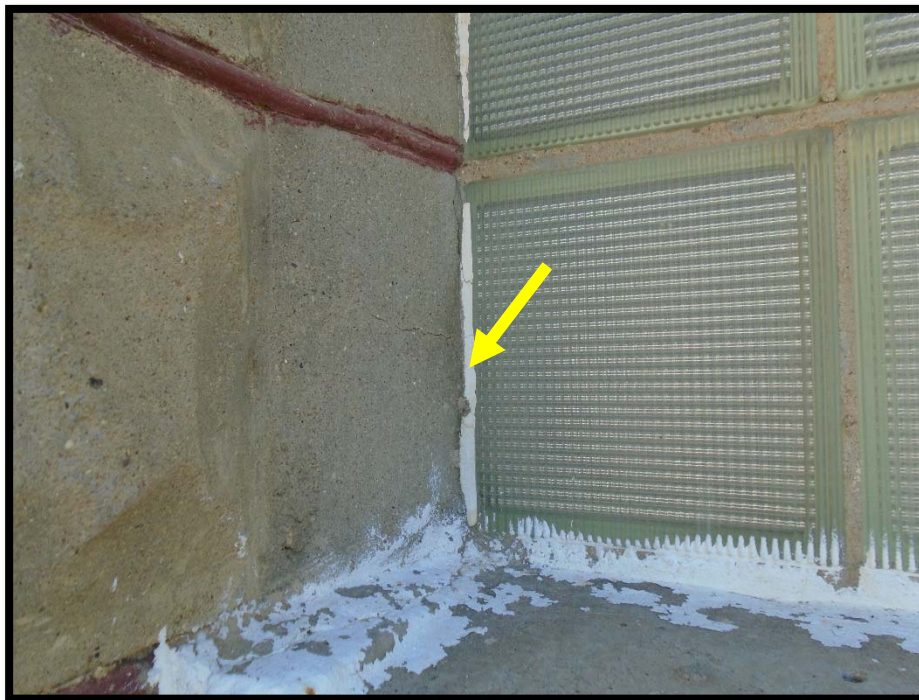
Exterior White Caulking on Cube Windows

One (1) sample of exterior white window caulking on the cube windows was collected during the assessment. The sample collected was found to contain 4.6% Chrysotile asbestos. Asbestos-containing exterior white caulking (see Photograph 5 in Appendix B) was observed in the following locations:

- Exterior, on cube windows (approximately 125 linear ft).

Photograph 5: Asbestos-Containing Exterior White Caulking on Cube Windows

If scheduled for impact, asbestos-containing exterior white caulking should be abated following low-risk abatement work procedures as outlined in the *Saskatchewan Asbestos Abatement Manual* (2017). Alternatively, as the white caulking was observed in good condition, and with a priority rating of 5 (please see the room by room spreadsheet provided in Appendix C for a description of the priority ratings), the caulking can be managed in place if not scheduled for impact.
