December 4, 2017

CITY OF SASKATOON

Asbestos-Containing Building Materials Assessment Report - Mayfair Lawn Bowling Clubhouse

Report Number: 1667963

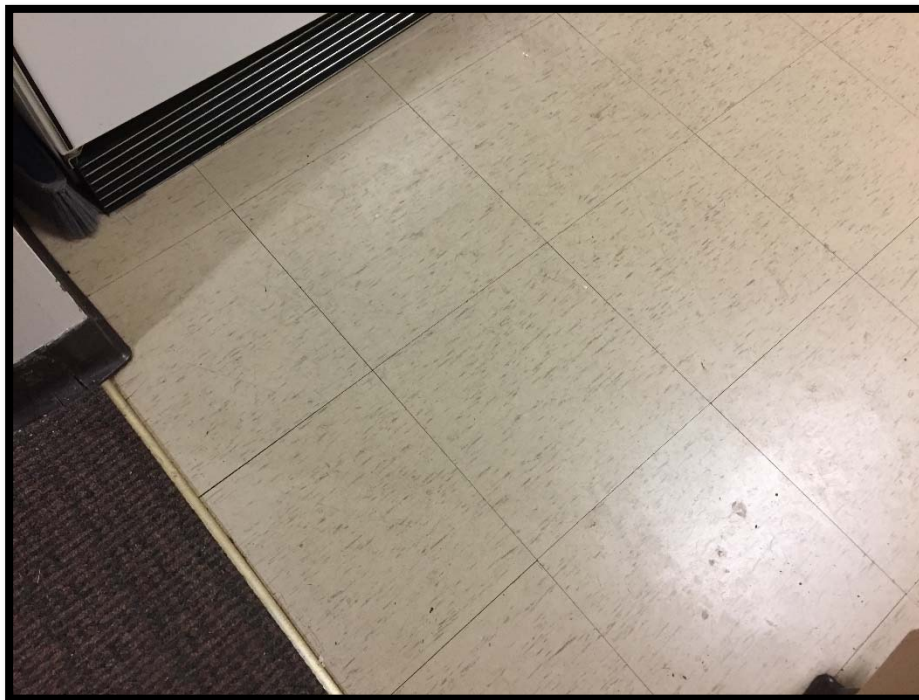
One (1) sample of 12"x12" beige floor tile with brown streaks was collected during the assessment. The sample collected was found to contain 2.3% Chrysotile asbestos. Asbestos-containing 12"x12" beige floor tile with brown streaks (see Photograph 1 in Appendix B) was observed in the following locations:

- Room 102 (approximately 230 ft²);
- Room 103 (approximately 35 ft²);
- Room 104 (approximately 150 ft²);
- Room 106 (approximately 40 ft²);
- Room 107 (approximately 150 ft²); and
- Room 108 (approximately 10 ft²).

Additional asbestos-containing 12"x12" beige floor tile with brown streaks may be located below the carpet in other areas of the Site.

Photograph 1: Asbestos-Containing 12"x12" Beige Floor Tile with Brown Streaks.

If scheduled for impact, asbestos-containing 12"x12" beige floor tile with brown streaks should be abated following low-risk abatement work procedures as outlined in the *Saskatchewan Asbestos Abatement Manual* (2017). Alternatively, as the 12"x12" beige floor tile with brown streaks was observed in good condition, and with a priority rating of 5 (please see the room by room spreadsheet provided in Appendix C for a description of the priority ratings), it can be managed in place if not scheduled for impact.

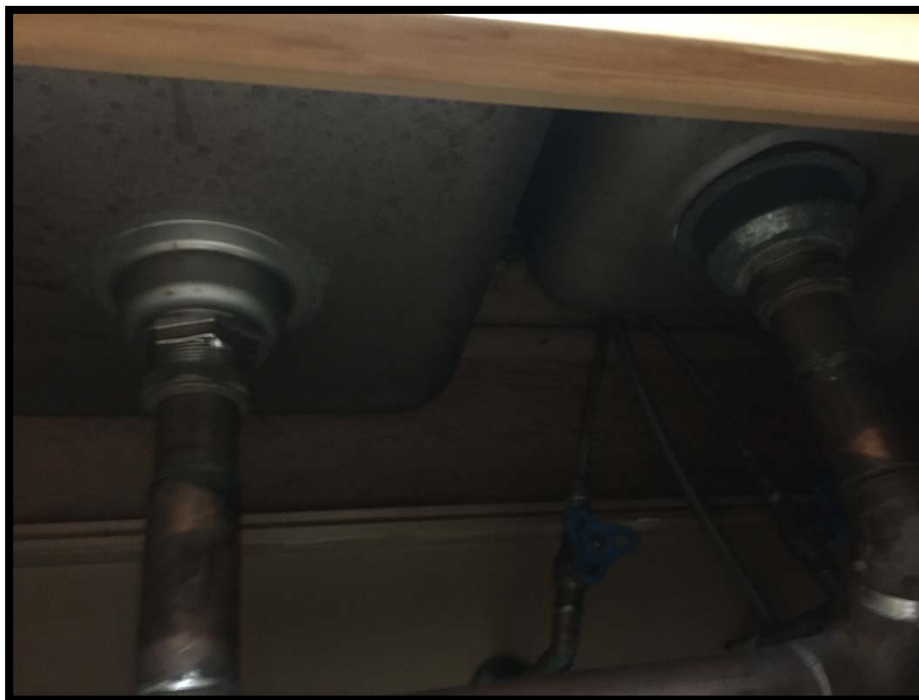
One (1) sample of silver sink undercoat was collected during the assessment. The sample collected was found to contain 1.7% Chrysotile asbestos. Asbestos-containing silver sink undercoat (see Photograph 2 in Appendix B) was observed in the following location:

- Room 102 (approximately 3 sinks).

Photograph 2: Asbestos-Containing Silver Sink Undercoat.

If scheduled for impact, asbestos-containing silver sink undercoat should be abated following low-risk abatement work procedures as outlined in the *Saskatchewan Asbestos Abatement Manual* (2017). Alternatively, as the silver sink undercoat was observed in good condition, and with a priority rating of 5 (please see the room by room spreadsheet provided in Appendix C for a description of the priority ratings), it can be managed in place if not scheduled for impact.
