July 12, 2017

CITY OF SASKATOON

# Asbestos-Containing Building Materials Assessment Report - Mayfair Library

**Report Number: 1667963**

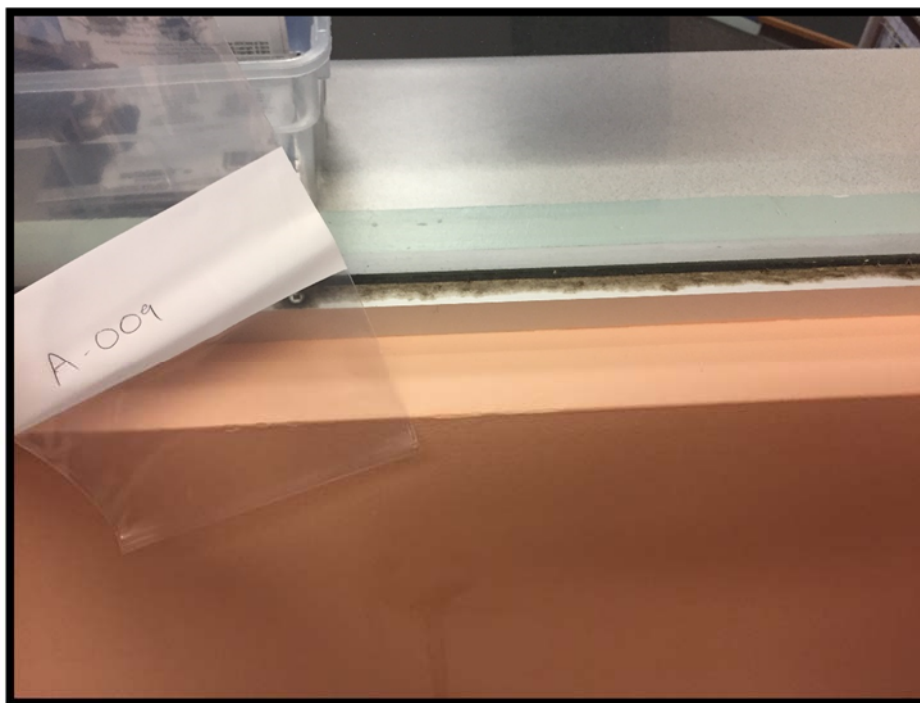
Two (2) samples of black window caulking were collected during the assessment. The samples collected were found to contain 1.8% to 1.9% Chrysotile asbestos. Asbestos-containing black window caulking (see Photographs 1 and 2 in Appendix B) were observed in the following locations:

- Room 103 (approximately 20 linear ft); and
- Washroom Vestibule (approximately 20 linear ft).

**Photograph 1: Asbestos-Containing Black Window Caulking.**

If scheduled for impact, asbestos-containing black window caulking should be abated following low-risk abatement work procedures as outlined in the *Saskatchewan Asbestos Abatement Manual (2017)*. Alternatively, as the black window caulking was observed in good condition, and with a priority rating of 5 (please see the room by room spreadsheet provided in Appendix C for a description of the priority ratings), it can be managed in place if not scheduled for impact.

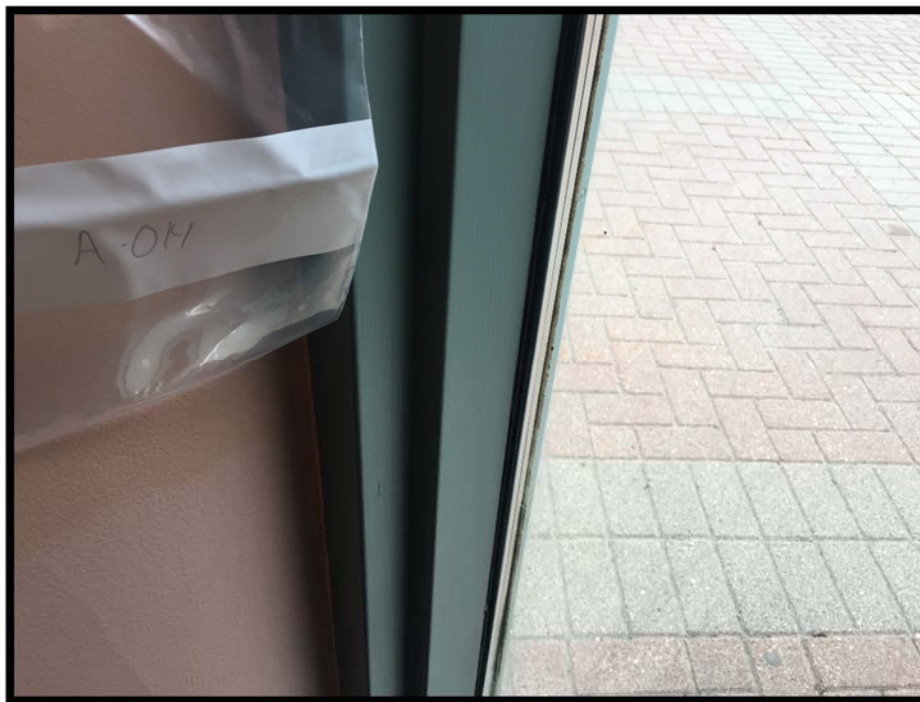
**Photograph 2: Asbestos-Containing Black Window Caulking.**
