CITY OF SASKATOON

Asbestos-Containing Building Materials Assessment Report - Meewasin Park Pavilion

Report Number: 1667963

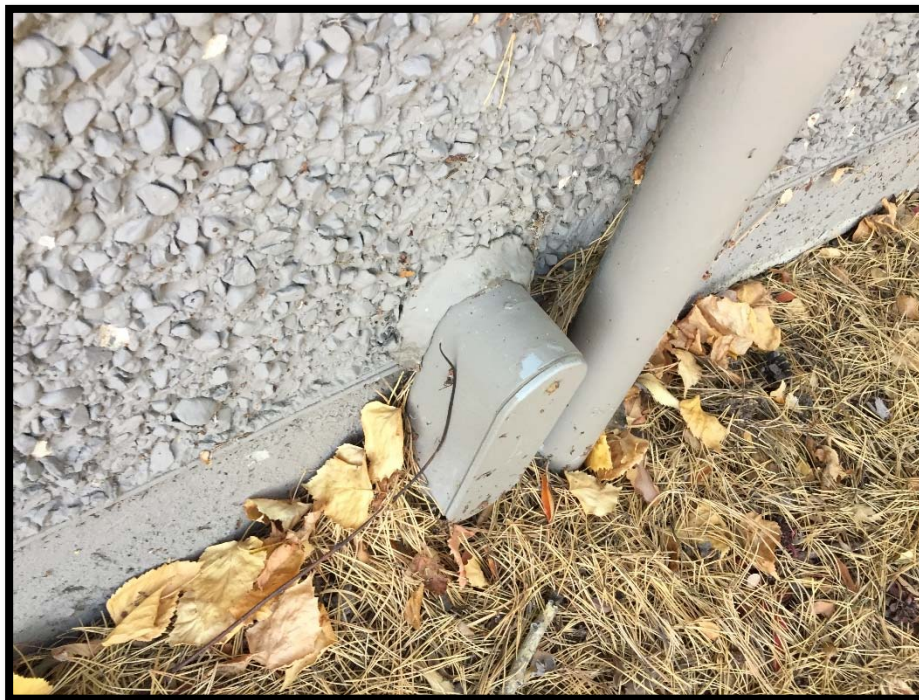
One (1) sample of brown firestop was collected during the assessment. The sample collected was found to contain 10% Chrysotile asbestos. Asbestos-containing brown firestop (see Photograph 1 in Appendix B) was observed in the following locations:

- Exterior (approximately 2 ft²).

Photograph 1: Asbestos-Containing Brown Firestop.

If scheduled for impact, asbestos-containing brown firestop should be abated following low-risk abatement work procedures as outlined in the *Saskatchewan Asbestos Abatement Manual* (2017). Alternatively, as the brown firestop was observed in good condition, and with a priority rating of 5 (please see the room by room spreadsheet provided in Appendix C for a description of the priority ratings), it can be managed in place if not scheduled for impact.
