July 14, 2017

CITY OF SASKATOON

# Asbestos-Containing Building Materials Assessment Report - Mendel Park Site Washrooms

**Report Number: 1667963**

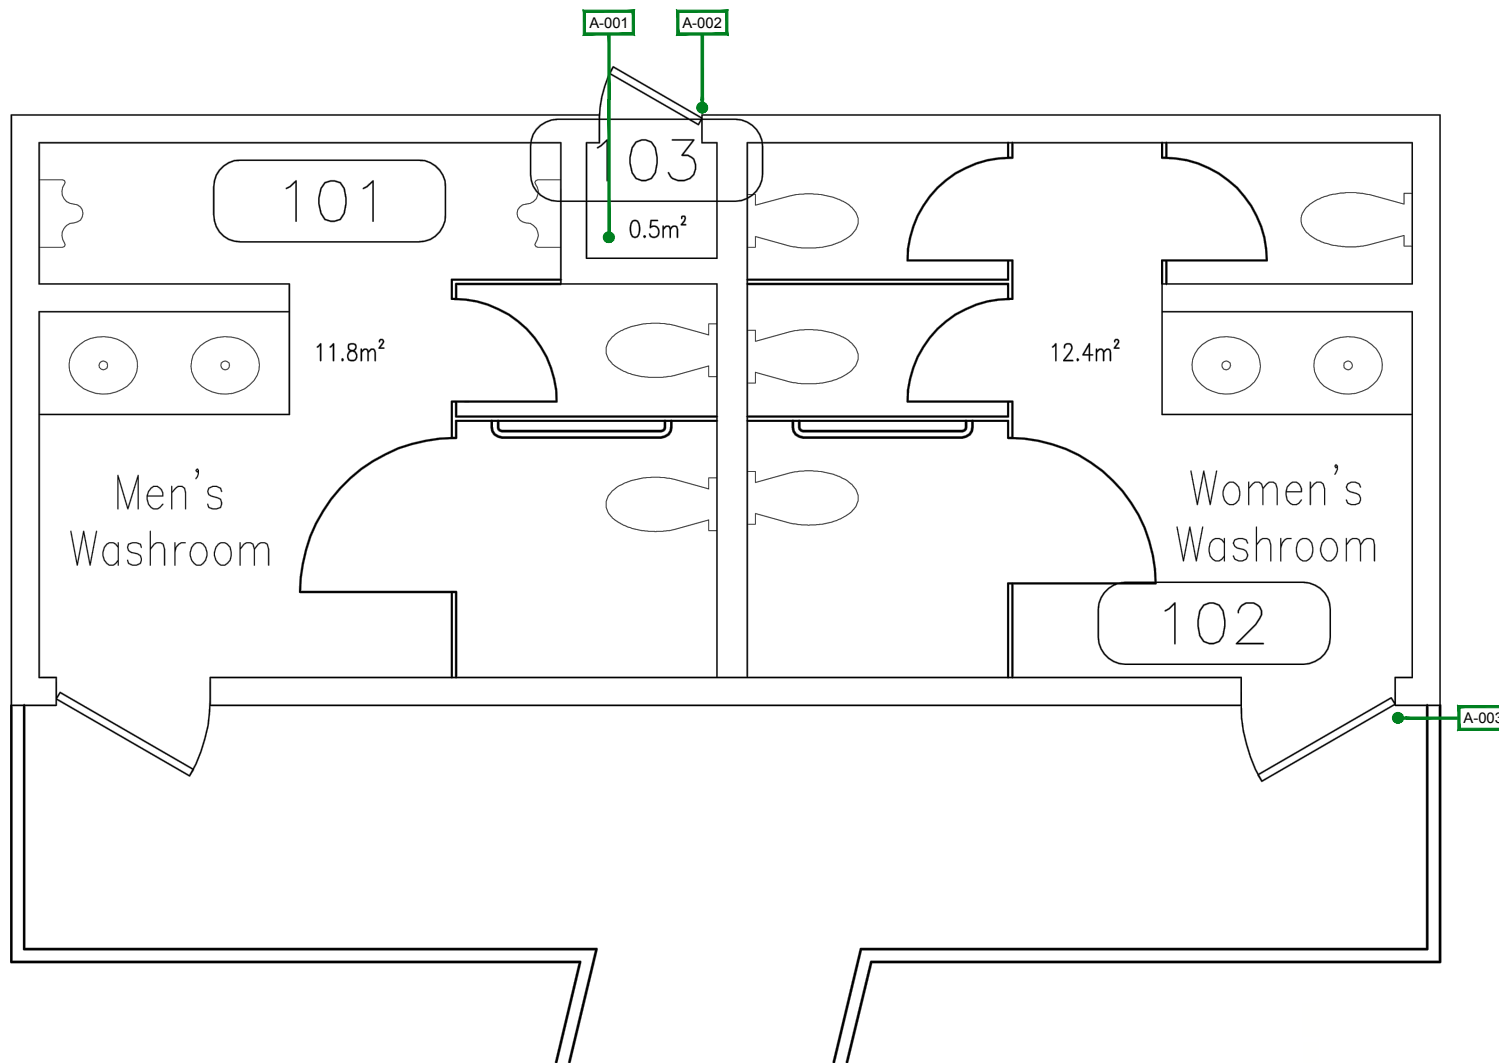
FIGURE  
1

1. ASBESTOS IS A CARCINOGEN. DO NOT BREATHE ASBESTOS DUST.
2. ASBESTOS-CONTAINING MATERIALS WERE NOT OBSERVED WITHIN THE WASHROOMS AT THE TIME OF THE ASSESSMENT.
