July 14, 2017

CITY OF SASKATOON

Asbestos-Containing Building Materials Assessment Report - Nicholson Yards Lunch Trailer

Report Number: 1667963

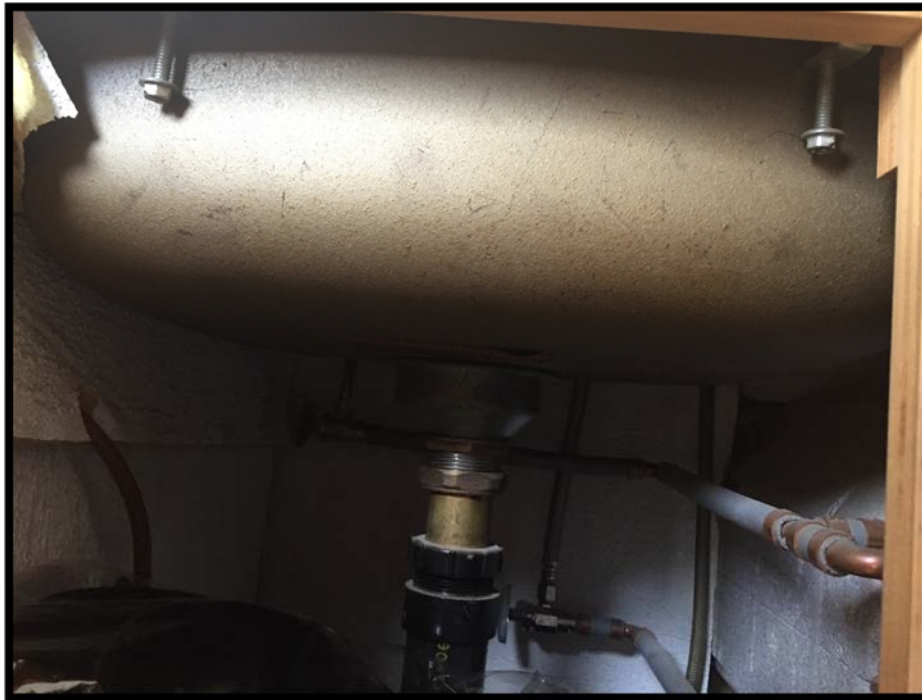
One (1) sample of gold sink undercoat was collected during the assessment. The sample collected was found to contain 4.1% Chrysotile asbestos. Asbestos-containing gold sink undercoat (see Photograph 1 in Appendix B) was observed in the following location:

- Room 100 (approximately 1 sink); and
- Room 101 (approximately 1 sink).

Photograph 1: Asbestos-Containing Gold Sink Undercoat.

If scheduled for impact, sinks with asbestos-containing gold undercoat should be abated following low-risk abatement work procedures as outlined in the *Saskatchewan Asbestos Abatement Manual* (2017). Alternatively, as the gold sink undercoat was observed in good condition, and with a priority rating of 5 (please see the room by room spreadsheet provided in Appendix C for a description of the priority ratings), it can be managed in place if not scheduled for impact.

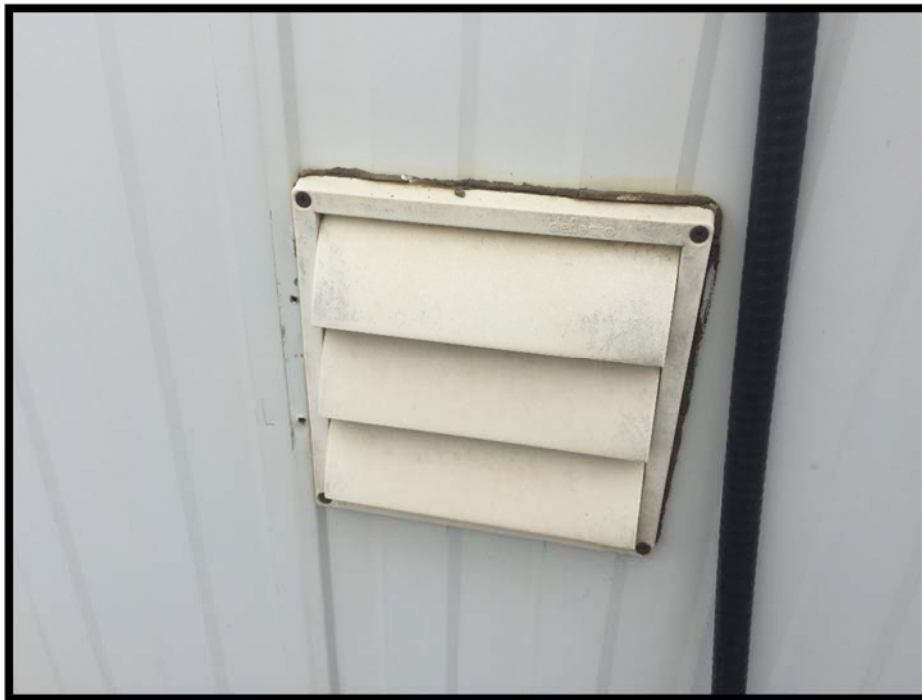
One (1) sample of brown building caulking was collected during the assessment. The sample collected was found to contain 6.7% Chrysotile asbestos. Asbestos-containing brown building caulking (see Photograph 2 in Appendix B) was observed in the following location:

- Exterior (approximately 24 linear ft).

Photograph 2: Asbestos-Containing Brown Building Caulking.

If scheduled for impact, asbestos-containing brown building caulking should be abated following low-risk abatement work procedures as outlined in the *Saskatchewan Asbestos Abatement Manual* (2017). Alternatively, as the brown building caulking was observed in good condition, and with a priority rating of 5 (please see the room by room spreadsheet provided in Appendix C for a description of the priority ratings), it can be managed in place if not scheduled for impact.

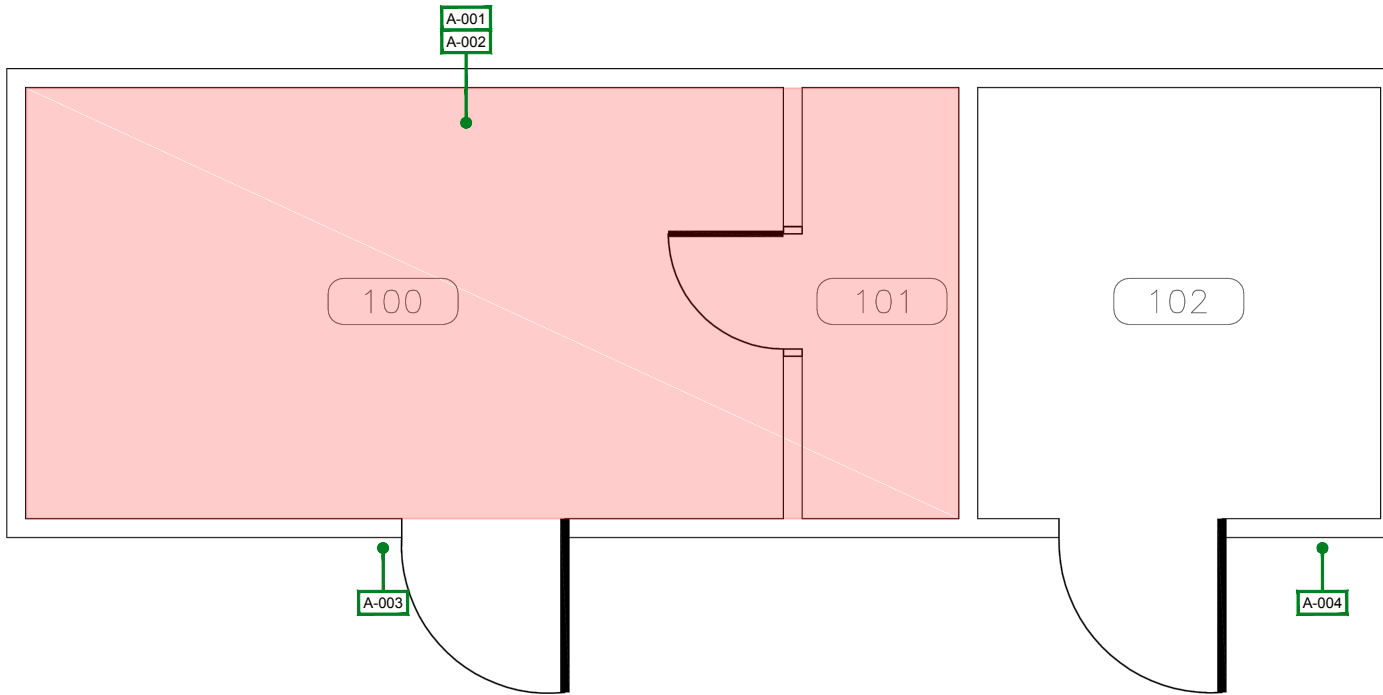
FIGURE
1

1. ASBESTOS IS A CARCINOGEN. DO NOT BREATHE ASBESTOS DUST.
2. ASBESTOS-CONTAINING BROWN BUILDING CAULKING IS LOCATED ALONG THE EXTERIOR OF THE BUILDING.
