August 25, 2017

CITY OF SASKATOON

# Asbestos-Containing Building Materials Assessment Report - North Central Substation/Electrical Transformer Building

**Report Number: 1667963**

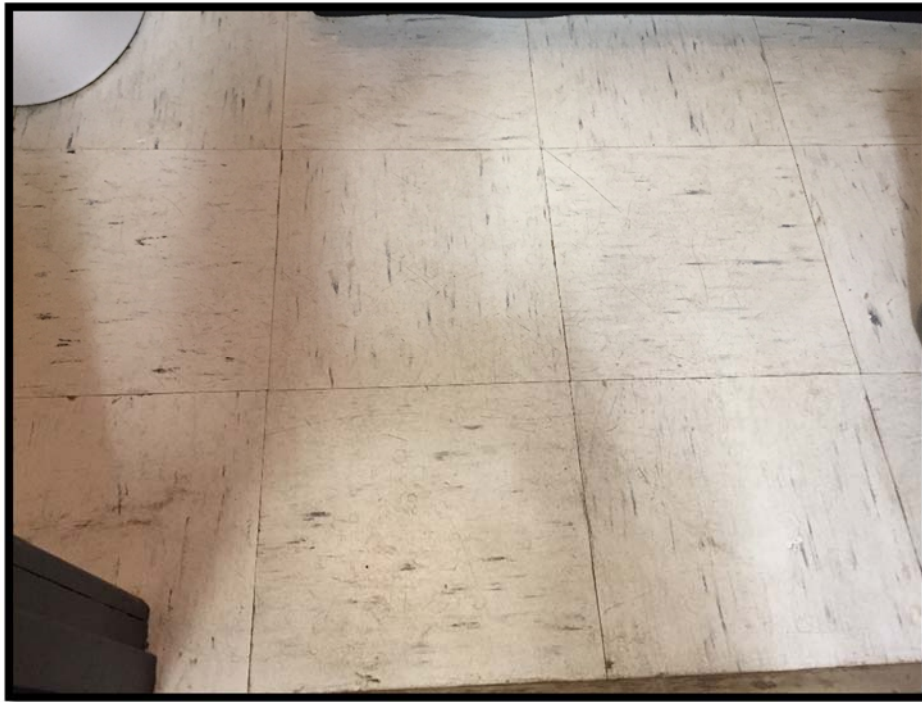
One (1) sample of 1'x1' off-white floor tile with black flecks was collected during the assessment. The sample collected was found to contain trace Chrysotile asbestos. Asbestos-containing 1'x1' off-white floor tile with black flecks (see Photograph 1 in Appendix B) was observed in the following locations:

- Room 106 (approximately 50 ft<sup>2</sup>).

Asbestos was positively identified within the 1'x1' off-white floor tile with black flecks on Site. Asbestos was not identified in the remaining samples collected and analyzed.

**Photograph 1: Asbestos-Containing 1'x1' Off-White Floor Tile with Black Flecks.**

If scheduled for impact, asbestos-containing 1'x1' off-white floor tile with black flecks should be abated following low-risk abatement work procedures as outlined in the *Saskatchewan Asbestos Abatement Manual (2017)*. Alternatively, as the 1'x1' off-white floor tiles with black flecks were observed in good condition, and with a priority rating of 5 (please see the room by room spreadsheet provided in Appendix C for a description of the priority ratings), the tiles can be managed in place if not scheduled for impact.

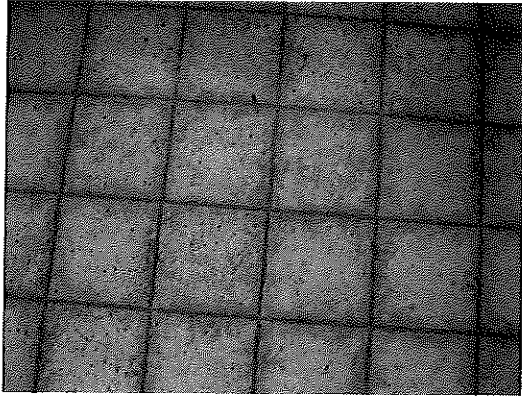
#1) Sheet Flooring

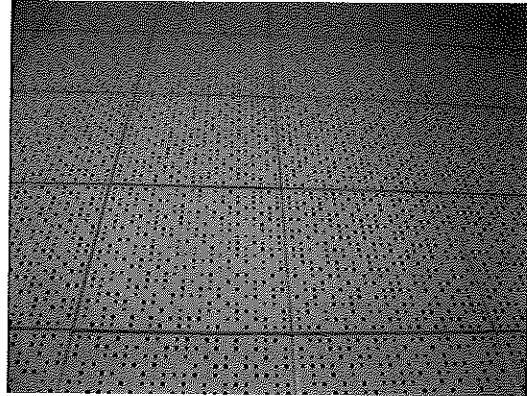
#2/3) Wall/ Ceiling  
Board
