**City of Saskatoon  
Nutana Kiwanis Maintenance / Office Buildings  
Asbestos Survey Report**

**December 2015**

**Prepared By: Bersch & Associates Ltd.  
Project No. : B67SRL17**

**Project: Nutana Kiwanis Maintenance Office – 2235 McEown Ave – Installation of Central Vacuum System**

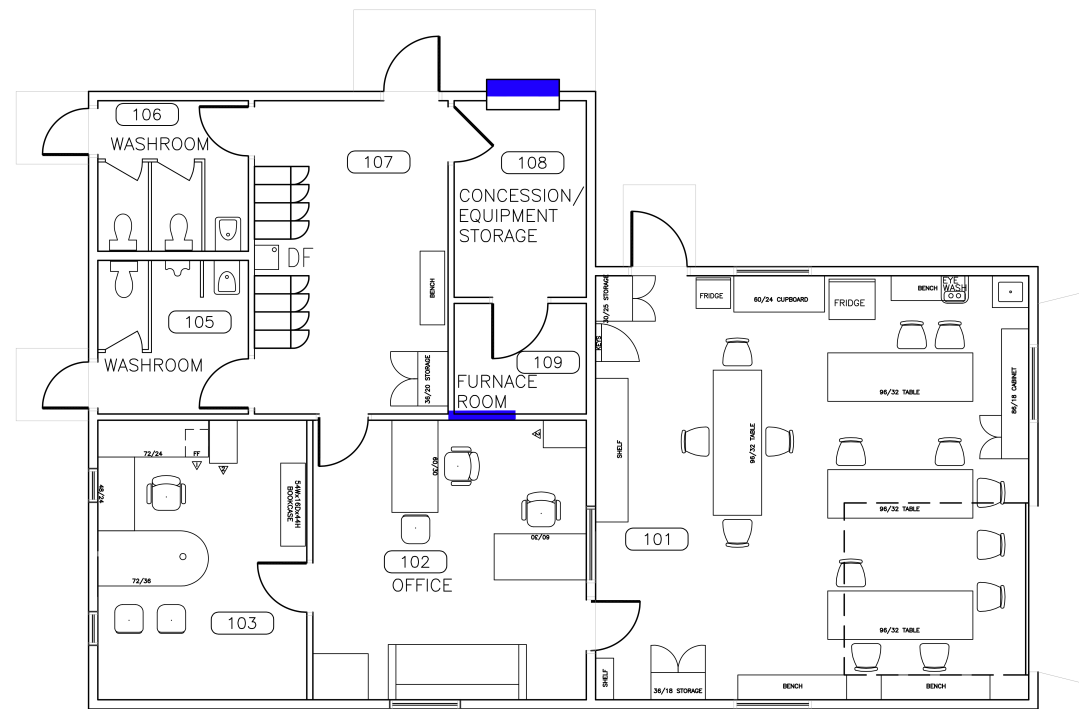
FACILITY #904.002

- **Transite Board** has been identified within the Nutana Kiwanis Maintenance Office Building. The samples were collected from the 109 Furnace Room and the sill on the exterior west wall of 108 Concession Equipment Storage.

M		Exterior Office	Sample	B67-ASB.3	17/12/2015	Chrysotile	25	Transite Board	Good	3	Office Building #904.002 - Exterior Of 108 Concession Equip. Storage Room - Transite Board On The Sill On The West Wall.	Transite Board	Low	Manage	The Transite Board Is Located On The Exterior Sill Of The Concession Wall Opening.
M	110	Maintenance Shop										No Accessible ACM			
M	111	Mechanical Room										No Accessible ACM			
M	112	Tool Storage										No Accessible ACM			
M	113	Office										No Accessible ACM

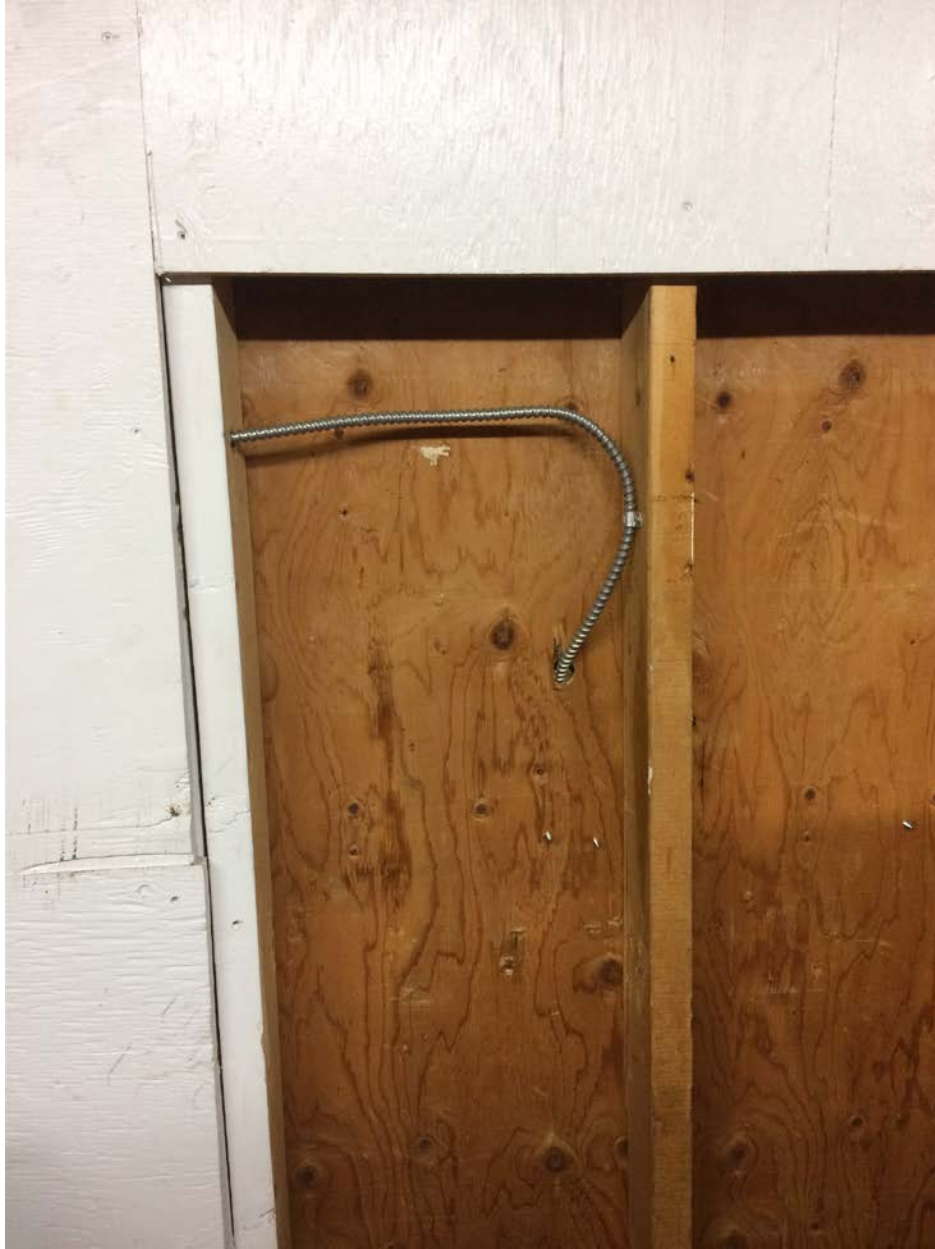
Based on observations during the site visit, there is no asbestos concern regarding the proposed renovations within the maintenance shop.

**Figure 1- Wall adjoining storage room and maintenance shop where vacuum is to be mounted.**

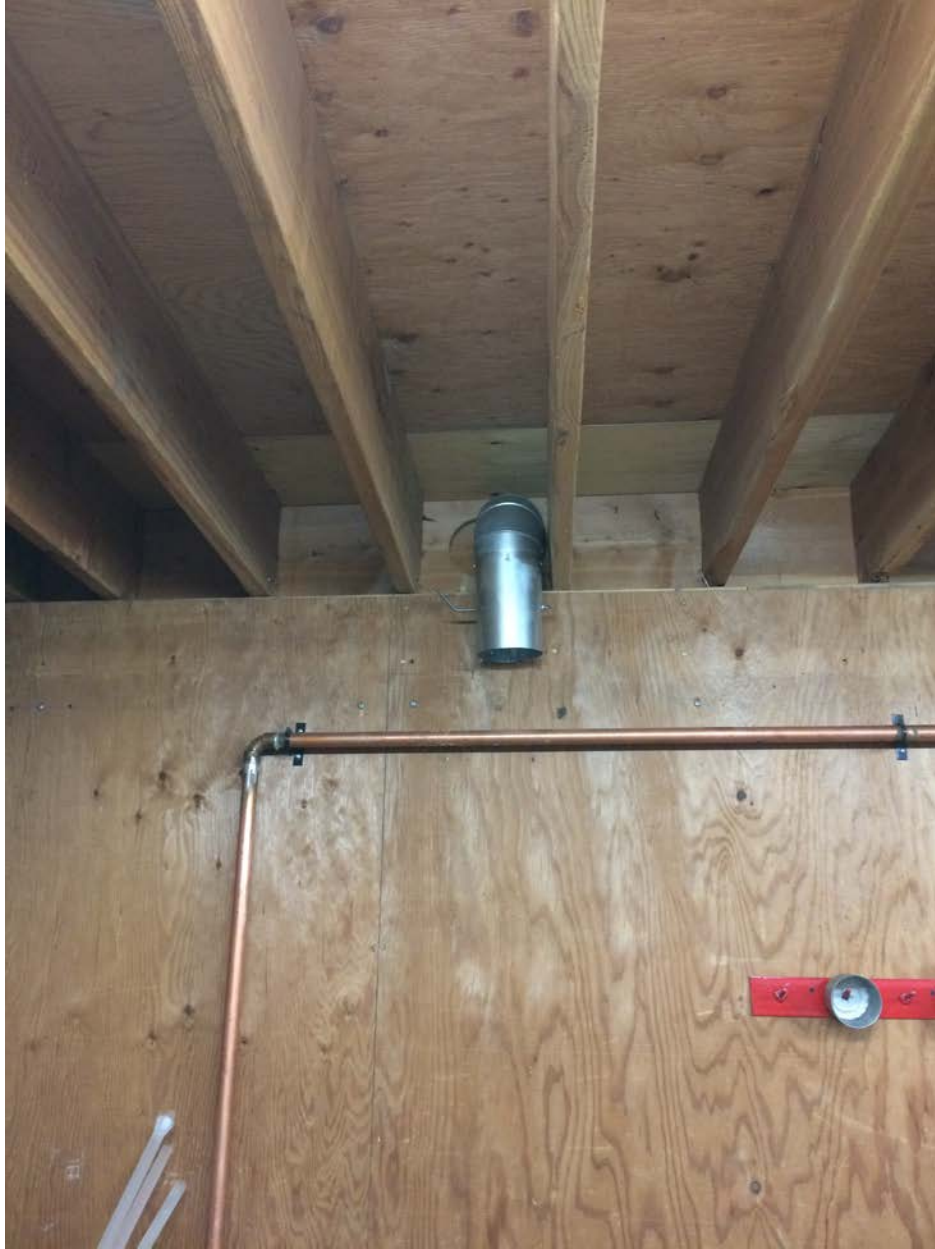
Figure 2- Exterior wall of storage room showing existing vent to be used.

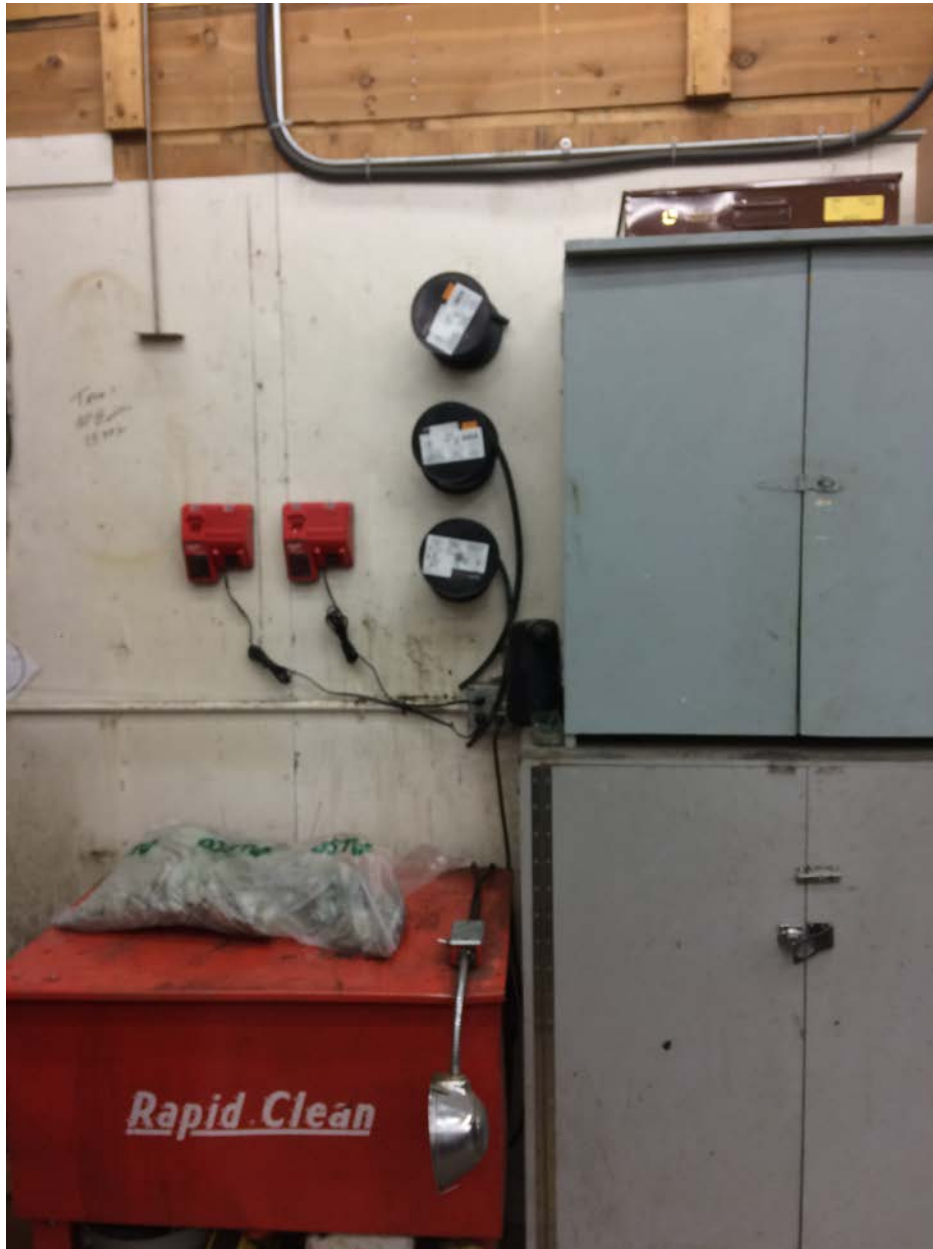
Figure 3- Wall adjoining maintenance shop and storage room.
