## CITY OF SASKATOON

# Asbestos-Containing Building Materials Assessment Report - Nutana Lawn Bowling Clubhouse

**Report Number: 1667963**

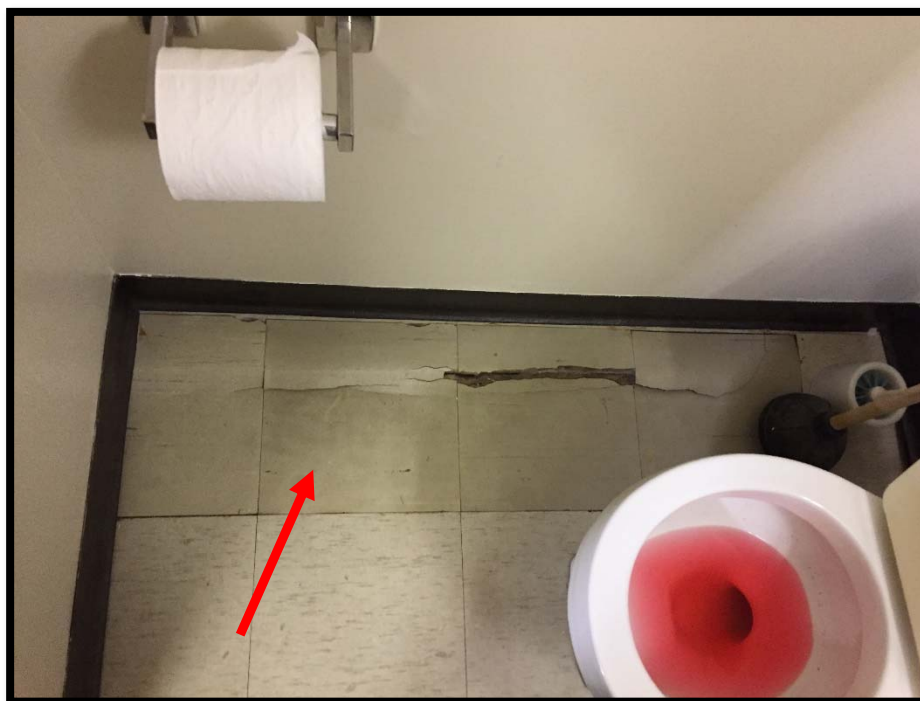
One (1) sample of 12"x12" beige floor tile with black and white streaks was collected during the assessment. The sample collected was found to contain 0.75% Chrysotile asbestos. Asbestos-containing 12"x12" beige floor tile with black and white streaks (see Photograph 1 in Appendix B) was observed in the following locations:

- Room 100 (approximately 200 ft<sup>2</sup>);
- Room 103 (approximately 4 ft<sup>2</sup>); and
- Room 106 (approximately 2 ft<sup>2</sup>).

Additional asbestos-containing 12"x12" beige floor tile with black and white streaks may be located below the carpet in other areas of the Site. Please note the asbestos-containing 12"x12" beige floor tile with black and white streaks was observed to be in poor condition within Room 103.

**Photograph 1: Asbestos-Containing 12"x12" Beige Floor Tile with Black and White Streaks.**

The asbestos-containing 12"x12" beige floor tiles with black and white streaks in poor condition within Room 103 should be abated following low-risk abatement work procedures as outlined in the *Saskatchewan Asbestos Abatement Manual* (2017).

If the remaining asbestos-containing 12"x12" beige floor tile with black and white streaks are scheduled for impact, they should be abated following low-risk abatement work procedures as outlined in the *Saskatchewan Asbestos Abatement Manual* (2017). Alternatively, as the 12"x12" beige floor tile with black and white streaks observed in good condition were given a priority rating of 5 (please see the room by room spreadsheet provided in Appendix C for a description of the priority ratings), they can be managed in place if not scheduled for impact.

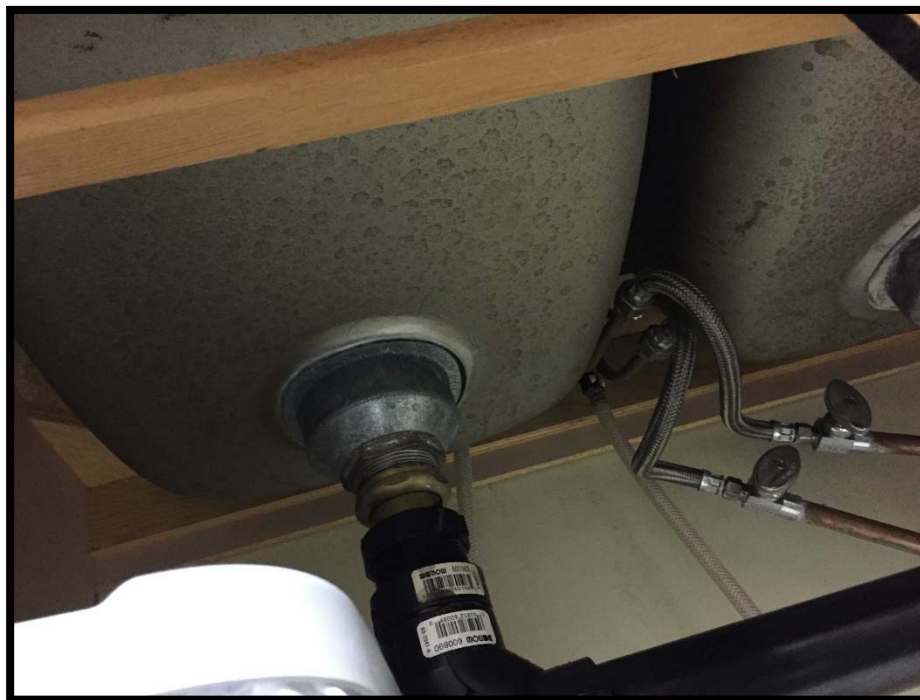
One (1) sample of silver sink undercoat was collected during the assessment. The sample collected was found to contain 1.6% Chrysotile asbestos. Asbestos-containing silver sink undercoat (see Photograph 2 in Appendix B) was observed in the following location:

- Room 106 (approximately 2 sinks).

**Photograph 2: Asbestos-Containing Silver Sink Undercoat.**

If scheduled for impact, asbestos-containing silver sink undercoat should be abated following low-risk abatement work procedures as outlined in the *Saskatchewan Asbestos Abatement Manual* (2017). Alternatively, as the silver sink undercoat was observed in good condition, and with a priority rating of 5 (please see the room by room spreadsheet provided in Appendix C for a description of the priority ratings), they can be managed in place if not scheduled for impact.
