CITY OF SASKATOON

Asbestos-Containing Building Materials Assessment Report - Nutana Lawn Bowling Storage Garage

Report Number: 1667963

Asbestos-Containing Building Materials Assessment Report - Nutana Lawn Bowling Storage Shed

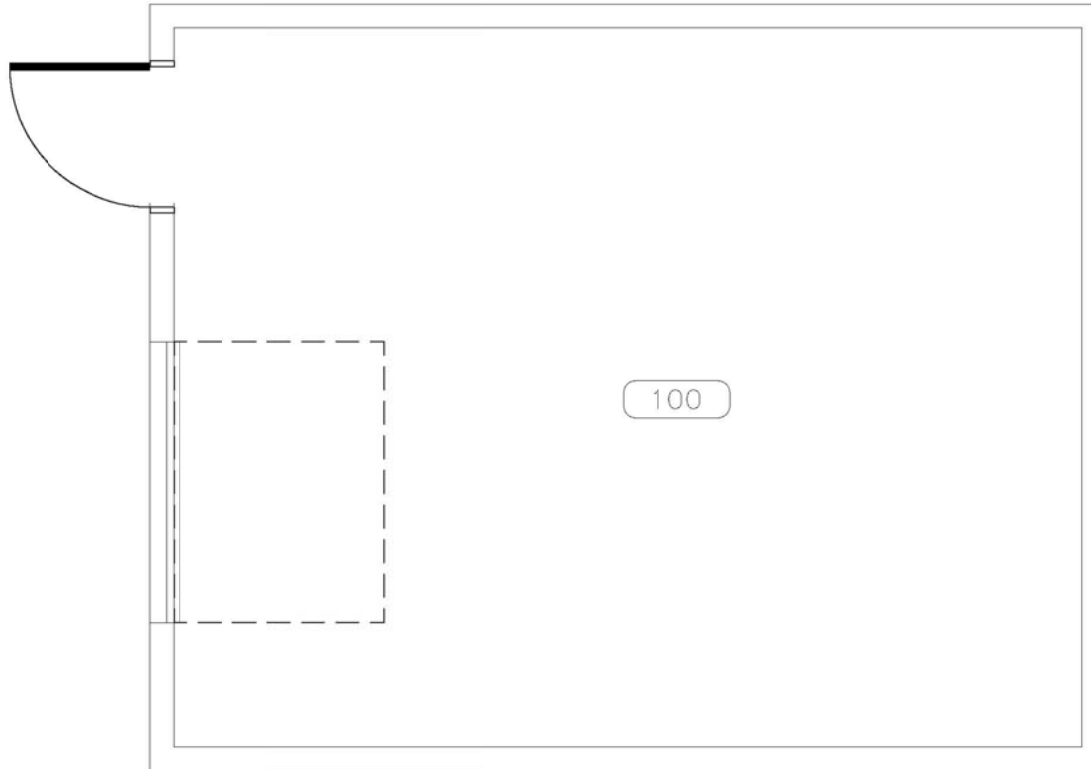
TITLE
STORAGE GARAGE

1. ASBESTOS IS A CARCINOGEN. DO NOT BREATHE ASBESTOS DUST.
2. ASBESTOS-CONTAINING MATERIALS WERE NOT OBSERVED WITHIN THE GARAGE AT THE TIME OF THE ASSESSMENT.

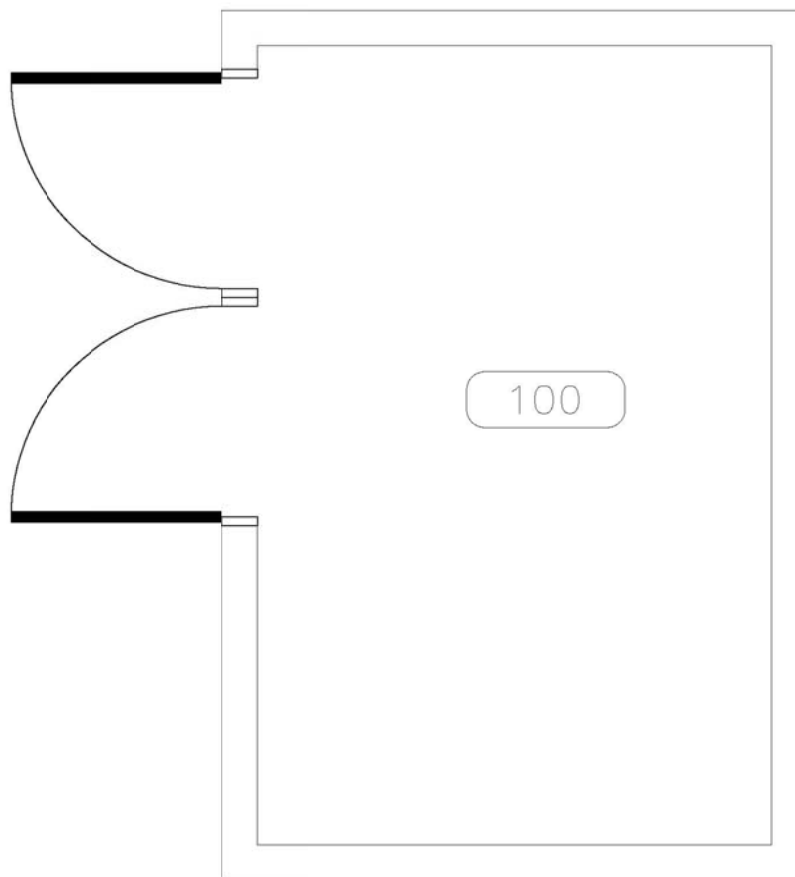
TITLE
STORAGE SHED

1. ASBESTOS IS A CARCINOGEN. DO NOT BREATHE ASBESTOS DUST.
2. ASBESTOS-CONTAINING MATERIALS WERE NOT OBSERVED WITHIN THE SHED AT THE TIME OF THE ASSESSMENT.

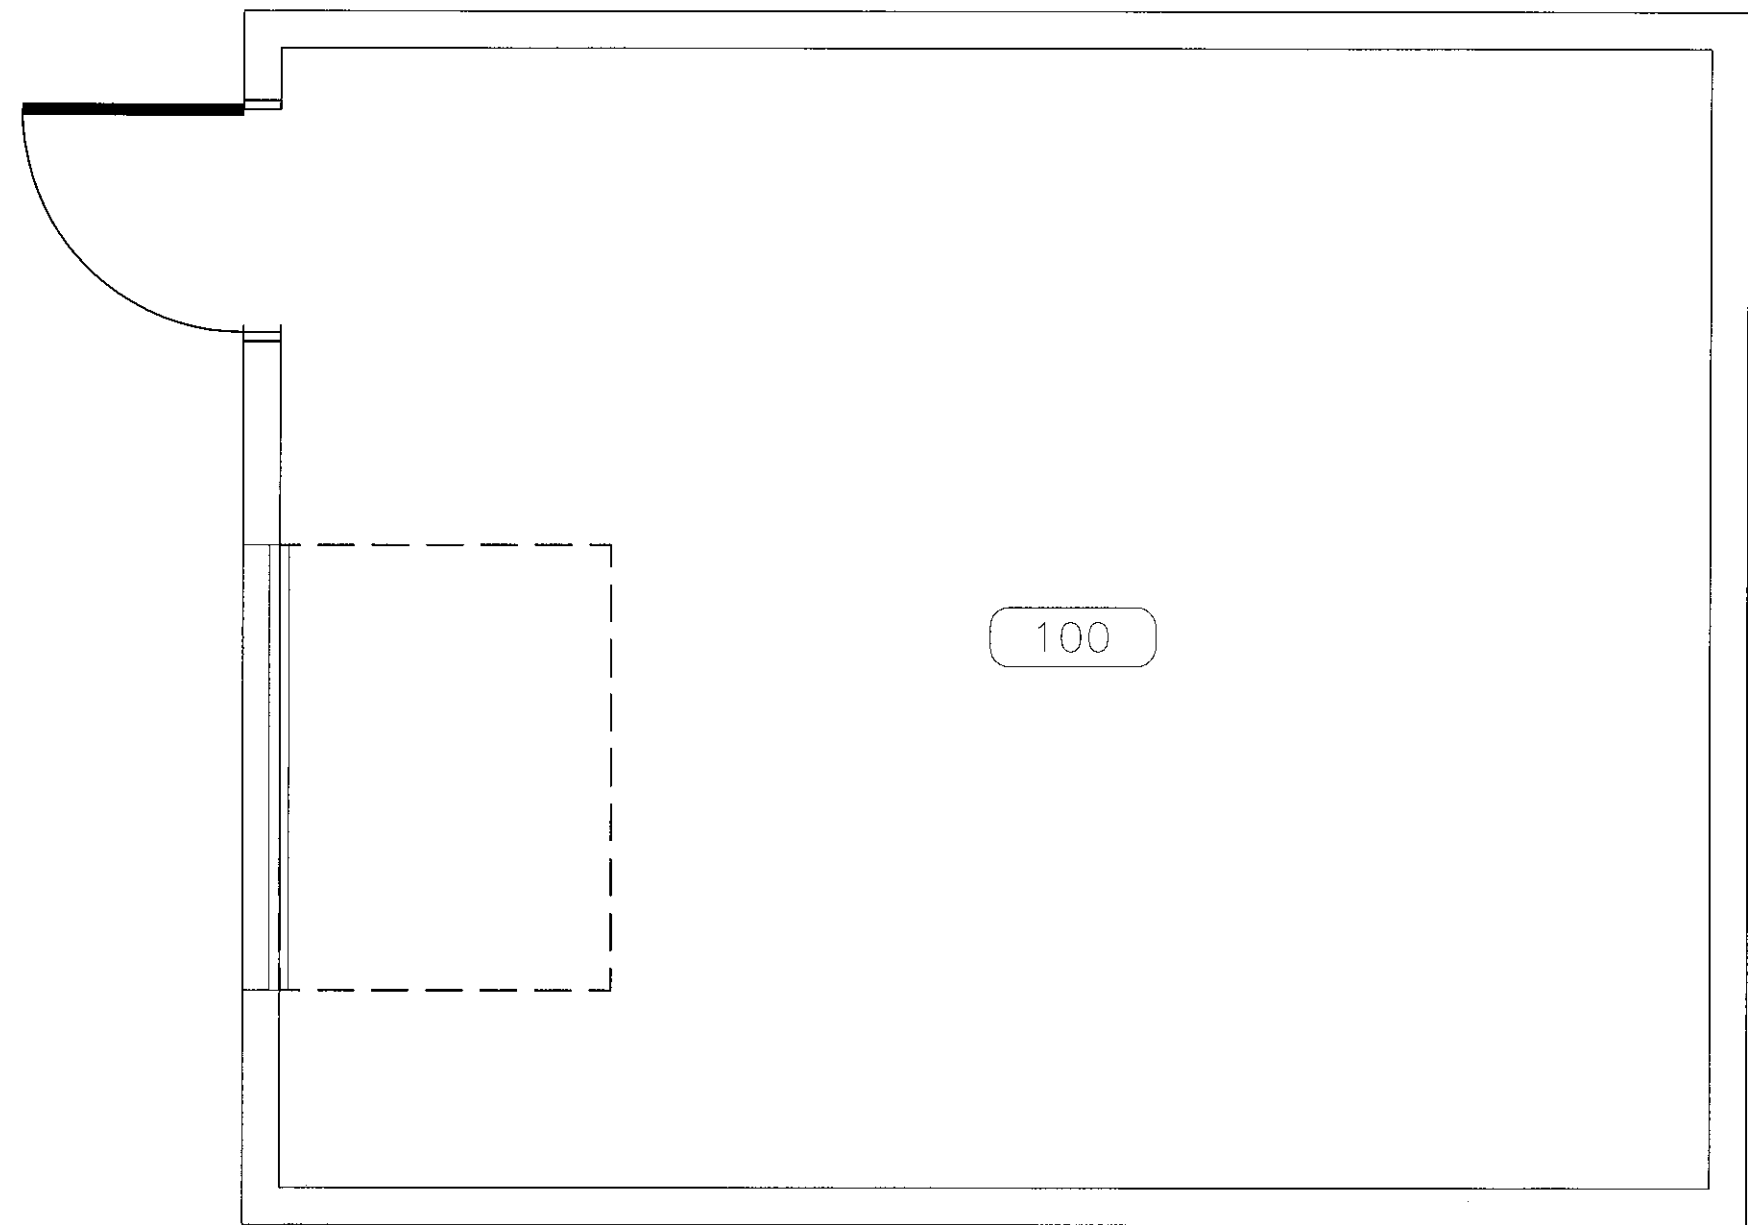
SHEET NAME
Storage Garage
Base Plan

No suspect asbestos-containing materials were observed during the assessment.

Notes: 1) Asbestos is a carcinogen. Avoid breathing dust.
2) No suspect asbestos-containing materials were observed on site during the assessment.
