November 3, 2017

CITY OF SASKATOON

# Asbestos-Containing Building Materials Assessment Report - Parc Canada Rec Unit

**Report Number: 1667963**

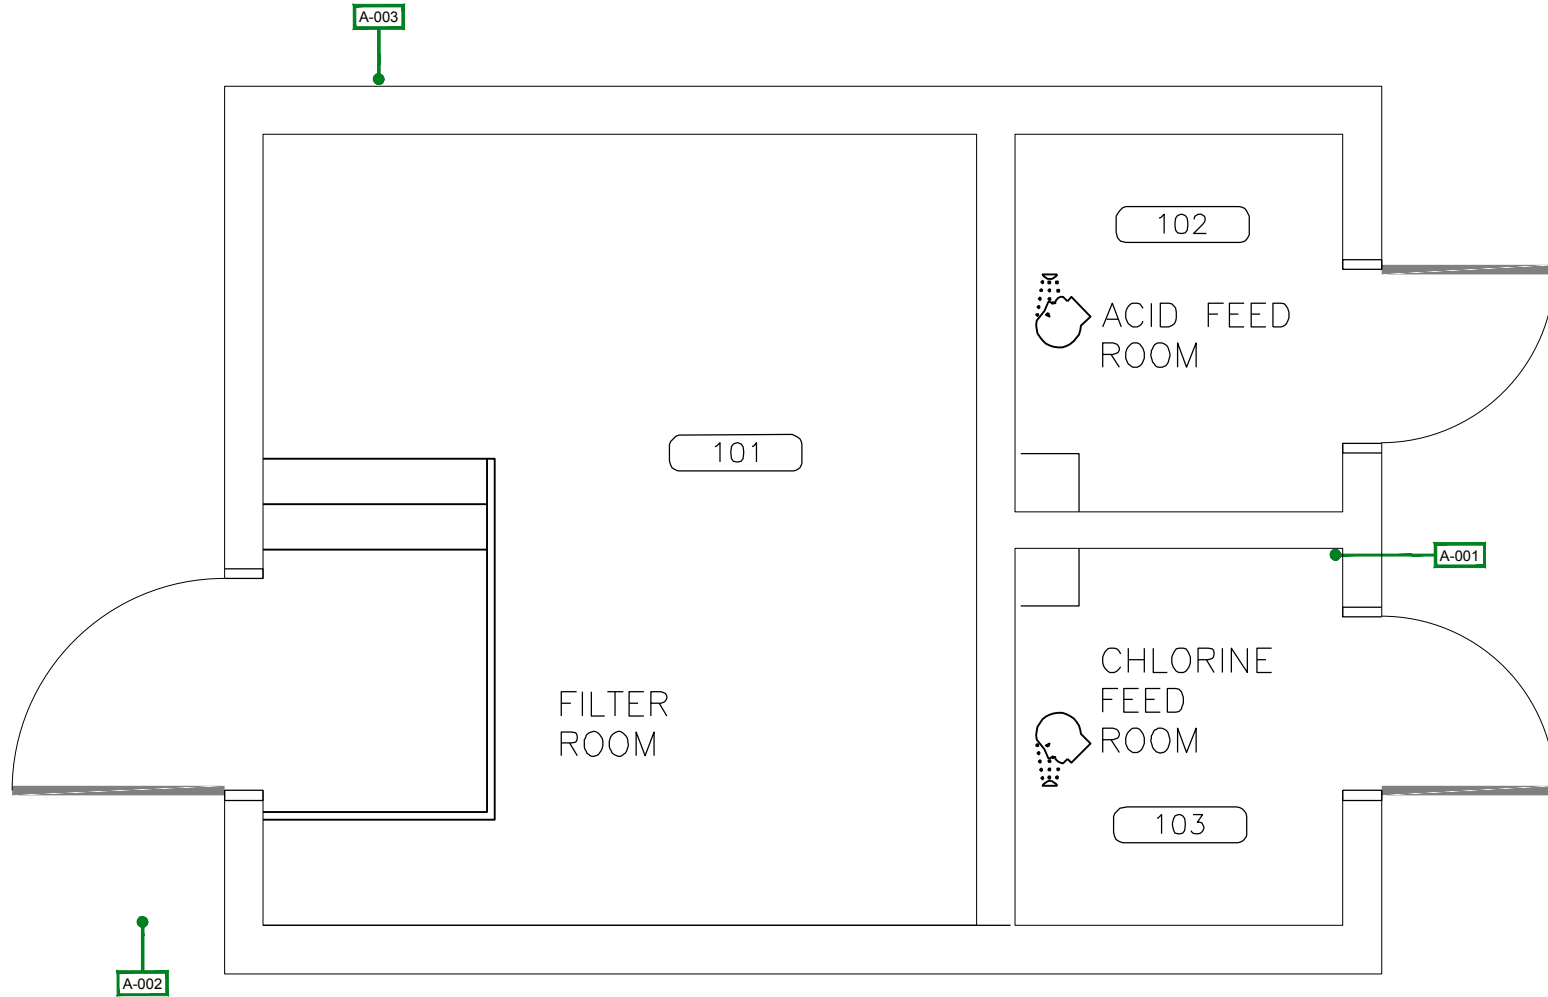
TITLE  
**MAIN FLOOR**

**NOTE(S)**  
 1. ASBESTOS IS A CARCINOGEN. DO NOT BREATHE ASBESTOS DUST.  
 2. ASBESTOS-CONTAINING MATERIALS WERE NOT OBSERVED ON SITE DURING THE ASSESSMENT.
